Surveillance of the banks of reservoirs on the Drava River in Slovenia after extensive floods

Pavel Žvanut*¹

¹Slovenian National Building and Civil Engineering Institute, Ljubljana, Slovenia

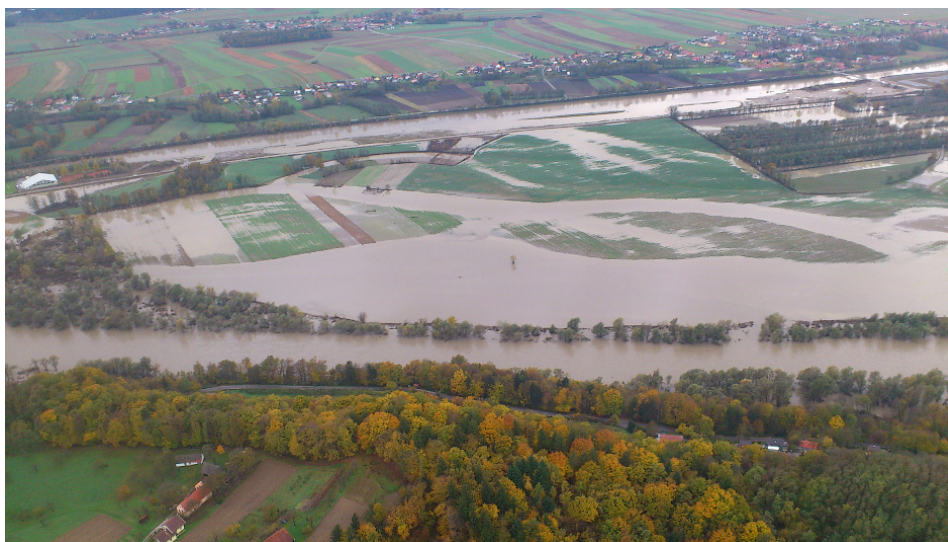
The worst floods were caused by the Drava River (in the middle and lower reaches of the river; see Fig. 6), which - also due to the extremely increased inflow from Austria on 5th November in the morning - rose sharply and reached record flows. The extremely high flows of the Drava River (i.e. more than 2600 m³/s at the Dravograd Dam, whereas at the border with Croatia the flow was even estimated at about 3000 m³/s; see Fig. 7) greatly exceeded the flow of the Drava River just before this event, which was about 500 m³/s at the Dravograd Dam, and also exceeded 100-year return period of flood event (see Fig. 8) [9-11].

Fig. 6. Extensive floods of the Drava River in Hajdoše near Ptuj (downstream from Zlatoličje HPP) on the 6th November 2012 at 10:50 CET (Photo: Prlekija on net photo archive).

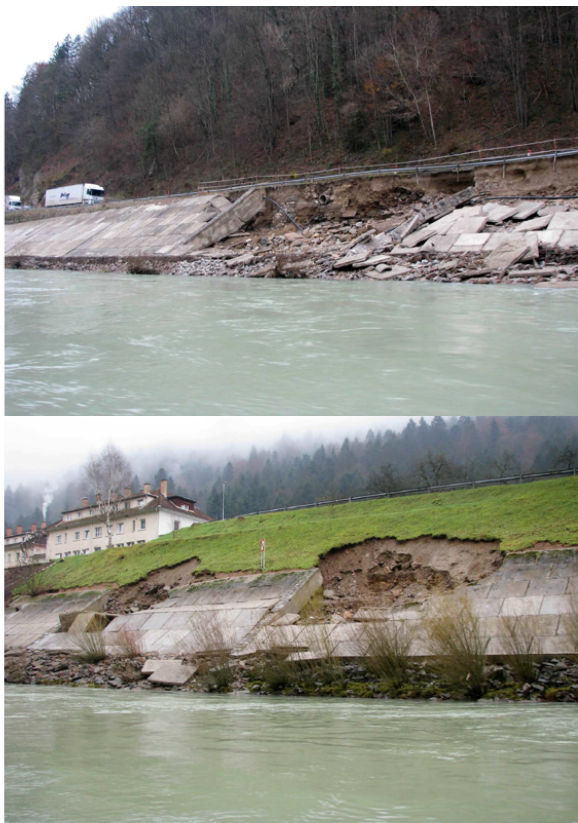
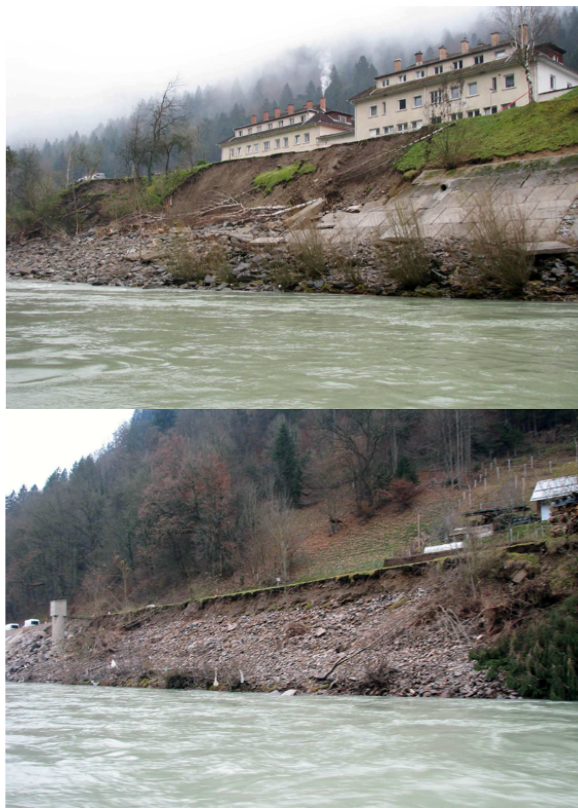
As a result of extraordinary visual inspections numerous landslides and landslips were identified, as well as damage due to erosion in the zone of water level fluctuations, damage to nearby buildings and retaining structures, and also damage and threat to nearby transport infrastructure (i.e. roads, railway lines, bicycle trails) (see Fig. 9). It was found out that the most damaged banks of reservoirs and levees of the derivation channels, as well as the damaged infrastructure, should be rehabilitated as soon as possible [12].

Fig. 9. Some examples of damaged banks of reservoirs on the Drava River after extensive floods (Photos: A. Geršak).

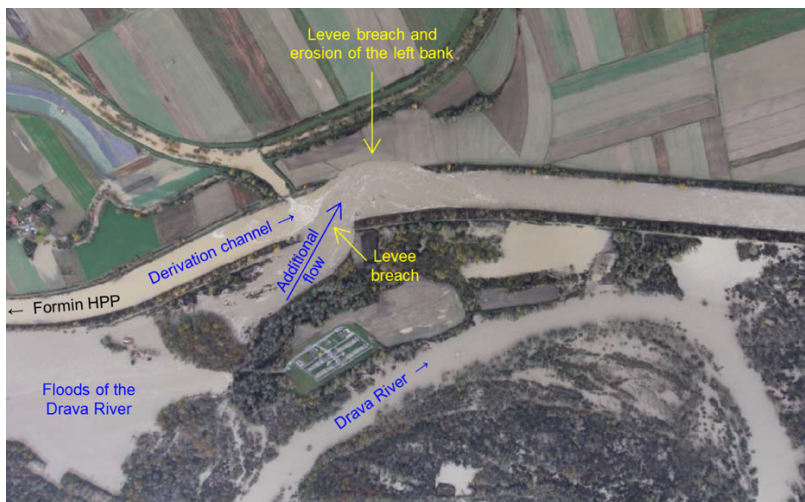
The most extensive damage was registered in the area of the derivation channel of the Drava River, about 1.5 km downstream of the Formin HPP (see Figs. 10 and 11), where the flood waters of the Drava River caused an additional river flow, which first broke through the right levee of the derivation channel and then also broke through the left levee of the derivation channel (see Figs. 12 and 13), where caused the erosion of the left bank of the derivation channel (see Fig. 14). Of course, the concrete diaphragm walls, installed in levees on both sides of the derivation channel, which prevented the drainage of groundwater into the derivation channel, were also demolished in this area (see Fig. 15). In addition, the flood waters of the Drava River transported large amounts of gravel into the derivation channel (see Fig. 14), which dammed water in the channel, with that caused rising of the water level in the channel and consequently flooding of the machine hall area of the upstream located Formin HPP [12-14]. Due to the high risk of additional damage and deterioration of the stability of the damaged banks of derivation channel, the main rehabilitation works began immediately after the detailed inventory of all noticeable damage was made, and they were completed quickly and successfully.

Fig. 12. The area with the greatest damage - during flooding (Photo: Mensuras photo archive).

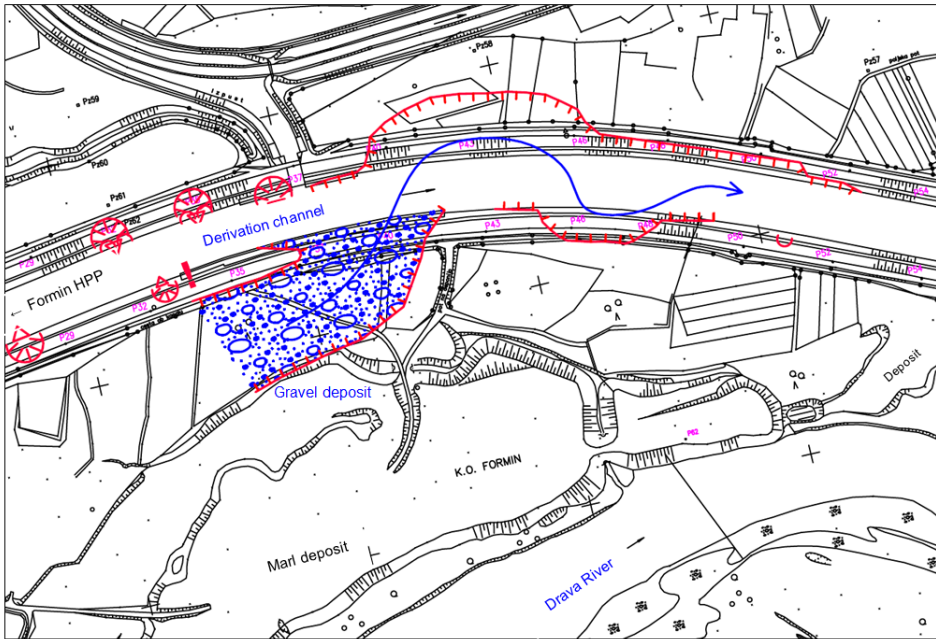
Fig. 13. Topographic map with registered damage at the area with the greatest damage.
