Mechanisms of Premature Fracture in Modular Neck Stems Made of CoCrMo/Ti6Al4V and Ti6Al4V/Ti6Al4V Alloy

Abstract: In this paper, we present the mechanisms of premature fracture of modular neck stems in two case studies: (I) when the neck and stem are both made of the same Ti6Al4V alloy, and (II) when the neck and stem are made from two different alloys, CoCrMo and Ti6Al4V alloy. Our study integrates two orthopedic patients who have undergone primary uncemented THA for usual indications in two orthopedic centers (Community Health Centre and University Medical Centre). Both centers are part of the national public health care system. Both surgeries were performed by two skilled orthopedic surgeons with more than 10 years of experience in THA. The survivorship of the modular neck of cast CoCrMo alloy was 24 months. The survivorship of the modular neck from Ti6Al4V alloy was 84 months. Multivariate analyses were performed to assess the differences in the fretting, corrosion, and fatigue of the two prematurely failed modular neck stems: stereo light microscopy (SLM), scanning electron microscopy (SEM), X-ray energy-dispersive spectroscopy (EDS), and electron backscatter diffraction (EBS

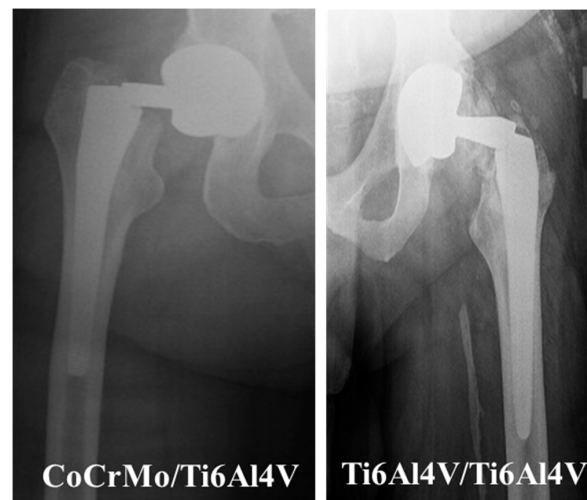
Figure 2. (left panel) Standard calibrated 110 cm AP pelvic X-rays of a fractured CoCrMo/Ti6Al4V modular neck of a 51-year-old male, survivorship 24 months. (right panel) X-ray of a fractured Ti6Al4V/Ti6Al4V modular neck of a 42-year-old male, lifetime 84 months.

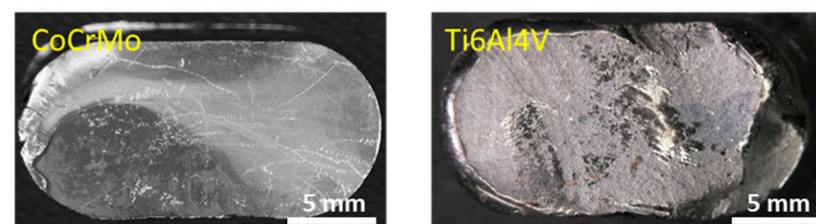
Figure 3. (Left panel) Fractured surface of CoCrMo modular neck of a 51-year-old male, survivorship 24 months. (Right panel) Fractured surface of Ti6Al4V modular neck of a 42-year-old male, survivorship 84 months. Stereo light microscope Tagarno FHD trend was used for the visualization of fractured surfaces of the CoCr Mo modular neck and Ti6Al4V modular neck.

The fractured modular neck of cast CoCrMo alloy, manufactured by Wright Medical Technology/Microport, Profemur Plus Modular Neck size /°8 with reference PHAC 1254 (CoCr Mo alloy), was retrieved and provided by a community hospital. The femoral stem of forged Ti6Al4V alloy, manufactured by Wright Medical Technology Microport, was retrieved, with a stem size of 5 and length of 125 mm (Ti6Al4V alloy). The modular neck stem (CoCrMo/Ti6Al4V) is the femoral component of the hip endoprosthesis and BioloX Delta femoral head, size 32 mm PHA0410—the alumina matrix composite is a modern press-fit acetabulum acetabular component. The fractured sample was provided by the community hospital. The survivorship of the hip endoprosthesis was 24 months (2 years). The fracture surface of the retrieved implant is presented in Figure 3, left panel.

The fractured modular neck of forged Ti6Al4V alloy manufactured by Wright Medical Technology/Microport was retrieved, fractured, Profemur Plus Modular Neck size /°8 with reference PHAC 1254 (Ti6Al4V alloy). The femoral stem of forged Ti6Al4V alloy manufactured by Wright Medical Technology/Microport was retrieved, with a stem size of 8 and length of 140 mm (Ti6Al4V alloy). The modular neck stem (Ti6Al4V/Ti6Al4V) is the femoral component of the hip endoprosthesis and the BioloX Delta femoral head, size 32 mm PHA0410—the alumina matrix composite is a modern press-fit acetabulum component. The failed endoprosthesis was provided by the University Medical Center. The survivorship of hip endoprosthesis with a modular neck stem of the same alloy (Ti6Al4V neck and Ti6Al4V stem) was 84 months (7 years). The fracture surface of the retrieved implant is presented in Figure 3, right panel.

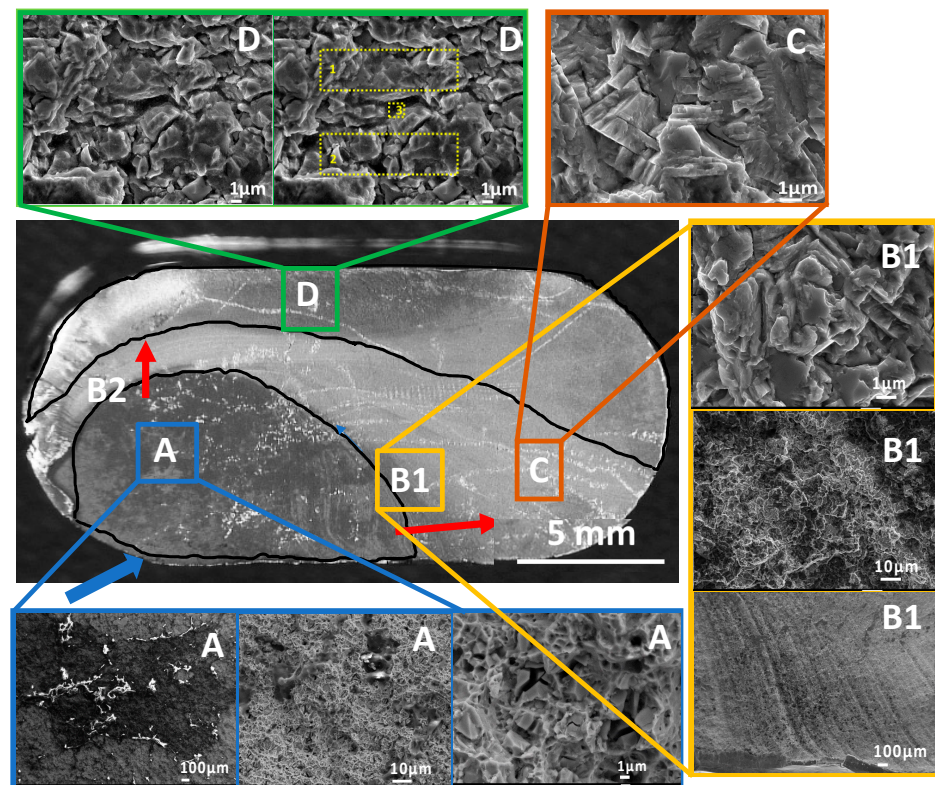
Figure 4 represents in the inner panel the SLM image of the fractured surface of the CoCrMo modular neck in the inner panel with the marked Zones A, B1, B2, C, and D.

Details of the first part of the fracture, marked as Zone A, are shown in Figure 4. Deposits of biological material were observed on the surface, as well as cracked carbide particles. The crack initiated on the surface of the CoCrMo modular neck stem (pink arrow in Figure 4) due to several different factors, but the dominant mechanisms were fretting and crevice corrosion. The CoCrMo femoral neck was dynamically loaded, exposed to a corrosive medium in the human liquids, and surrounded by a Ti6Al4V alloy with different electrochemical potentials. Constant micromotions caused repeated breakage of the passive oxide films and an unstable electrochemical environment within the crevice for both the cobalt alloy and Ti alloy passive films, as reported in the literature [17–20]. AES and XPS analyses of the thin oxide (passive film), described in detail in our previous studies [12,13], show that the oxide film on CoCrMo consists of Cr₂O₃ and traces of CoO₃ oxides with an estimated thickness of 2 nm. The oxide film on Ti6Al4V alloy consists of TiO₂ and traces of Al₂O₃ with an estimated thickness of 7 nm. Thermodynamic data of passive oxide formation as well as electrochemical studies on CoCrMo and Ti6Al4V alloy confirm that the re-passivation is much faster on Ti [21–26].

Figure 4. SLM of the fractured surface of CoCrMo neck on the main inside image represents the mechanism of CoCrMo alloy modular neck fracture. The blue arrow indicates the crack initiation; Zone A, the corroded fractured surface with deposited biological material, is shown in three SE images in three blue-marked panels: the **left** panel (A) at lower magnification, the detail of fatigue fracture and cracked carbides at higher magnification, panel (A) in the **middle**, and cracked carbide at highest magnification in the **right** panel (A). The red arrows show the direction of fatigue crack propagation in location (B1) and location (B2). The fatigue striations were observed in SE images in areas marked in yellow, and the microstructure details are shown in the **middle** and **upper** panels. In Zone (C), the fracture surface is very rough and angular. The fracture surface shows several secondary cracks that are perfectly straight and short. Next to these flat cracks, larger secondary cracks can be seen, which are branched and longer than the flat ones. The lower SEI shows the crack propagation and the **middle** and **upper** SEI shows the details at higher magnifications. The SE image of Zone (D), marked in green, shows a sudden fracture. Zone (D) in the **right** panel shows areas of EDS analysis of the fracture surface (yellow squares marked in the **right** panel).

In the zones marked B1 and B2, in Figure 4 (main inside panel), gradual fatigue crack progression is visible, and the main direction of crack progression is also marked with red arrows. Traces of the gradual progression of the crack at slightly higher magnifications using a scanning electron microscope are shown in panel B1, marked in yellow. Smaller secondary cracks are also present on the fracture surface, which were formed during the gradual progression of the main crack. The topography of the fracture is rounded, which is an indication that the crack was present for a long time and that during use, there was regular mutual contact between the two parts of the implant, which led to wear and, as a result, a smooth fracture surface [14].

In Zone C, the fracture surface is very rough and angular. The fracture surface shows several secondary cracks that are perfectly straight and short. Next to these flat cracks, larger secondary cracks can be seen, which are branched and longer than the flat ones. Based on the microstructure of the CoCrMo alloy, it can be concluded that the straight and short cracks originated at the twin boundaries (deformation twins in the microstructure)

Due to crack propagation, the loads on the diminishing cross-section of the modular neck increased. When the remaining nonfractured area was too small, the rest of the material suddenly fractured. The fracture surface is shown in Figure 4, Zone D, marked in green. The marked yellow rectangles represent areas of EDS analysis. EDS analysis of the fracture surface showed that there was indeed some transfer of Ti from the Ti6Al4V part of the prosthesis to the CoCrMo part. The results of the EDS analysis are given in Table 4. EDS analysis confirms the dissolution of Co into the soft tissue, which is evident from the low content of cobalt on the fracture surface. The same observation is reported in the literature where cobalt is present in the serum, erythrocytes, and urine of patients caused by MoM (metal-on-metal) joints [26].

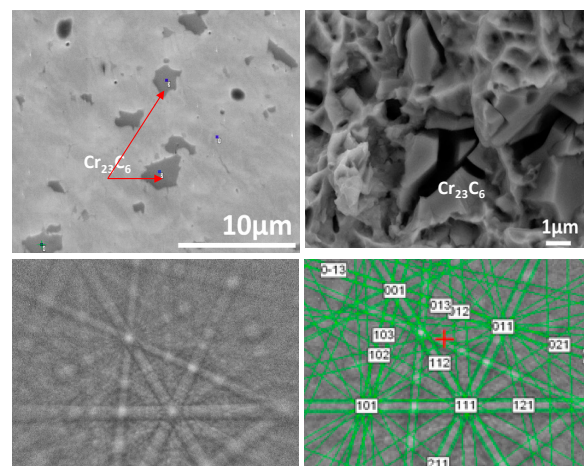
The upper half of Figure 5 shows the SE image of the CoCrMo microstructure, which was found under the fracture surface. For this purpose, a sample 15 mm below the fracture surface was cut and the metallographic sample was prepared by classic metallographic preparation methods, as described in Section 2.4. The brittle Cr_{23}C_6 carbides are embedded in the tough CoCrMo matrix. The fracture surface exhibits the cracked carbide Cr_{23}C_6 , determined using EBSD–Kikuchi lines, as seen in the lower half of Figure 5. In addition to fretting and crevice corrosion, modular neck stems made of different alloys also suffered galvanic corrosion [23,26]. Our previous studies determined that the CoCrMo passive layer is thinner than the passive layer of the Ti6Al4V alloy and that CoCrMo is vulnerable to crevice corrosion on the surface due to the carbide formation and depletion of Cr [13].

Figure 5. SE image of CoCrMo microstructure. The sample was cut 15 mm under the fractured surface. Matrix hcp structure is light gray, and brittle Cr_{23}C_6 carbide is dark gray. The fractured surface exhibits the cracked carbide Cr_{23}C_6 determined by the EBSD method by Kikuchi lines.

EDS results show the transfer of Ti ions from the stem to the CoCrMo neck, where Spectrum 3 shows an unexpectedly high titanium content (28.0 mass%) and, vice versa, a very low content of Co (34.7 mass%). According to Gilbert [26], the preferential dissolution of Co and the formation of intermetallic-phase Ti–CrMo occurred.

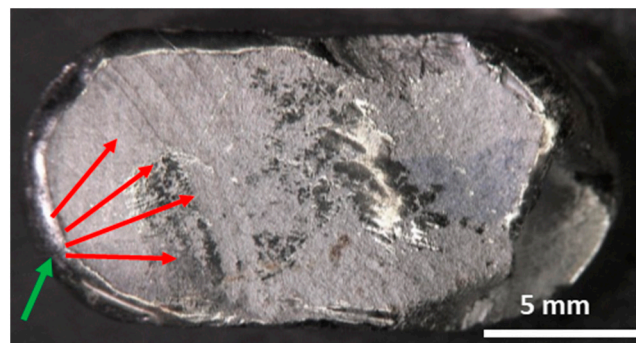
The fracture surface of the Ti6Al4V neck is shown in Figure 6. The crack initiation site is marked by a green arrow, and the red arrows represent the direction of fatigue crack propagation.

Figure 6. SLM image of the fractured modular neck made from Ti6Al4V alloy, taken from a 42-year-old male, lifetime 84 months. See the text for a description of the arrows.

With the increased stresses on the modular neck stem interface, passive oxide layers of Ti6Al4V are interrupted and re-passivation of the metal surface is prevented due to poor oxygen supply, which causes the release of chloride ions within the joint, and the consequence is a lower local pH. An anaerobic and acidic environment is created, and further abrasive wear and corrosion increase the risk of modular neck fracture over time [12,13,21,24–26].

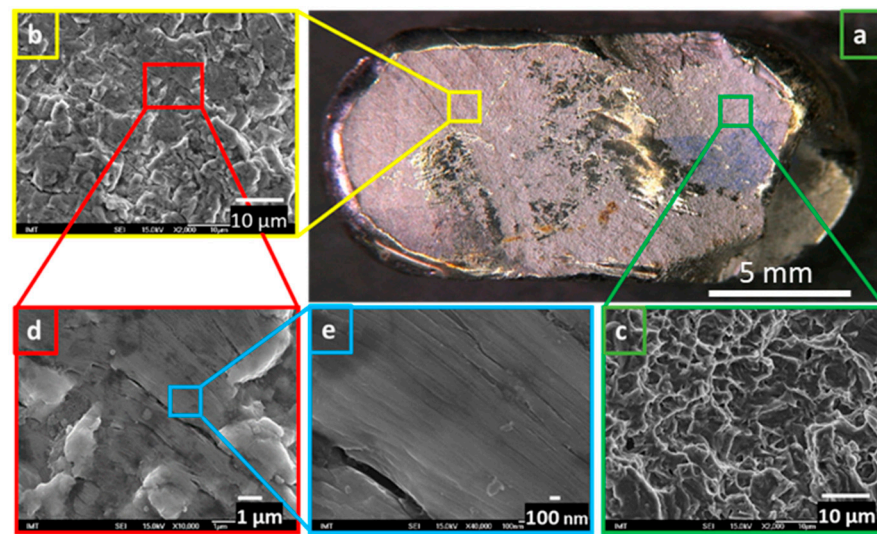
The part of the fractured surface was covered with organic material of ultra-high-molecular-weight polyethylene (UHMWPE) nanoparticles. The load on the rest of the cracked modular neck increased and traces of gradual crack progression appeared. When the remaining nonfractured area was too small, the rest of the material suddenly fractured.

Figure 7 shows the fractured surfaces on the Ti6Al4V long modular neck (a), where two different regions are found on the fractured surface; the first one is marked with a yellow square (b), and the second is marked with a green square (c). The first region shows signs of mechanical deformation due to walking, and in that region, signs of gradual crack propagation are visible at higher magnification where fatigue striations are seen in the range of 50–100 nm steps (d and e). The second region (a–c) shows the surface of the sudden fracture where a rough and uneven ductile fractured surface is seen with visible ridges and dimples, indicating tearing and deformation of material before the final fracture.

Figure 7. (a) Image of different fractured surface regions of fractured Ti6Al4V modular neck; (a–b) yellow-marked region and yellow-framed SE image of fatigue failure and with higher magnifications (b,d,e); (a,c) green-marked region and green-framed SE image with sudden ductile fracture. Organic deposits on fractured Ti6Al4V surface due to PE nanoparticle migration were found and visible as blue color (a).
