-----  
VINGT-SIXIÈME CONGRÈS DES GRANDS BARRAGES  
*Autriche, juillet 2018*  
-----

## **BEHAVIOUR OF THE BACKFILLED RIGHT BANK OF THE MAVČIČE DAM**

Pavel ŽVANUT

Rudi BRINŠEK

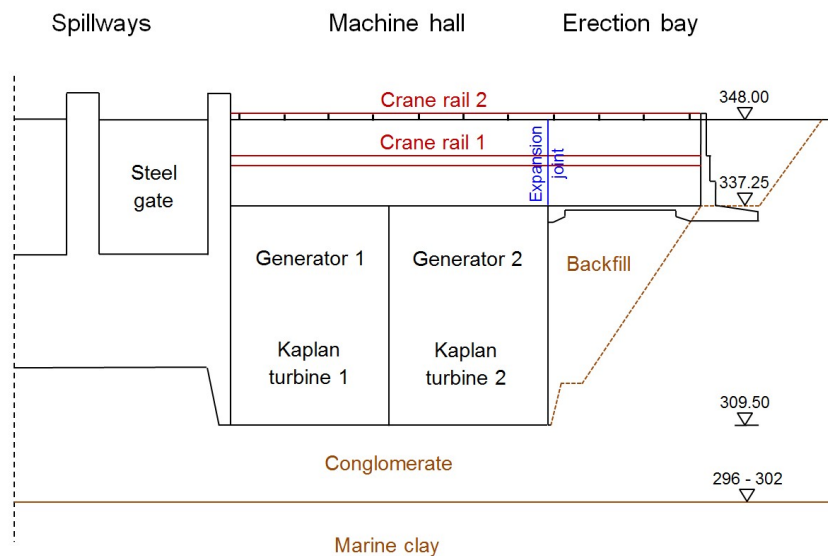
Most of the Mavčiče Dam is founded on permeable Quaternary conglomerate bedrock, so that a cut-off grout curtain had to be constructed to a depth of up to 60 m below the ground surface, i.e. up to 296 - 302 m above sea level, where a layer of impermeable Oligocene marine clay occurs. The foundation of the machine hall is, for instance, at the altitude of 309.50 m. However, the erection bay, which is located on the right bank of the dam, is founded on a layer of gravel backfill, up to about 25 m thick, which lies on top of the conglomerate bedrock. The upper courtyard, which is located behind the erection bay, has an altitude of 348.00 m, whereas the lower courtyard, which lies in front of the erection bay, is located 10.75 m lower, i.e. at the altitude of 337.25 m [3]. The foundation of the right portion of the dam is presented in Fig. 3.

Fig. 3  
The foundation of the right portion of the Mavčiče Dam

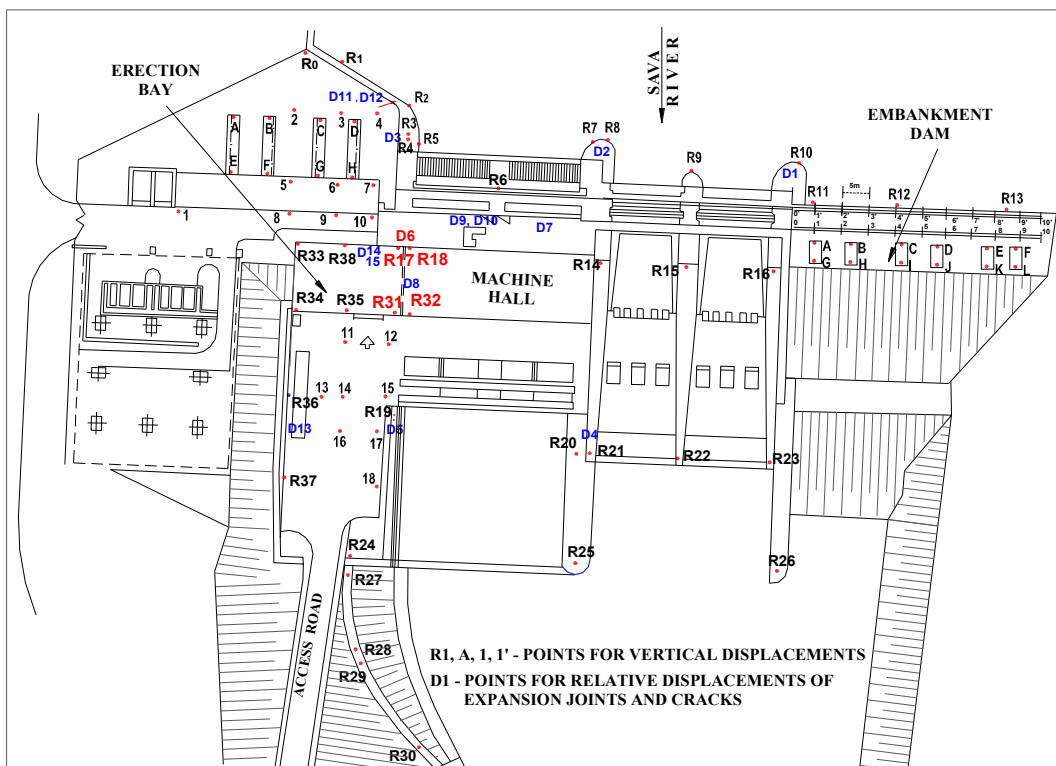
Fig. 4

The monitoring system for measurements of vertical and relative displacements

The results of the vertical displacement measurements at eight points in the lower courtyard, since the end of rehabilitation works in 2000, showed settlements up to 8 mm, which is similar as in the case of the erection bay. Since 2000, the settlements at ten points in the upper courtyard did not reach 8 mm, whereas at the remaining eight points the settlements reached locally even up to 32 mm.

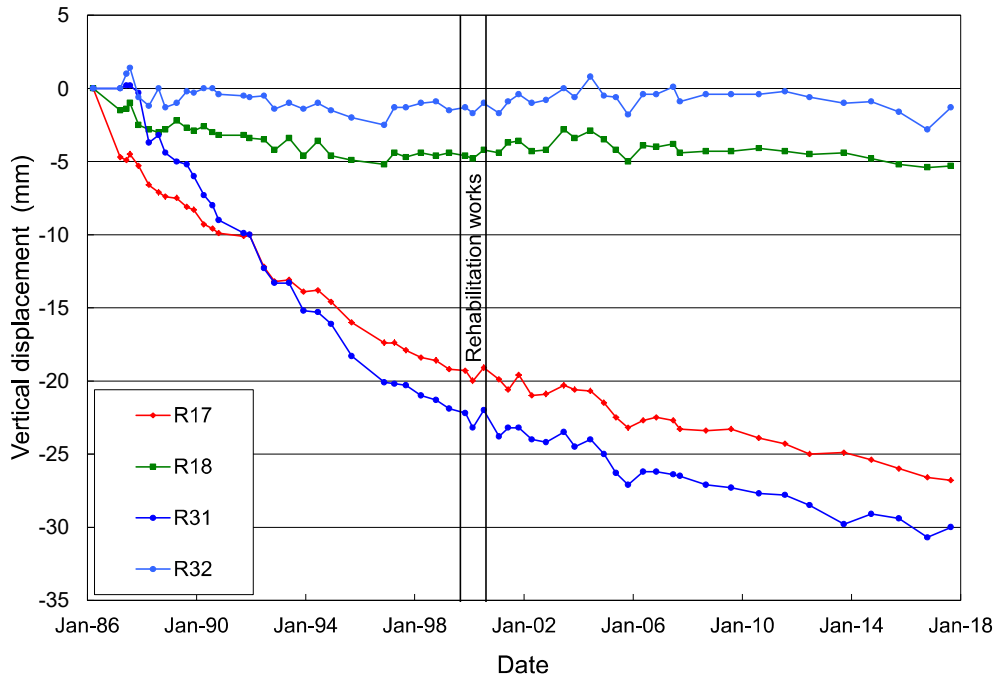
In general, the results of measurements and visual inspections did not show any abnormalities. However, this was not the case for the erection bay located on the top of the backfilled right bank of the dam, where the results of measurements of vertical displacements showed increasing settlements [6]. By 1999, i.e. over a period of 12 years, these settlements had increased to 22 mm (see Fig. 5). These results were confirmed by measuring the relative displacements of expansion joint D6, located between the erection bay and the machine hall (see Fig. 6).

The results of investigations, by drilling three research boreholes (one in the upper courtyard and two in the erection bay) in 1993, and another six such boreholes (four drilled in the upper courtyard and another two drilled in the lower courtyard) in 1996, indicated that the settlements were the consequence of the secondary consolidation of the backfill, and probable also due to scouring of fine material from the backfill. Due to the resulting differential settlements, the crane rail which connects the erection bay to the machine hall, as well as the crane rail which is located along the crest of the dam, became non-functional, and needed height corrections (see Fig. 7). For this reason rehabilitation works of the backfill and of the substratum of the right bank of the dam were performed between September 1999 and August 2000, using 50 m long grouted boreholes (see Fig. 8). This grouting was performed using a combination of water reactive polyurethane and a cement-bentonite mixture [7]. Measurements performed since then have shown that the settlement rate of the erection bay has slowed down slightly (by 2017, i.e. over the last 17 years, the settlements had increased by up to 8 mm, see Fig. 5), but from the point of view of the operation of the two crane rails the settlement process needed to be stopped.

Fig. 5  
Vertical displacements of the erection bay

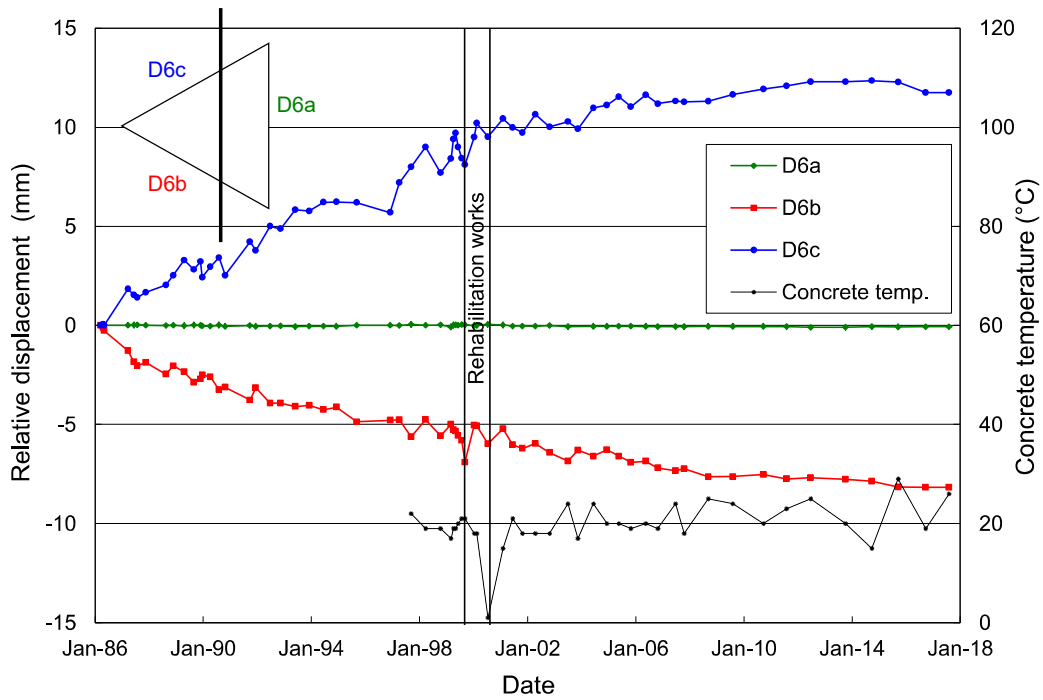
Fig. 6  
Relative displacement of expansion joint D6

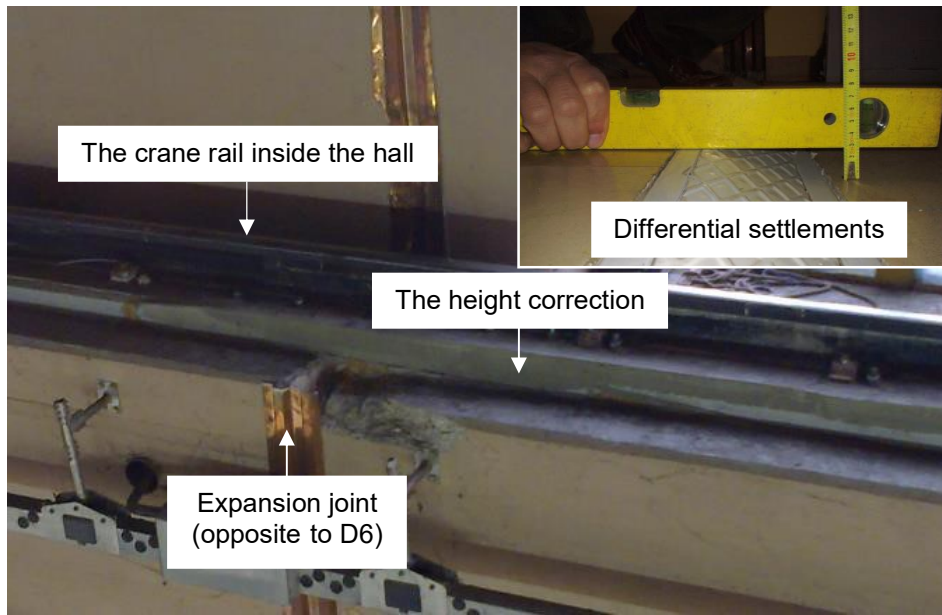
Fig. 7  
Height corrections of the crane line inside the erection bay

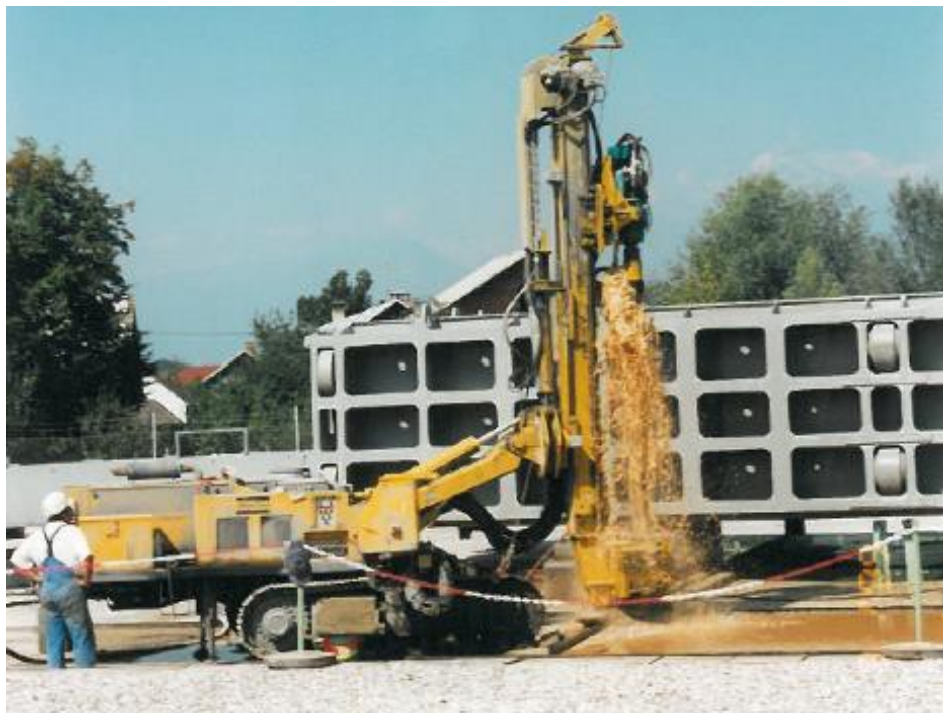
Fig. 8  
Rehabilitation works at the right bank of the dam

In order to achieve a final solution to the problem of the subsidence of the erection bay, additional rehabilitation works of the backfill and substratum of the right bank of the dam, by grouting the permeable zones, would be needed in order to stop both the scouring of fine material from the backfill, as well as any internal erosion of the cavernous conglomerate at the base of the backfill. The latter concerns the long-term stability of the right bank of the dam with potentially serious results.
