Characterization of Micro-Threaded Stem Taper Surfaces of Cementless Hip Endoprostheses

Abstract: We investigated micro-threaded stem taper surface and its impact on premature failures, aseptic loosening, and infection in cementless hip endoprostheses. Our study focused on the fretting, and crevice corrosion of micro-threaded tapers, as well as the characterization of the microstructure and surface properties of two new and three retrieved Zweymüller stem tapers. The retrieved samples were selected and examined based on the head–stem taper interface being the sole source of modularity with a metallic component, specifically between the Ti alloy taper stem and the ceramic head. To determine the surface chemistry and microstructures of both new and retrieved hip endoprostheses stem taper titanium alloy, scanning -electron microscopy (SEM) was employed for morphological and microstructural analyses. Energy dispersive spectroscopy (EDS) was utilized for characterizing chemical element distribution, and electron backscattered diffraction (EBSD) was used for phase analysis. The roughness of the micro-threaded stem tapers from different manufacturers was investigated using an optical pro

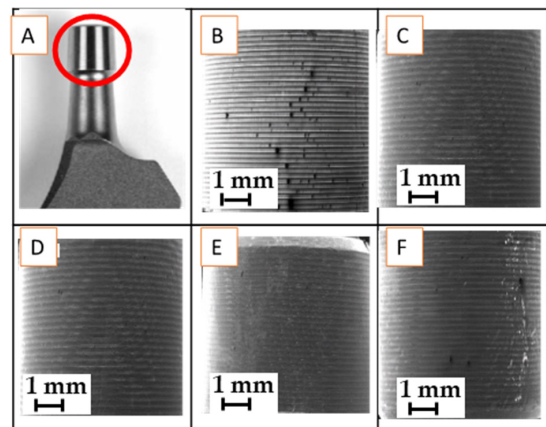
Figure 2. (A) The red circle indicates a micro-threaded 12/14 stem taper, new, Smith & Nephew, (B–F): 11× magnification SEM/SE images of different ZM 12/14 tapers and different manufacturers: (B) Alloclassic Varial new, (C) Lima new, (D) retrieved I-212-32 months, Smith & Nephew, (E) retrieved I-31-129 months, Smith & Nephew, and (F) retrieved A383-239 months, Endoplus.

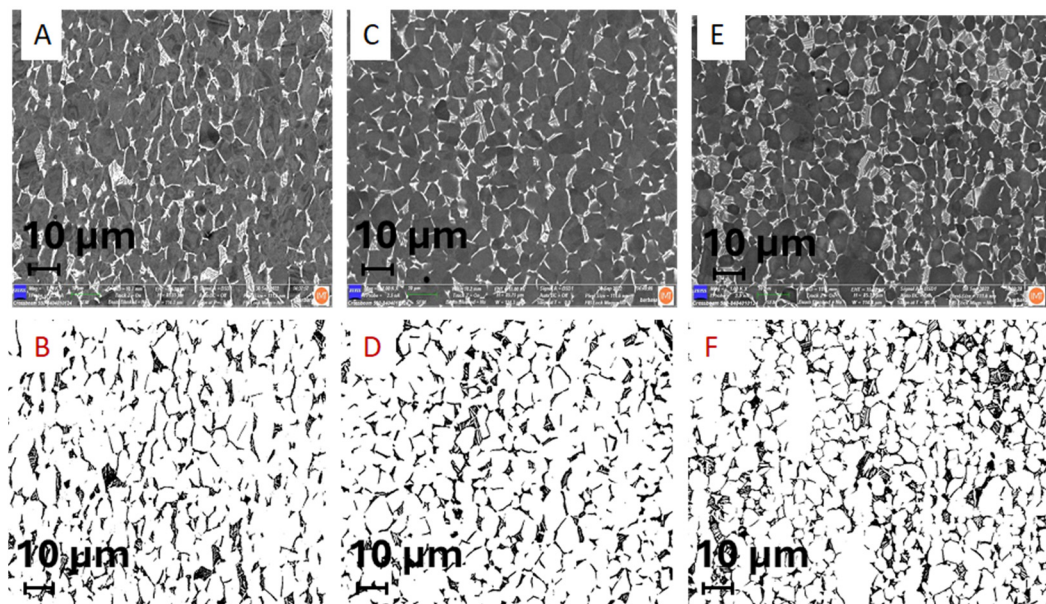
Figure 4. (A,B) BE/SE images of dual-phase microstructure ($\alpha + \beta$) and their distribution of a stem taper retrieved after 239 months (ENDOPLUS, London, UK) that prematurely failed due to aseptic loosening Ti6Al7Nb alloy A-283, M1000; (C,D) SEM/BE images of dual-phase microstructure ($\alpha + \beta$) and phase distribution in stem taper that prematurely failed after 3 months due to infection, I-31 Smith & Nephew (London, UK), M1000, (E,F) SEM/BE images of dual-phase microstructure $\alpha + \beta$ and their distribution of new stem taper Lima, made of Ti6Al4V alloy; M1000 β -phase in the row below (b, d, e) is black. The amount of α (Ti, Al, O, N, matrix) and β (Nb- or V-enriched phase) is represented in Table 2.

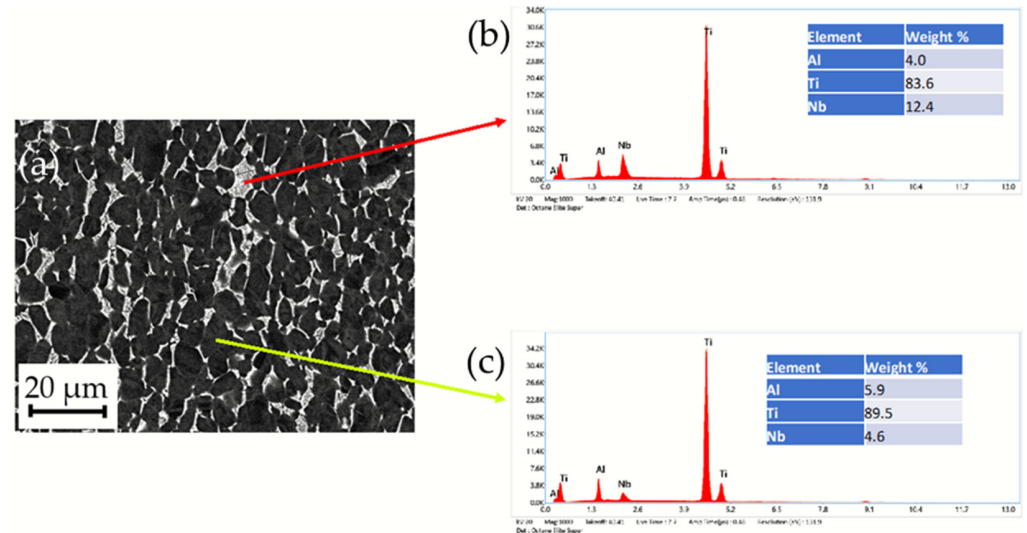
The SEM/EDS images of the surface chemistry are shown in Figure 6. The selected stem taper with a survivorship of 239 months prematurely failed due to aseptic loosening. The typical ($\alpha + \beta$) dual-phase Ti6Al7Nb alloy is shown in Figure 6a. Figure 6b shows

the distribution of Ti in the sample, (c) EDS mapping shows the distribution of Al in the microstructure, and (d) SEM/EDS mapping shows the distribution of Nb. We may conclude that the major dark-grey phase is the Ti matrix, α phase, and the light-grey phase, enriched with Nb is the β phase.

Figure 6. (a) SEM/BE images of A-283, Ti6Al7Nb alloy, stem taper of the hip endoprosthesis, survivorship 239 months, aseptic loosening, microstructure dual phase is observed; (b) red arrow shows Nb enriched β phase; (c) yellow arrow shows the matrix Ti6Al7Nb alloy.

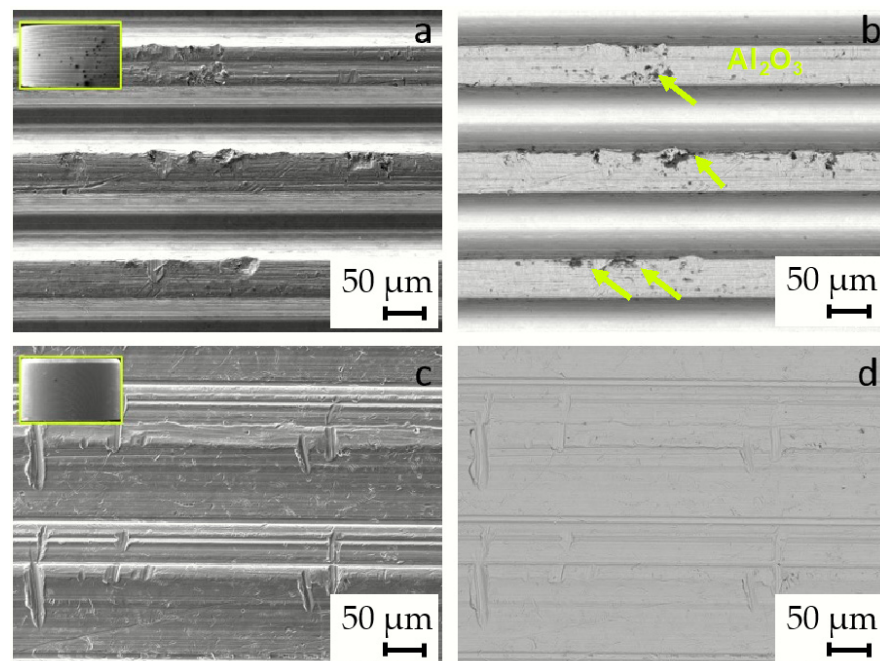
The images of the new, unused implants show some signs of abrasive damage and wear, which is attributed to the manufacturing process, as seen in Figure 7. Some dark particles are visible in the backscattered electron images (BE), in the case of the Alloclassic implant (Figure 7b), while in the case of the Lima Corporate implant taper, the surface seems rough, but no particles are visible in the (sub)surface area.

Figure 7. Images of the surface of the new, unused tapers. (a) SE image of Alloclassic new; (b) BE image of Alloclassic new; the remains of grit blasting are observed, dark particles, marked with yellow arrows; (c) SE image of Lima Corporate new; and (d) BE image of Lima Corporate new.

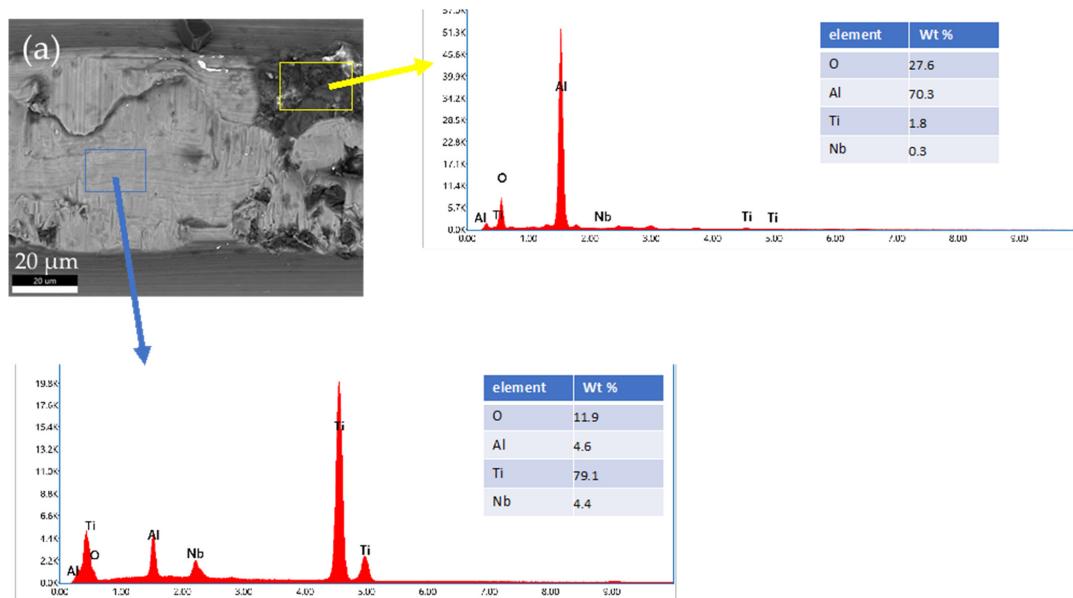
To identify the dark particles in the BE image of the Alloclassic taper part of the implant, we performed SEM/EDS mapping of a selected area. As is evident from the image in Figure 8a, the black particles are remnants of corundum (Al_2O_3) sandblasting that was performed as a finishing step in the taper manufacturing process. Additionally, the dual microstructure of the titanium alloy can be seen.

Figure 8. EDS analysis of a selected area of new Alloclassic taper. (a) BE image of the area. Yellow box indicates the remnants of Al_2O_3 (corundum) of micro-threaded blaster finishing, and blue box shows the matrix Ti6Al7Nb alloy.

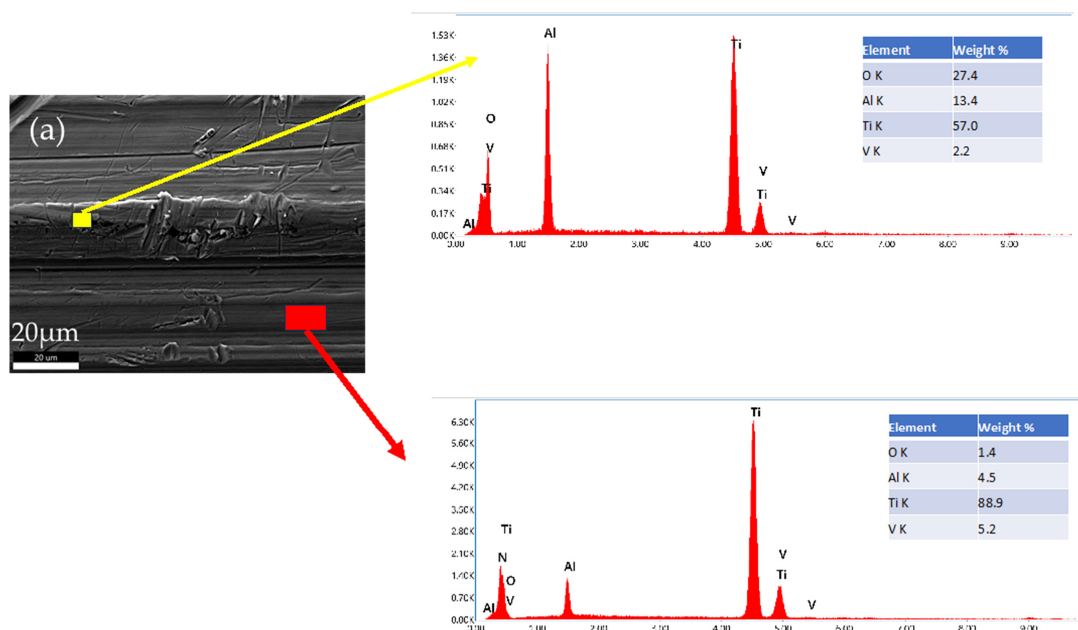
On the other hand, the new implant Lima Corporate does not show larger dark particles that are visible in the backscattered electron image. The surface of the new implant nonetheless shows signs of abrasive wear, as is evident from Figure 9.

Figure 9. (a) Surface damage (abrasive wear) of a new, unused Lima Corporate taper part of an implant. EDS mapping shows evidence of corundum Al_2O_3 particles implanted in the material due to the manufacturing process of the implant.

The new, unused tapers of the implants do not have a smooth surface in both cases; there is evidence of deposited material (Al_2O_3) from sandblasting, and mechanical wear damage is visible in both cases. It has been shown that corundum Al_2O_3 sandblasting remains from the process and affects the corrosion properties and can lead to an increased number of infections [11,12].

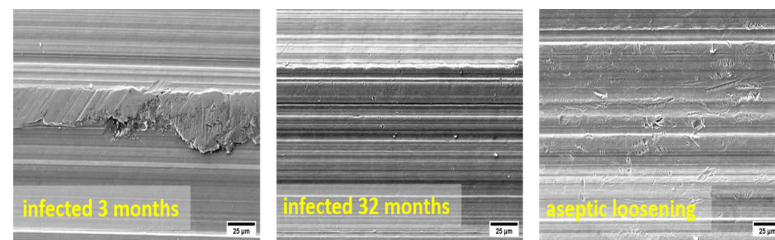
Three failed implants were chosen for examination with SEM/EDS. Two implants prematurely failed due to infection, the first one after 32 months and the second after 129 months, while the third implant failed because of aseptic loosening after 239 months. The images of the surfaces of the implant taper parts are shown in Figure 10.

Figure 10. SE images of the surface of the three failed implants. The surface area shown in the figures is $230\ \mu\text{m} \times 170\ \mu\text{m}$.

The surfaces of prematurely failed implants show signs of abrasive wear, like the new, unused implants, mainly due to machining and further sandblasting, as seen in Figures 11 and 12. No cracks or oxidation products are visible on the implant surfaces. Additional abrasive wear (most prominent in the case of the implant that failed due to aseptic loosening) could also be attributed to the revision surgery.

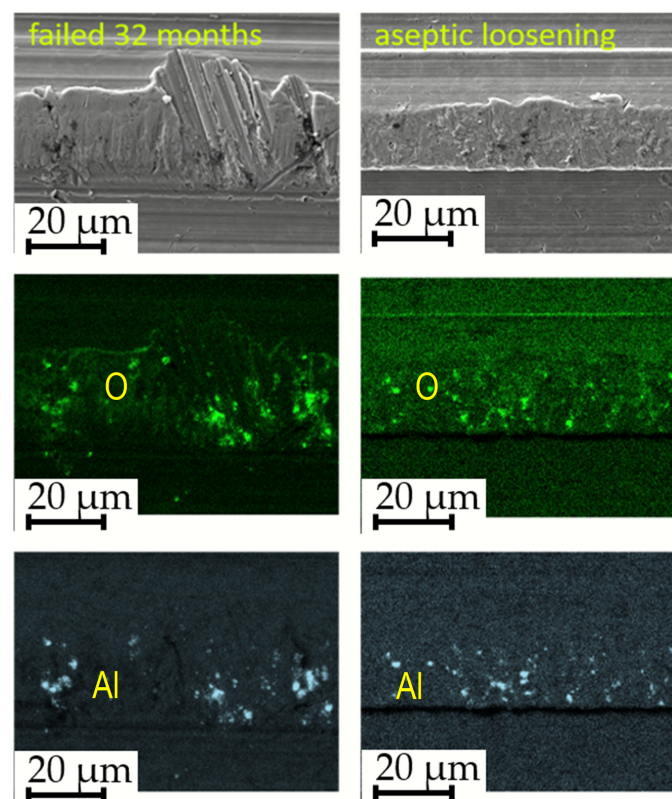
Figure 11. Evidence of corundum remains in an infected implant that failed after 32 months and an aseptically loosened implant after 239 months.

EDS mapping showed that there are some remnants of corundum in the subsurface layers of the failed implants, as is seen in Figure 11. The corundum remains are clustered, and the particle sizes are up to approximately 10 μm in diameter, with a similar distribution compared to the new Lima implants. No large particles (such as in the case of a new Alloclassic implant) were found on the examined surfaces of the failed implants. This is most evident from large-scale backscattered electron images, shown in Figure 12, upper panel. Only at higher magnification (lower panel of Figure 12, it is possible to distinguish individual clusters of small, embedded corundum particles. In all implants, no signs of corrosion or cracks due to fretting were observed.

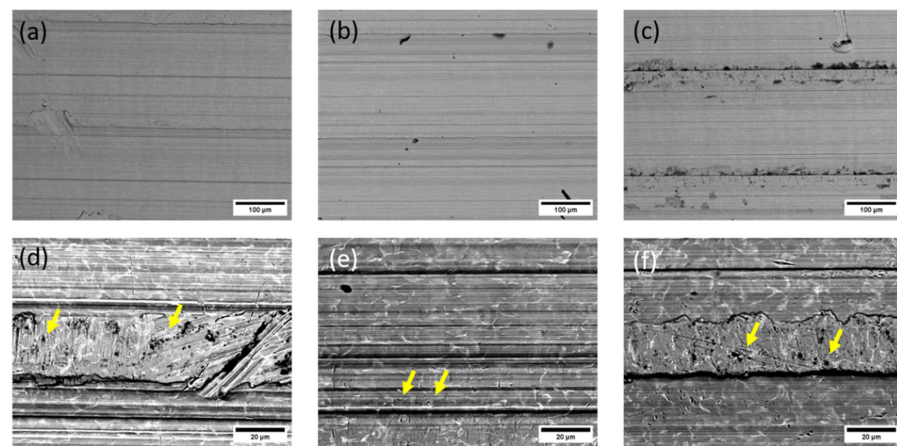
Figure 12. SEM/Backscattered electron images (BE) of the failed implant surfaces: (a,d) infected implant, failure time 3 months; (b,e) infected implant, failure at 32 months; and (c,f) failure due to aseptic loosening after 239 months. The arrows in the lower panel point to locations of embedded corundum particle clusters.
