# SEVERE METALLOSIS AFTER POLYETHYLENE LINER DISLOCATION IN CERAMIC-ON-Ti6Al4V TOTAL HIP ARTHROPLASTY. A CASE STUDY

Igor Potparić<sup>1</sup>, Monika Jenko<sup>3</sup>, Drago Dolinar<sup>1,2,3</sup>, Klemen Avsec<sup>1</sup>,  
Mojca Debeljak<sup>4</sup>, Matjaž Godec<sup>5</sup>, Boštjan Kocjančič<sup>1,2\*</sup>

doi:10.17222/mit.2025.1441

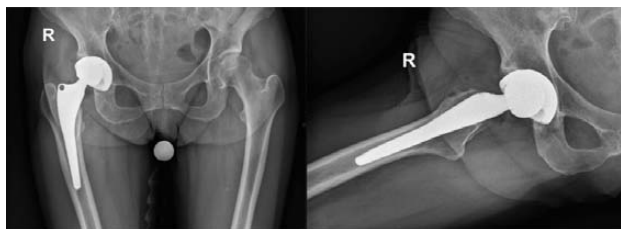
The initial THA surgery was performed 18 months prior due to hip dysplasia-induced osteoarthritis. The procedure and the rehabilitation protocol were carried out in accordance with the in-clinic protocol and were uneventful. Fourteen months after the initial surgery, the patient fell and suffered a contusion on the operated side. The initial radiographic evaluation showed no evidence of fracture or displacement of prosthesis components. However, in the weeks following the incident, the patient began reporting progressively worsening pain localized to the greater trochanteric region. Audible crepitus emerged shortly thereafter and became increasingly pronounced over time. Seventeen months after the initial surgery, the patient presented for a follow-up evaluation, citing persistent and debilitating pain. Repeat radiographs demonstrated cranial migration of the femoral head within the acetabulum, consistent with advanced polyethylene inlay wear (**Figure 2**). There were no ra-

**Figure 2:** Cranial migration of the femoral head within the acetabulum in two projections (Dept. for Orthopaedic Surgery, UMC Ljubljana)

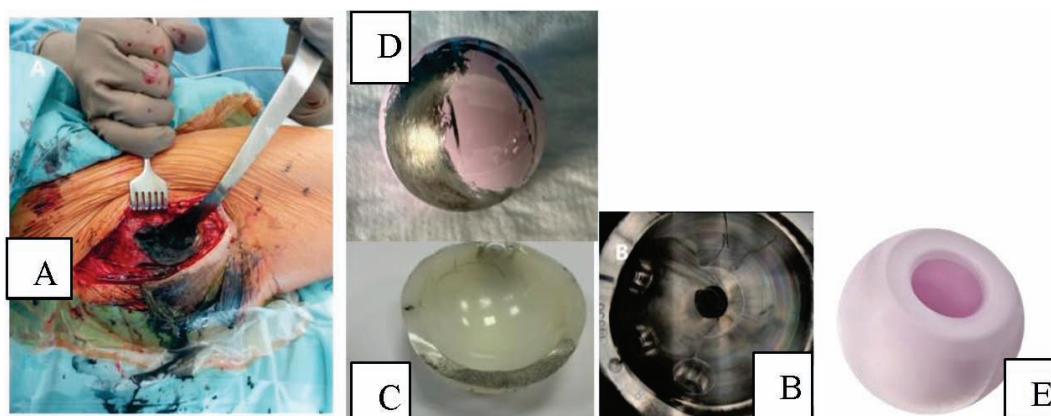
Intraoperatively, the superficial layers of tissue appeared unremarkable, with no evidence of inflammation. Upon incision of the fascia, a dark, viscous effusion was observed emanating from the hip-joint cavity (**Figure 3A**). The joint capsule and adjacent soft tissues exhibited pronounced discoloration, characterized by a dark-greyish-black pigmentation. Examination revealed a dislocated and damaged polyethylene inlay within the metal acetabular shell, which demonstrated significant wall thinning and ceramic acetabular head with thin Ti6Al4V film is shown in **Figure 3D**, **Figure 3E** shows new acetabular ceramic head.

**Figure 3:** (A) Dark viscous metal effusion was found during the surgery of patient at UMC Ljubljana, (B) SLM image of the inside of acetabular component and (C) acetabular HX PE inlay, both showing signs of wear and wall thinning, (D) ceramic acetabular head with the thin Ti6Al4V film due to tribological material transfer from Ti6Al4V stem and acetabular shell friction to the surface of ceramic (Aluminum oxide matrix consisting of approximately 80 % alumina, 17 % zirconia and 3 % strontium oxide), (E) new acetabular head, biolox delta ceramics.

The surrounding soft tissues showed no evidence of necrosis or structural compromise. A comprehensive irrigation and debridement of the joint cavity were performed. The acetabular component was explanted and replaced with a new acetabular component (size 50), secured using three trans acetabular screws. The femoral head was exchanged for a new ceramic head (size 32), while the femoral stem was retained as it exhibited no signs of damage, malalignment, or loosening. Removed prosthetic components and tissue specimens were obtained for microbiological and histological analysis. A histopathological examination confirmed a diagnosis of severe metallosis, while microbiological cultures re-

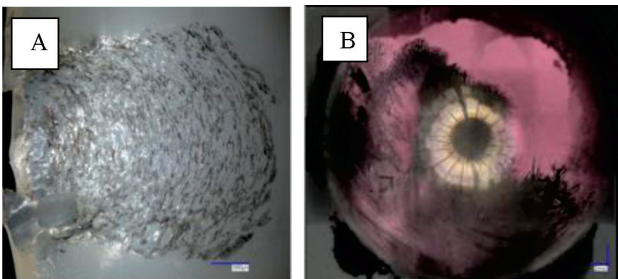
**Figure 4:** (A) SLM image of the HX PE inlayer wear, (B) SLM image of the Biolox Delta Ceramic femoral head with transferred thin Ti film, dark on the surface of delta ceramics head of pink colour, the golden yellow ring is due to the non-conductivity and charging of the sample, it was not possible to apply a thin layer of gold or palladium to prevent this phenomenon because the sample was too large to introduce it in the sputter device.

The SLM images show the surface wear on both the inlay (**Figure 4**), the acetabular component. **Figure 4A** shows dark spots on the ceramic head (**Figure 4B**). Although the hip resurfacing and THA surgery influence gait kinematics,<sup>12</sup> the wear on the acetabular component lays cranially on the acetabular component, which coincides with the position of peak contact pressure of the healthy hip joint during gait and standing as reported by both Gaffney et. al.<sup>13</sup> and Xiong et. al.<sup>14</sup> The dark spots on the ceramic head are caused by a metal transfer phenomenon<sup>15</sup> with possible metal transfer marks caused by surgical instruments during the revision surgery.

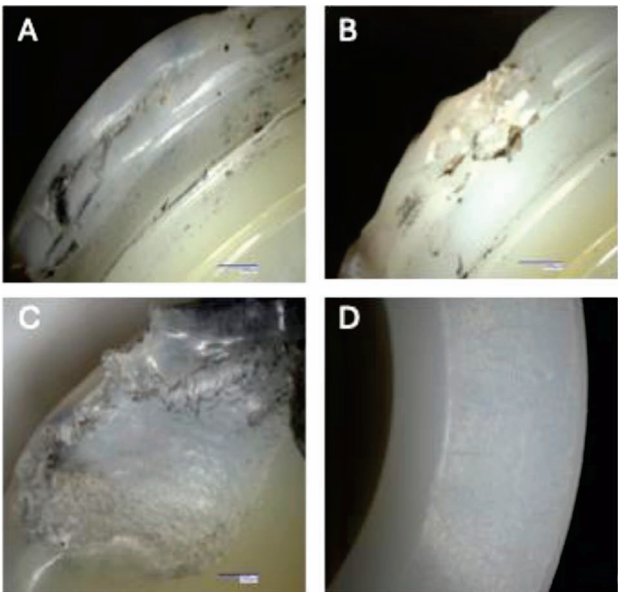
**Figure 5:** SLM images of retrieved damaged HX PE acetabular liner A, B, C and comparison with the new one D

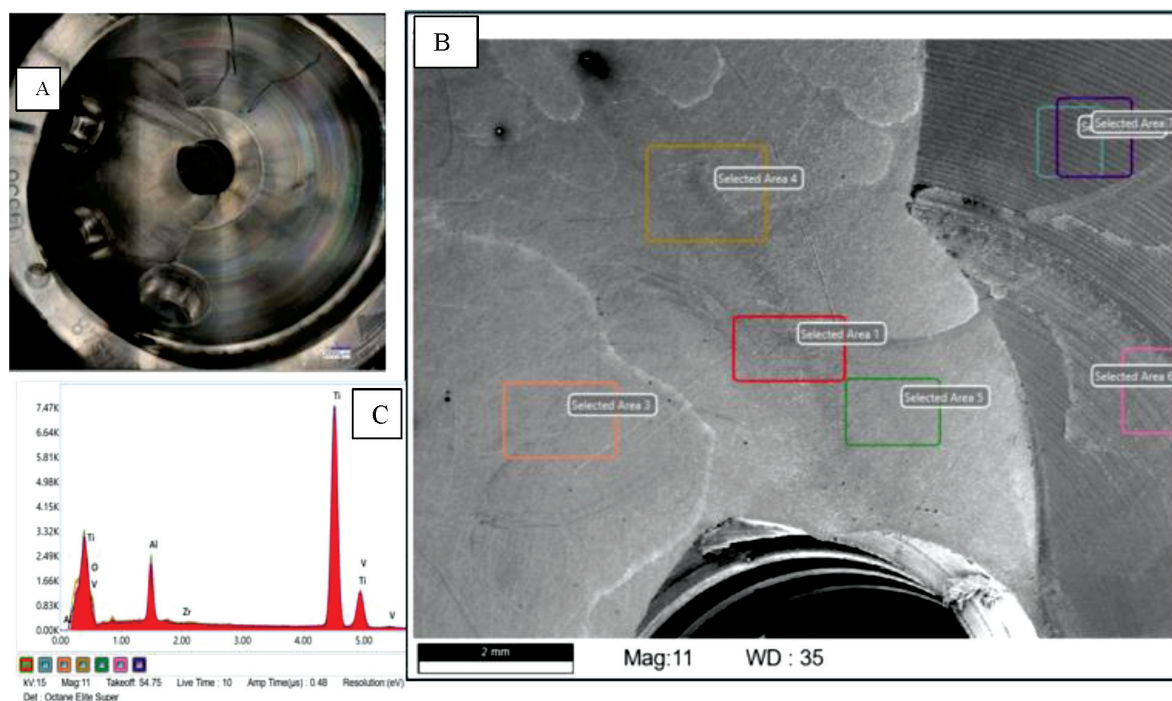
This finding was further investigated by high vacuum and low vacuum SEM and EDS analysis. We analysed 7 different locations on the surface of the femoral head, **Figure 6**. All the samples were positive for the transfer of Ti, and traces of Al, V, while delta ceramics is of Al<sub>2</sub>O<sub>3</sub> and ZrO<sub>2</sub> ions in similar proportions, all of which are usual components of alloys used to make metal prosthetic components and other biomaterials.<sup>8,10</sup> Certain spots contain traces of Cr, Mn, Fe, Ni ions (**Table 1**), all of which can be found in alloys, such as 316L stainless steel, used to make orthopaedic screws and surgical instruments. This finding does imply that during the prosthetic removal or possibly insertion, some surface metal transfer occurred from the surgical instruments to the acetabular head.

**Figure 6:** (A) SLM image of damaged acetabular cup, (B) SEM/BE image of detail from (A) with 7 selected area where EDS analysis was taken and (C) collected EDS spectra of all 7 selected area. It shows the EDS chemical analysis, of Ti, Al, O, and V elements, the traces of Zr are supposed to be from ceramic head. For the visualisation and EDS analysis Scanning Electron Microscope Apreo 2S of Thermo Fisher was used.

shown to be present in the intraarticular fluid and tissue surface as well as in the tissue macrophages. The mechanism of debris formation was most likely caused by fretting which occurred between the harder ceramic surface of the head and the softer Ti6Al4V acetabular cup, further exacerbated by the surface incongruencies between the two, as shown in **Figure 6**. Metallosis can cause adverse tissue reactions and can cause systemic reactions caused by ion toxicity,<sup>5-7,19</sup> although our patient did not show any signs of such. We also did not notice any local bone lysis or prosthetic component loosening which can occur due to metallosis.<sup>5,6,18</sup> Microbiological cultures returned negative for bacterial and fungal growth, which further corroborates our explanation of mechanical failure of the inlay locking mechanism due to high peak torsion forces during the patient's fall.
