## Laboratory Testing of Old Bridge Girders: Preliminary Results

**ABSTRACT:** This paper presents key results on the laboratory testing of old girders removed from a flood-damaged bridge located near Ljubljana, Slovenia. The structure was widened in 1989 to accommodate pedestrians and cyclists by integrating prefabricated prestressed reinforced concrete T-girders. To assess the structural behaviour of the bridge, six girders were subjected to a rigorous testing program involving bending and shear tests in a laboratory setting. The tests were performed on girders with static lengths of 12.20 meters and 9.90 meters. The program aimed to evaluate the structural performance of the girders. Preliminary results indicate satisfactory structural behaviour of the prestressed T-girders under the applied loads, with insights into their performance under both bending and shear stresses. This study contributes valuable data for assessing the long-term behaviour of bridges. The outcomes are particularly relevant for optimising resource allocation in bridge rehabilitation projects and ensuring safety and functionality in transportation networks.

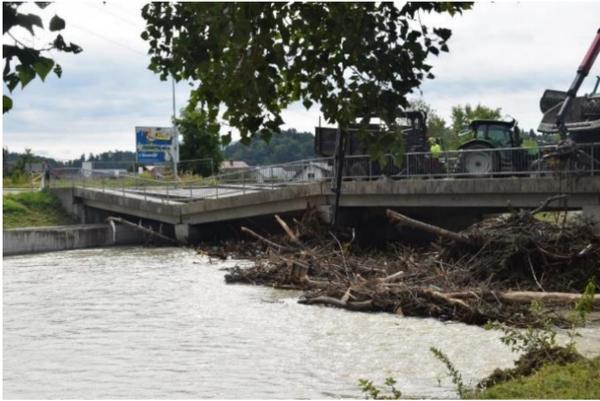
Following the catastrophic 2023 floods in Slovenia, the bridge partially collapsed, as shown in Figure 2 from the downstream side. While the intermediate supports were damaged, an inspection confirmed that the longitudinal girders remained in good condition. In agreement with the infrastructure manager and demolition contractor, selected girders were salvaged for laboratory testing (Figure 3).

Figure 2. Partly collapsed bridge after floods (upstream).

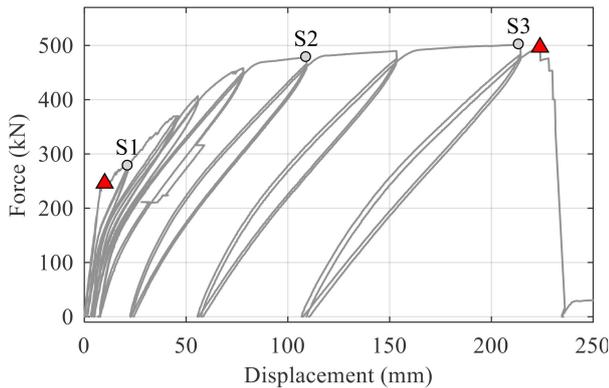
The flexural behaviour of the girder is represented by the hysteretic curve, which shows the relationship between applied force and mid-span displacement, as illustrated in Figure 5. The triangles indicate the state at initial cracking and the state just before failure. The labels S1, S2, and S3 denote engineering-

Figure 5. Hysteretic response of the girder at the middle.

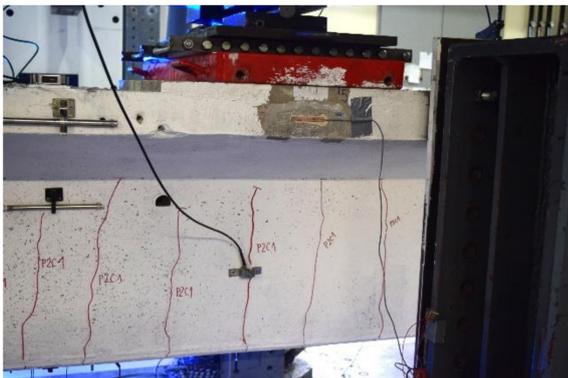
The initial cracks appeared during the second loading phase, forming in the load application area with an initial width of approximately 0.1 mm (Figure 6). Cracking began at an applied force of 246.1 kN and a corresponding displacement of 10 mm. These cracks closed completely upon unloading. As the loading progressed through subsequent phases, the cracks widened and propagated, increasing both in number and extent. Inclined (shear) cracks also began to appear in supports' region.

Figure 6. Damage state at the peak of the cycle when the first cracks appeared.

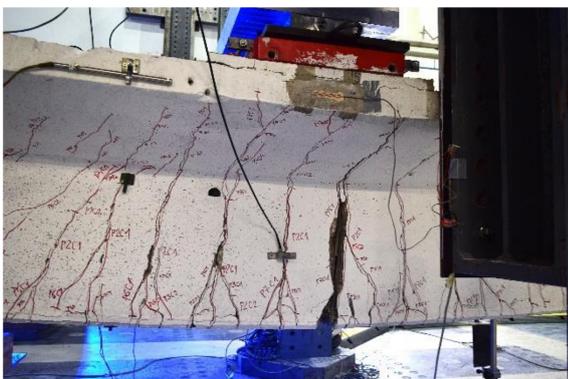
Figure 7. Damaged girder in the failure stage.

In the phase immediately preceding failure, the maximum observed crack width reached 4.5 mm, with a residual width of 3.0 mm after unloading. In the following phase at displacement of 22,4 mm and force 497 kN, the girder experienced flexural

failure, accompanied by the rupture of the prestressing tendons in the load application zone (Figure 7).

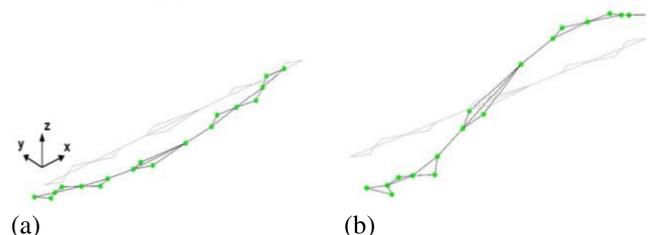
The reference natural frequencies of the first and second vertical bending modes amounted to 12.38 Hz and 45.81 Hz, respectively. As damage accumulates during load cycles, the girder's stiffness diminishes, which is reflected in the corresponding reduction of natural frequencies in Table 1. A reduction of 3% to 36% in the first natural frequency was observed as the damage evolved from cracking (S1) to near-collapse limit state (S3). Smaller decrease was obtained for the second vertical bending mode (1% to 11%), which is due to the applied load causing more damage near mid-span, where the amplitude of the second mode is nearly zero (see Figure 8b).

Figure 8. First (a) and second (b) vertical bending modes of B4 girder.

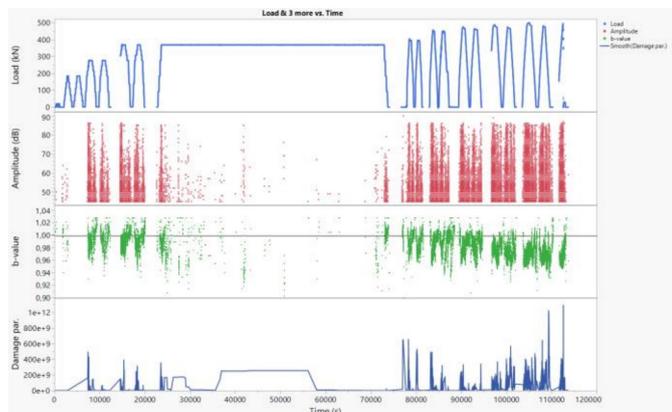
General acoustic emission activity, represented by the amplitude of each hit, the applied load, are time-dependent and presented in Figure 9. Nevertheless, The AE activity, i.e. damage evolution during loading and unloading phases, is visible. In addition, the b-value and the damage parameter as used by Vidya Sagar and Raghu Prasad [6] and Elbatanouny et al. [7] in similar investigations were calculated to evaluate the damage evaluation. The decrease of b-value and the increase of damage parameter with increased load are clearly visible.

Figure 9: Load and amplitude of individual hits, and b-value and damage parameter as a measure of damage evolution and propagation.

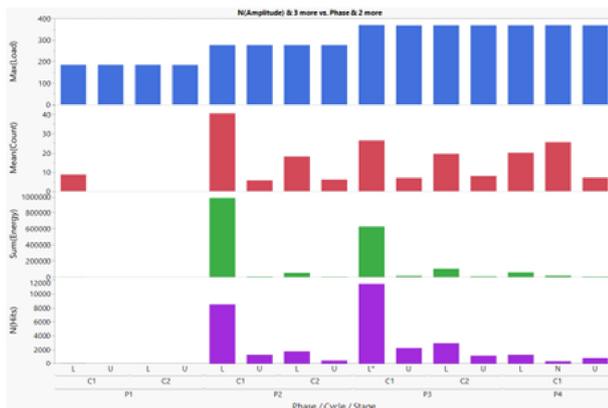
Figure 10: Maximum loads (Max - blue), and number of hits (N - purple), total energy (Sum - red) and mean count (Mean - green) of the hits for individual phases (P1, P2, P3), cycles (C1, C2) and stages (loading L and unloading U).

As an example of a more detailed analysis the number of hits, total energy and mean counts of the first three phases are presented in Figure 10. Each phase consists of two cycles of loading and unloading. A significant difference in AE activity between different phases, cycles within individual phases and

loading/unloading stage was recorded. A more detailed analysis is foreseen. It must be noted that some data of the phase 3, cycle 1, loading stage (marked L\* on graph), was unfortunately lost.
