# Evaluation of Oxinium (Oxidized Zr<sub>2.5</sub>Nb) Femoral Heads in Hip Endoprostheses—Case Report

Total hip arthroplasty (THA) is a widely performed and successful surgical treatment for degenerative joint disease. With increasing use in younger and more active patients, the demand for durable, biocompatible, and low-wear implant materials has grown. Oxidized zirconium (Oxinium, Zr<sub>2.5</sub>Nb) was introduced as a promising femoral head material, combining the strength of metal with the low-friction properties of ceramic. Despite encouraging early results, clinical reports have documented complications including head wear, especially after dislocation, and metallosis. We present the case of a 64-year-old male who underwent primary THA in 2009 and required revision in 2021 due to severe metallosis. Notably, no dislocation was observed that could explain the damage to the Oxinium head. Surface and subsurface analyses using X-ray photoelectron spectroscopy (XPS) and micro-indentation hardness testing revealed wear and deformation inconsistent with Oxinium's anticipated durability. These findings highlight the importance of the femoral head–polyethylene liner interface in impl

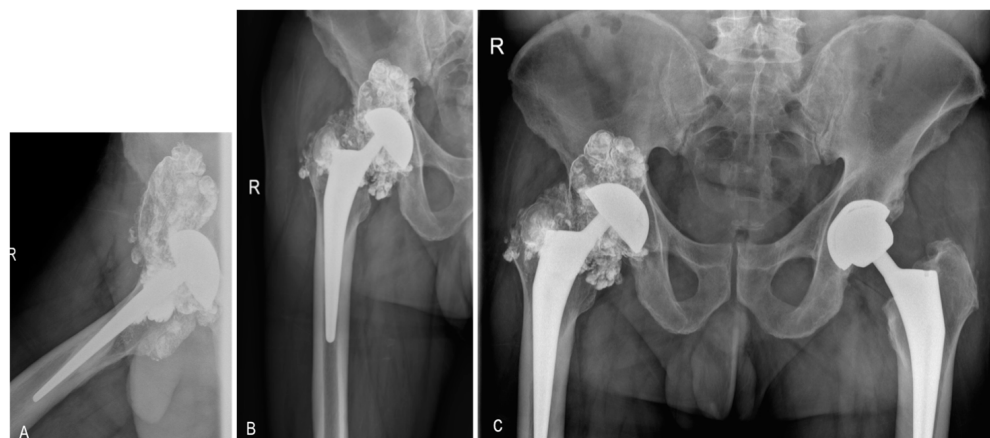
Approximately 140 months after the initial surgery, the patient sustained a fall while hiking, resulting in a contusion over the operated hip. At that time, radiographs revealed no evidence of fracture or prosthetic displacement. However, a polyethylene liner dislocation was noted, leading to direct articulation between the acetabular metal cup and the Oxinium femoral head. There was no polyethylene dislocation according to the radiographs, which would usually show this.

In Figure 3, the X-ray demonstrates asymmetrical positioning of the femoral head within the acetabulum, suggesting possible component damage and/or wear. The direct articulation between the Oxinium femoral head and the Ti6Al4V acetabular cup has resulted in extensive metallosis around the prosthesis, visible as a characteristic cloud-like opacity. Metallic component wear is strongly suspected, since polyethylene liner wear would not be radiographically apparent other than through the observed head subluxation or asymmetry.

**Figure 3.** (A) Axial X-ray of the affected hip prosthesis. (B) Anteroposterior X-ray of the affected hip prosthesis. (C) X-ray of the whole pelvis showing right-affected hip prosthesis with extensive metallosis and normal left, non-affected hip. X-ray shows asymmetrical positioning of the femoral head within the acetabulum, suggesting damage and/or wear of the prosthetic components. There is evidence of direct contact between the Oxinium femoral head and the Ti6Al4V acetabular cup, which has resulted in extensive metallosis surrounding the prosthesis, visible as a cloud-like peri-prosthetic opacity. The findings indicate wear of metallic components, since polyethylene acetabular liner wear would not be radiographically visible apart from femoral head malposition. The Oxinium femoral head demonstrates severe wear, particularly involving the diffusion (ceramic) layer. Left hip/prosthesis: Symmetrical positioning of the components and femoral head with normal radiographic appearance.

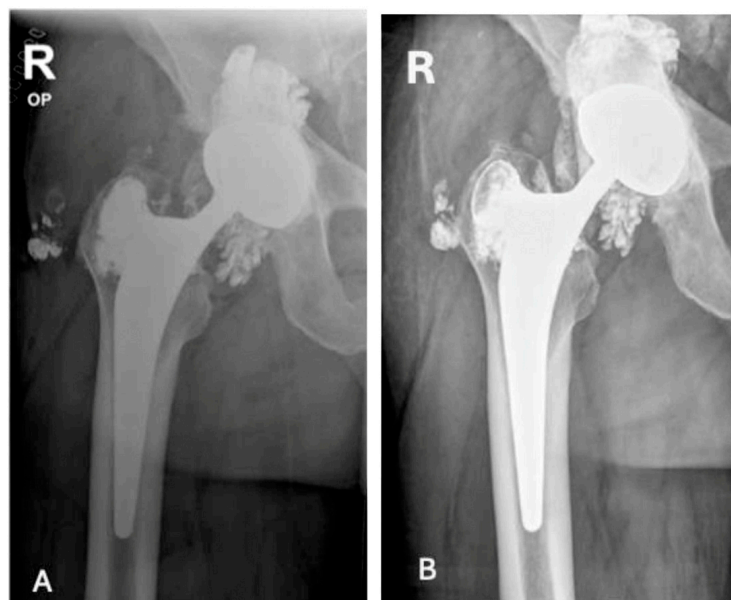
In Figure 4, the X-ray after revision surgery demonstrates the symmetrical positioning of components. A lot of metallosis surrounding the soft tissues was removed; note the diminished peri-prosthetic opacity. All microbiology cultures and sonication of the explanted parts of the prosthesis were negative. No histology of the removed soft tissue was performed.

**Figure 4.** (A) 31 March 2021. X-ray after revision surgery. Extensive metallosis was found and mostly removed. Damaged femoral head, polyethylene, and acetabular cup were replaced. Proper symmetrical positioning of components was performed after femoral head and acetabular components were replaced. A lot of metal-infused soft tissues were removed—note the diminished cloud around the prosthesis. (B) Routine X-ray at follow-up 2 months after surgery showed no dynamics.

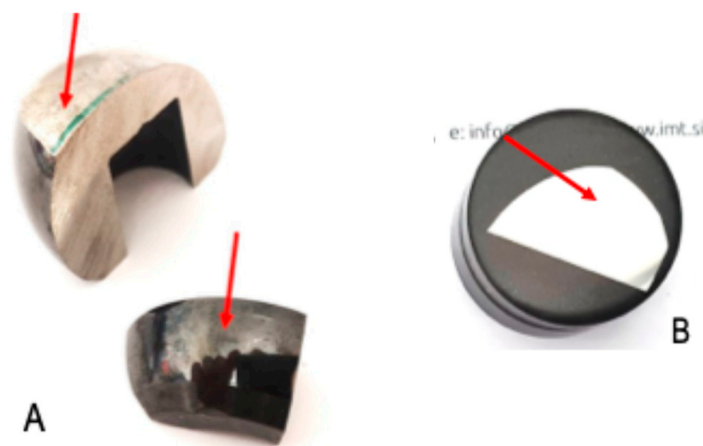
The results of the hardness measurements of the ceramic-like diffusion layer vs. worn layer are presented (Figure 5).

**Figure 5.** (A) Sample of retrieved Oxinium femoral head HV from the worn surface region, 383 HV, and from the diffusion layer, 1159 HV, as shown in Figure 6. Red arrow indicates the location of measurements. (B) Cross-section of metallographic sample of retrieved Oxinium femoral head used for hardness measurement.

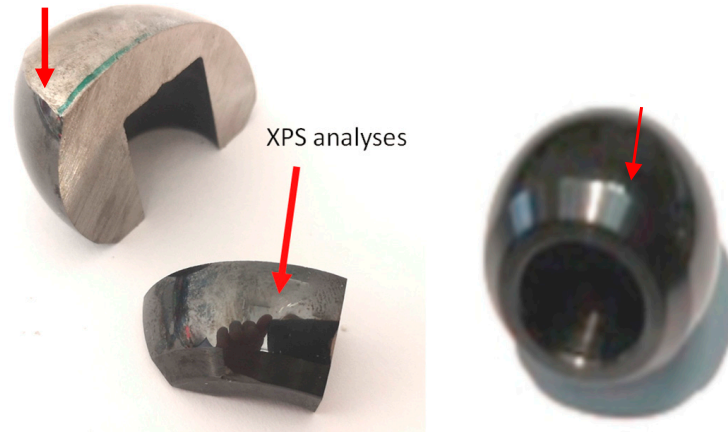
XPS measurements were performed on the worn surface of the retrieved and new femoral heads, as indicated in Figure 7. The red arrows indicate the locations on the worn surface where the XPS analysis was performed on the retrieved femoral head and on the surface of the new Oxinium femoral head.

**Figure 7.** Red arrows indicate the locations where the XPS analysis was performed on worn and unworn surfaces of retrieved femoral head and new Oxinium femoral head for comparison studies.

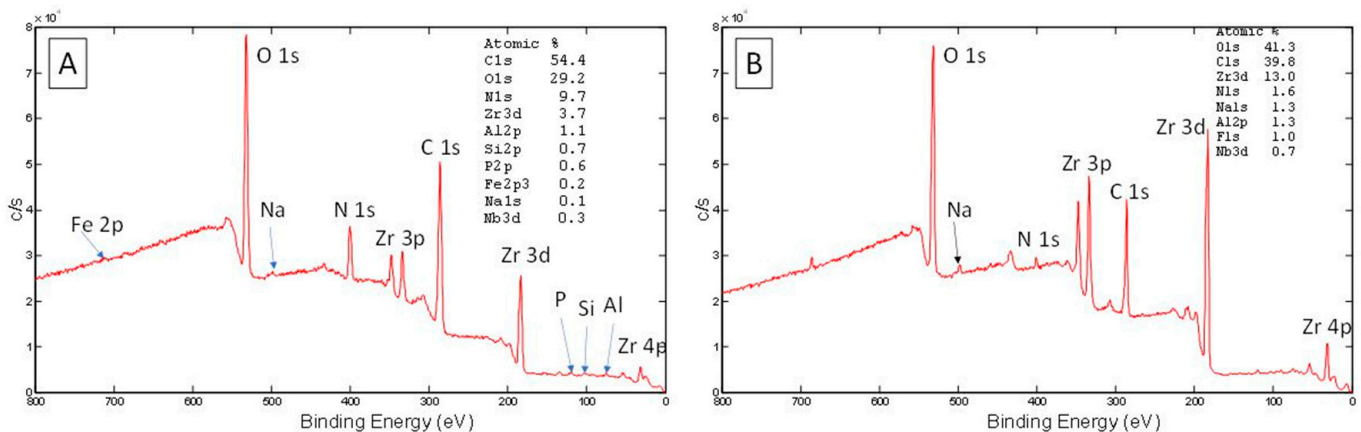
**Figure 8.** XPS spectra at the surface of (A) retrieved and (B) new Oxinium ceramic-like diffusion layer of femoral heads.

The XPS spectra at the surface of the retrieved and new Oxinium ceramic-like diffusion layer of the femoral heads are shown in Figure 8A,B. The surface composition, shown in Figure 8, of the retrieved femoral Oxinium head shows that the main phase is ZrO<sub>2</sub>, and 0.3%Nb is present at the surface. Carbon is present, possibly from XLPE or contamination, and there is also 10% N, which may originate from soft tissue near the hip endoprosthesis. We found Al 1.1, Si 0.7, Fe 0.2, P 0.6, and Na 0.1 (all in at.%). For comparison, we investigated the new unused femoral head and the surface composition was similar, with the main phase being ZrO<sub>2</sub> with 0.7 Nb; at the surface, C was present due to contamination and the elements present included Al 1.3; F 1.0; and Na 1.3 (at.%). Figures A1–A3 in Appendix A show the high-energy resolution XPS spectra Zr 3d, Nb 3d, O 1s, C 1s, and Al 2p from the surface of the retrieved Oxinium femoral head. Figure A4 in Appendix A shows the XPS spectra O 1s and C 1s from the surface of a new Oxinium femoral head.

A significant amount of nitrogen (10 at.%) is present on the surface of the retrieved femoral head (with worn Oxinium), probably due to soft tissue. Other elements are also present on the surface, like Fe, P, Si, and Na, on the worn coating. On the new Oxinium femoral head, the elements O, C, Zr, and Nb, and traces of Al and F are present.

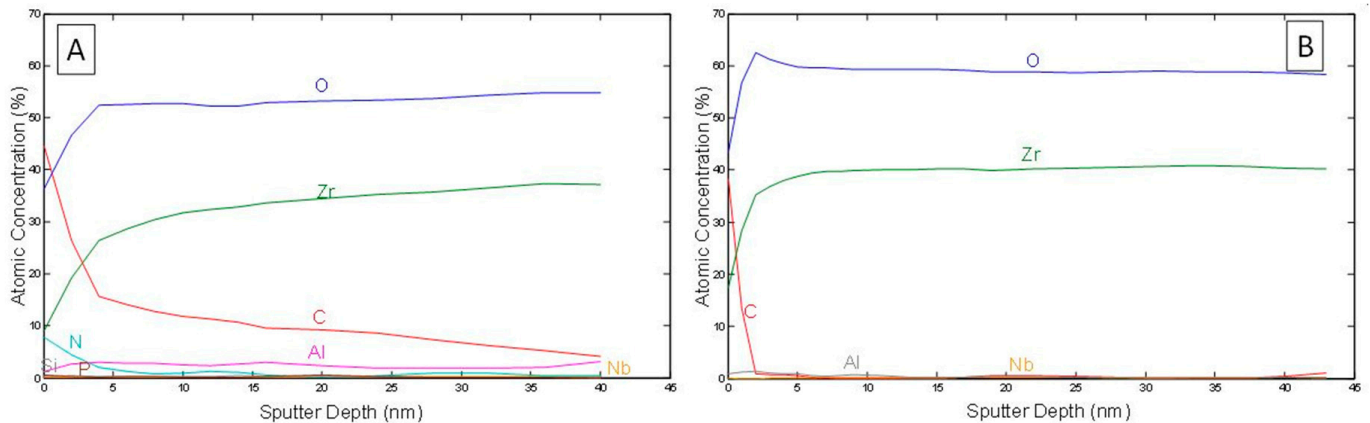
Figure 9 presents the XPS depth profile of surface layer between 0–40 nm of the retrieved (Figure 9A) and new Oxinium femoral heads from the hip endoprostheses (Figure 9B).

**Figure 9.** XPS depth profile of surface layer between 0–40 nm for oxidized Zr<sub>2.5</sub>Nb ceramic-like diffusion layer of retrieved (A) and new Oxinium femoral heads (B); ZrO<sub>2</sub> is the main phase in subsurface region, Al (~2–3 at.%) is present in subsurface region, and carbon decreases strongly from surface (only very thin contamination of 1–2 nm). Minor elements like Nb (0.2 at.%) are present in the coating.

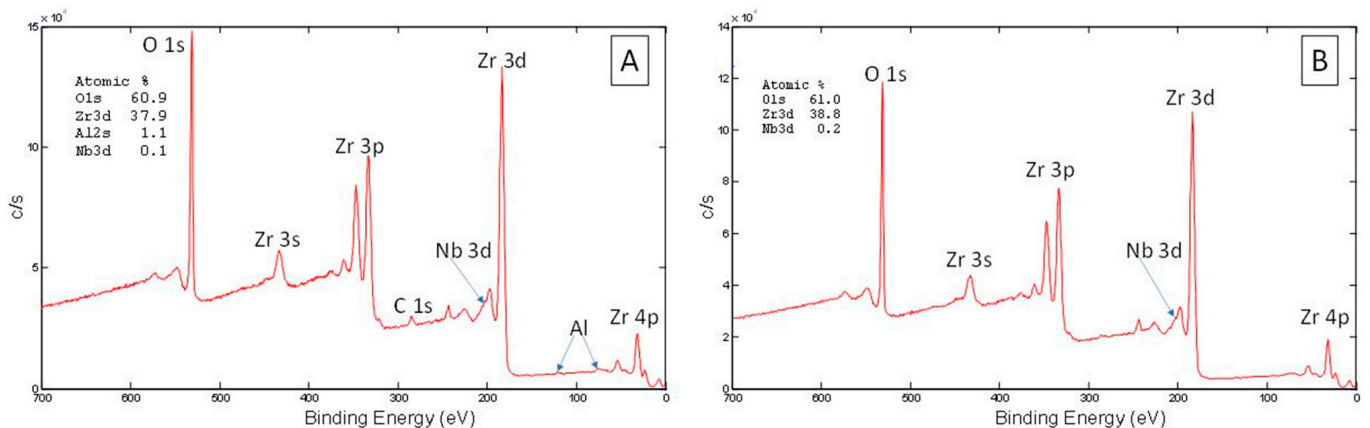
**Figure 10.** XPS spectra at a depth of 40 nm for retrieved (A) and (B) new Oxinium femoral heads from the diffusion ceramic-like layer.

Shown in Figure 10 are the XPS spectra presenting the surface compositions at a depth of 40 nm (Figure 10A) of the retrieved and (Figure 10B) new Oxinium femoral heads. The main phase of the composition at 40 nm is ZrO<sub>2</sub>, 0.1 at.%, with Nb present and 1.1 at.% of Al.
