# INITIATION OF STRESS CORROSION CRACKING IN BRASS COMPONENTS FOR DRINKING WATER SYSTEMS: SELECTED CASE STUDIES

Mirjam Bajt Leban\*, Tadeja Kosec

Slovenian National Building and Civil Engineering Institute, Dimičeva ulica 12, 1000 Ljubljana, Slovenia

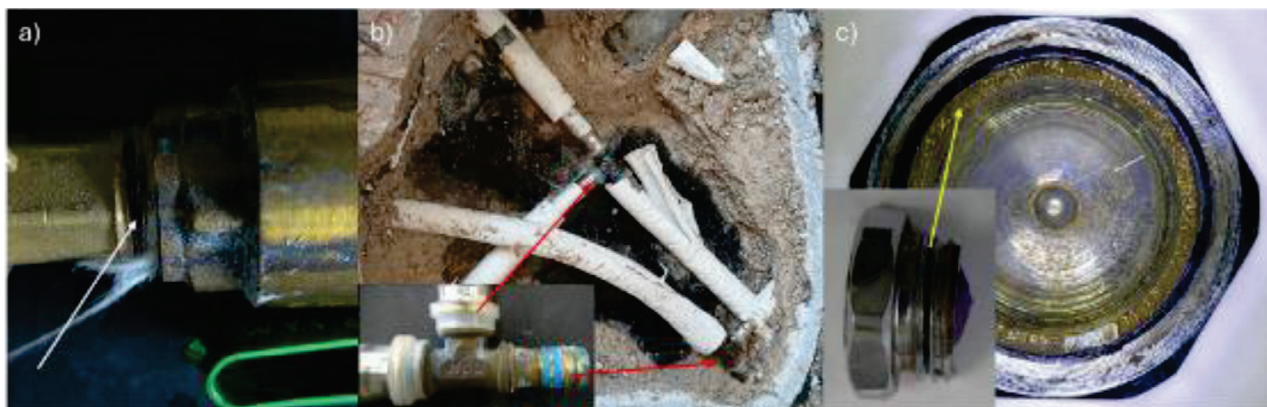
**Building A:** Several connection components of hot-water system valves in an internal water supply installation failed a few months after being installed in a new building, causing a leakage.

**Building B:** In a public building, several brass press T-fittings, connecting composite pipes for cold drinking water, began to leak due to fractures after 18 years of operation. The T-fittings were installed in the cement screed on the building floor.

**Building C:** Only a few days after installation and the start of operation, an angle valve plug collapsed.

**Figure 1:** Failed brass components from building A (a), B (b), and C (c). The white arrow in (a) indicates the fracture of the outside thread; red arrows in (b) show the position of T-fittings inserted in the cement screed on the floor; and the yellow arrow in (c) indicates the position of the fracture at the outer thread of the plug.

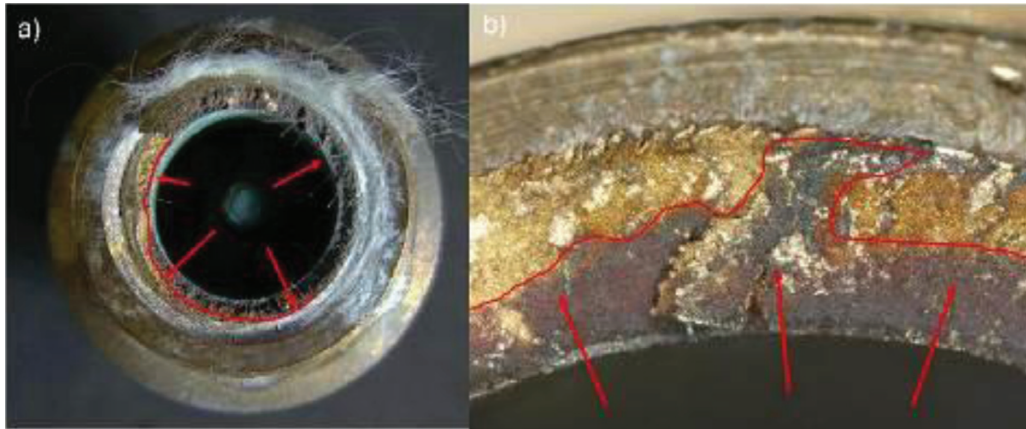
**Brass component A:** Examination of the fractured surface of this component (**Figure 2a**) showed that the main crack originated from the pipe interior. On some of the failed elements, stepwise crack propagation is present (**Figure 2b**). The main crack surface is, based on additional EDS mapping analysis, enriched with Zn and oxygen, indicating the presence of dezincification products (**Figure 3**).

**Figure 2:** Photographs of the fractured surface of failed component A. The red line indicates the transition between SCC and ductile final fracture. The red arrows indicate the SCC mode of fracture.

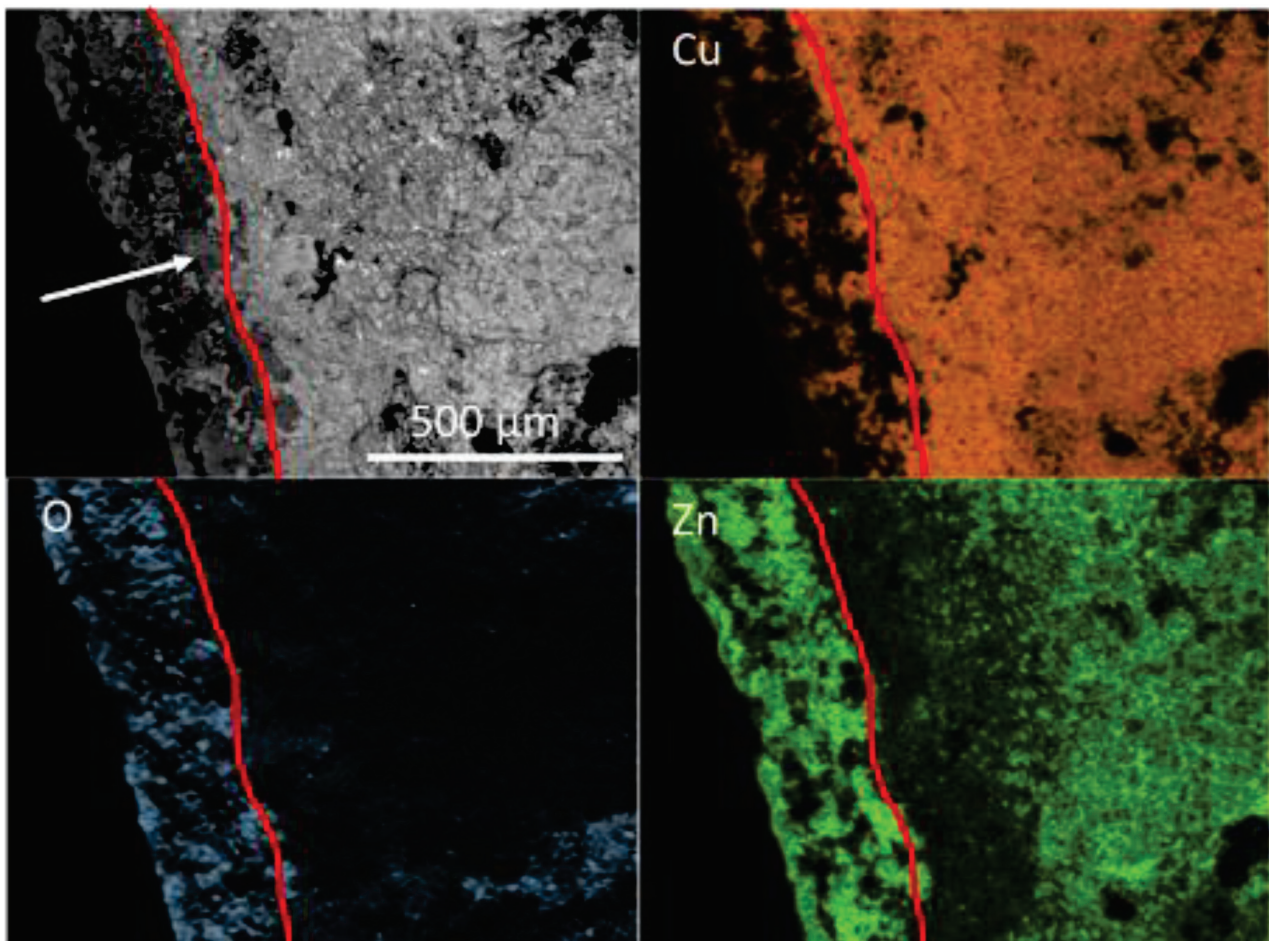
**Figure 3:** SEM-BSE (top left) and EDS mapping analysis for Cu, Zn and O of the cracked surface of specimen A

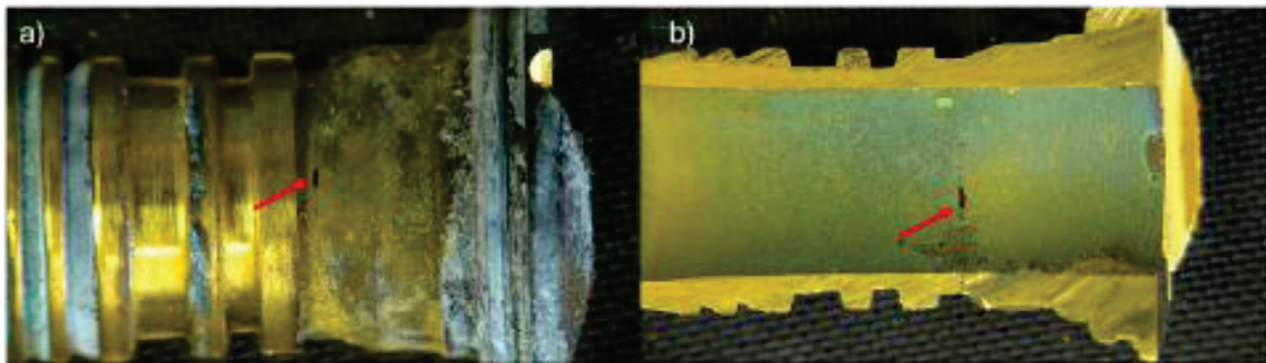
from the thinnest to the thickest part (**Figure 4**). A small hole is visible in this part through which water was leaking (marked with a red arrow in **Figure 4**). After removal from the water supply system, one of the fittings was deliberately broken in the laboratory along the crack to examine the old section of the crack, which can be clearly distinguished from the fresh overload fracture. The old

Figure 4: Press fitting (B) failure – outer surface (a) and inner surface (b). The red arrow indicates the initiation site of SCC.

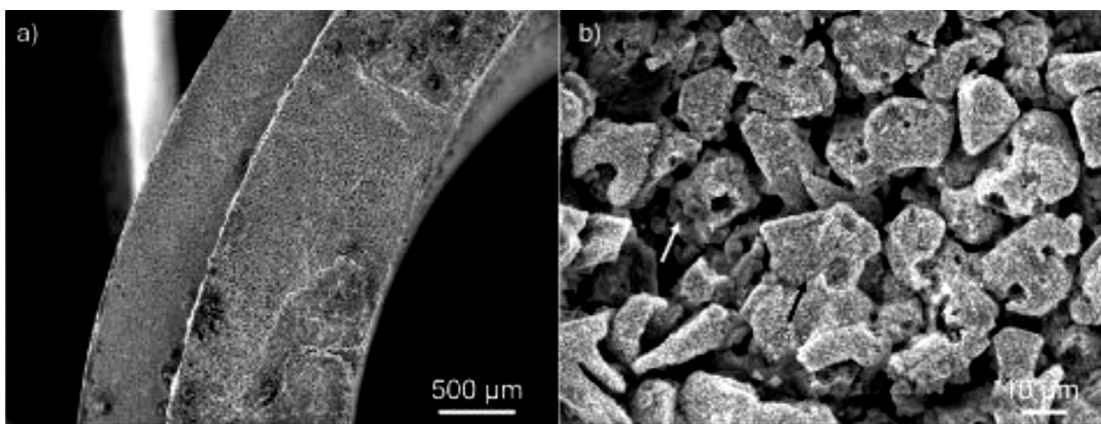
fracture (**Figure 5**) consists of Cu-rich grains (identified by EDS and marked with a black arrow in **Figure 5b**) and Sn-rich cubic crystals, marked with a white arrow in **Figure 5b**. The Zn-rich phase is absent, indicating a dezincification process in which its products, unlike those in building A, were not hydrolysed, but dissolved.

Figure 5: SEM photo of the fracture surface of press fitting B

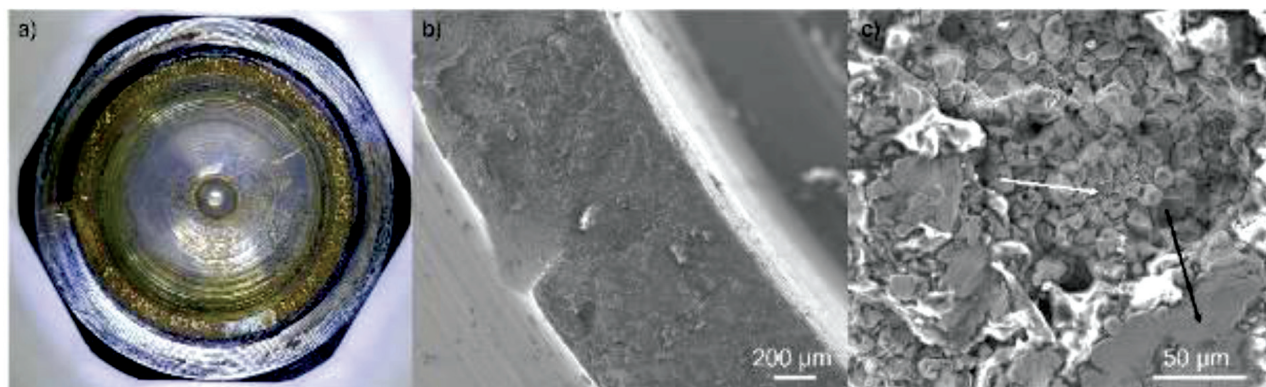
Brass component C: Numerous steps are visible on the fractured surface of this element (Figure 6a). SEM analysis of the fracture revealed flat facets (Figure 6c, black arrow), probably caused by the friction between the fracture surface and the opposite side after the break, as well as intergranular corrosion between the grains present at the fracture surface, indicating the presence of intergranular corrosion (Figure 6c, white arrow).

Figure 6: Fractured surface of angle valve plug with visible corrosion damage of nickel (Ni) coating at the bottom (a), and SEM images with details of the fractured surface (b and c)

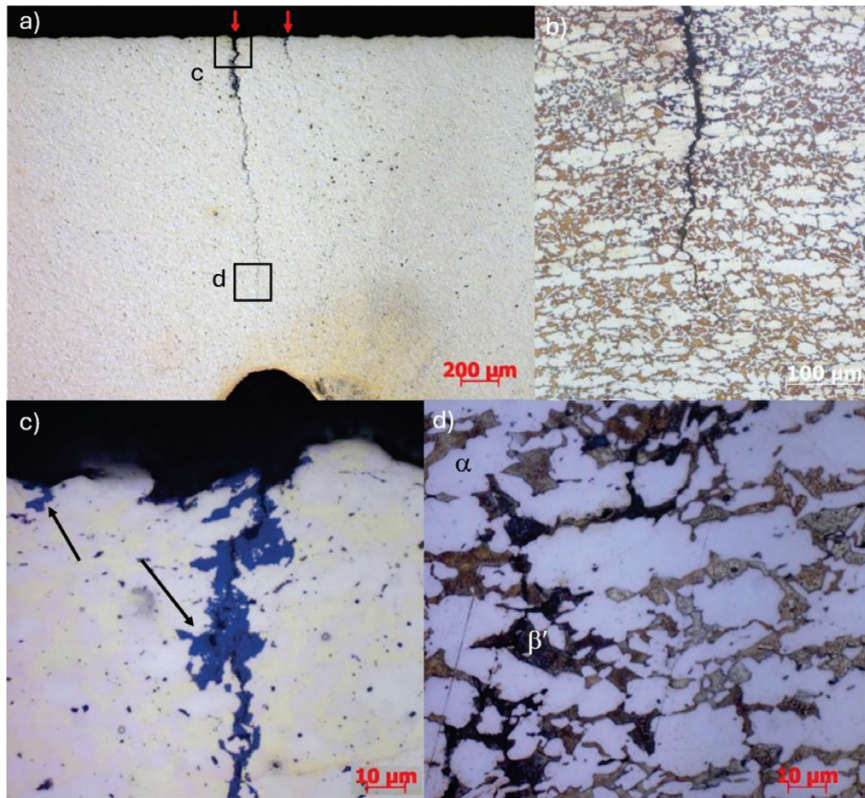
Brass component A: As shown by metallographic analysis (Figure 7), the microstructure (Figure 7b) exhibits distinctly elongated  $\alpha$  grains aligned with the deformation direction, while the  $\beta'$  phase is distributed in narrow, banded regions, characteristic of cold-deformed, non-recrystallised  $\alpha + \beta'$  brass. Several cracks propagated across the cross-section of the wall of the component (Figure 7a). Stress-corrosion cracks propagated from the internal wall of the joining component towards the externally threaded brass component. The primary

crack propagation direction is in the  $\beta$ -phase, which is richer in zinc. Near the initiation site (Figure 7c), cracks are more open and the crack walls consist of a Zn-rich product; areas of dezincification are grey, similar to those described by Zhang et al.<sup>23</sup> This particular type of

corrosion was also indicated by the EDS analysis presented in Figure 3. Cracks propagate either transgranularly through  $\beta'$ -grains or intergranularly between  $\alpha$  and  $\beta'$  grains (Figure 7d).

**Figure 7:** Metallographic cross-section of a cracked site with two visible cracks in brass component A (initiation sites marked with red arrows a); microstructure near the main crack b); initiation sites of the cracks filled with grey products c); the end of the crack which propagated mainly between  $\alpha$  and  $\beta'$  phases, or through  $\beta'$  phase d)

In the case of brass component A, cracks initiated on the inner side in contact with water and propagated through the material towards the nearest thread root. As the crack approaches the end, its branching is visible (**Figure 7c**). Similar crack propagation was observed for the failed brass component B, with the exception that the initiation site was at the outer surface, which was not in contact with drinking water (**Figure 8c**). On the other hand, in the case of the brass component A, the walls of the opened part of the crack (around 200  $\mu\text{m}$ ) were filled with grey Zn-containing products (**Figure 3**), which were not observed within the crack walls of the brass component B. However, some secondary cracks near the main crack of brass component B began to propagate from such grey products at the surface. These products consist of porous, redeposited  $\text{ZnO}/\text{Zn}(\text{OH})_2$ , formed as a result of dezincification<sup>25</sup> due to the presence of water (or high humidity) in the cementitious material, in which this component was installed. Usually, such products dissolve, leaving a Cu-rich phase; however, for the elements investigated, it is very likely that the chemical properties of the water (pH, chlorides) did not permit this.

However, a detailed view of the cross-section of the crack in this component near its initiation (**Figure 7b**) reveals selective corrosion of the  $\beta'$  phase.

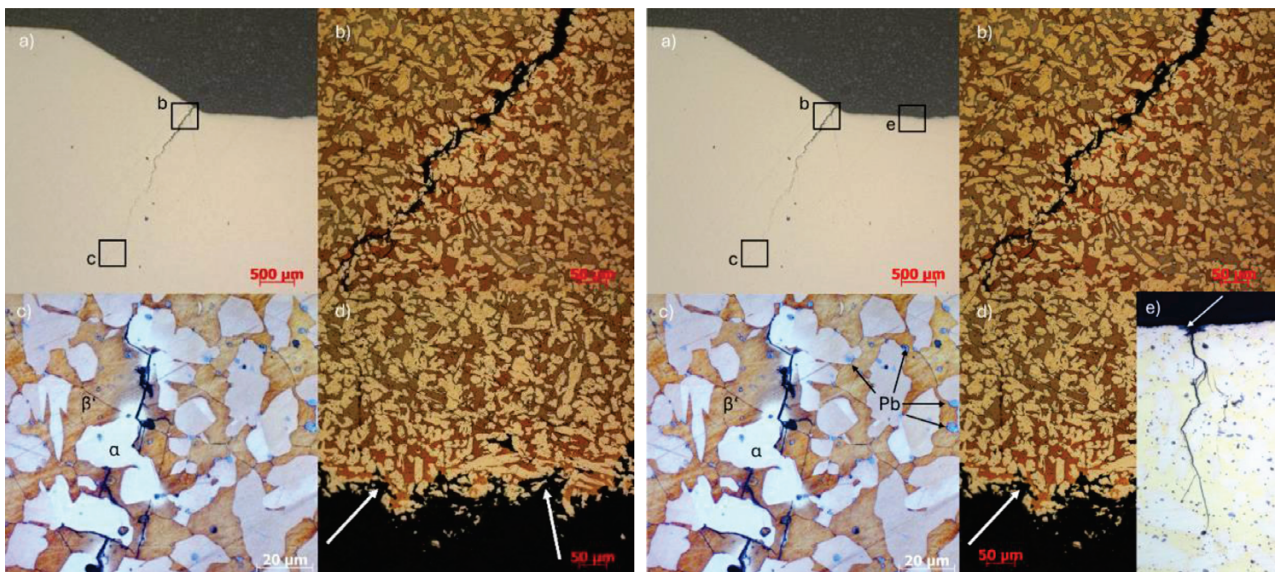
**Figure 8:** Metallographic cross-section of the cracked site, showing a visible crack initiated at the geometric transition of brass component B (a); initiation site of the crack (b); the end of the crack, which propagated mainly between the  $\alpha$  and  $\beta'$  phases or through the  $\beta'$  phase, with light grey Pb particles marked by black arrows (c); the inner side of the fitting with dezincification, marked by a white arrow (d); secondary cracks near the main fracture with a visible initiation site on Zn corrosion products (white arrow) (e).

Brass component B: As shown in **Figure 8b**, the microstructure is recrystallized, with evenly distributed  $\beta$ -phase, and rounded, polygonal  $\alpha$  grains. The crack propagated transgranularly across  $\beta'$ -grains, and also intergranularly between  $\alpha$  and  $\beta'$  grains near its end (**Figure 8c**), most likely due to cyclic bending (fatigue) of the fitting. **Figure 8d** presents a metallographic image of the inner side of the fitting, indicating that the microstructure is surface-dezincified – the  $\beta'$  phase (darker appearance) is absent from the surface, having dissolved in the water during the dezincification process. Only the  $\alpha$  phase, which is resistant to dezincification, remains at the edge.

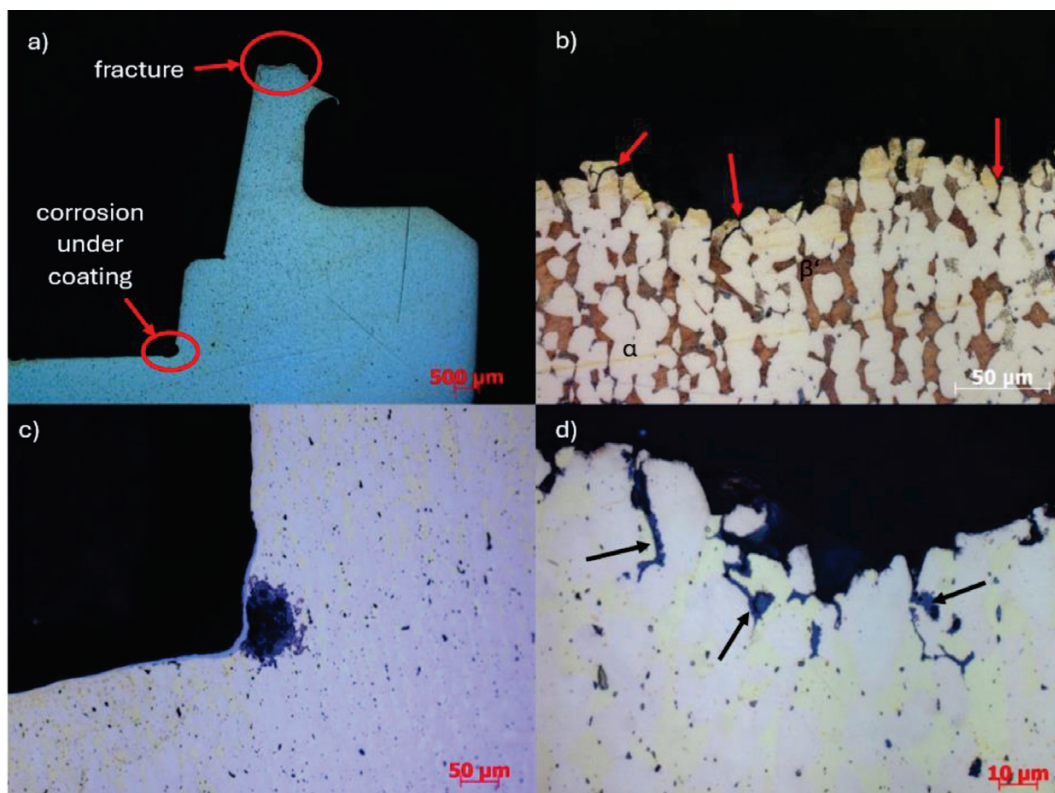
Brass component C: The microstructure (**Figure 9b**) consists of clearly separated  $\alpha$  and  $\beta'$ -phases with relatively coarse, equiaxial grains, indicating a heat-treated (annealed) condition in the  $\alpha + \beta$  range. Two types of corrosion failures were observed: intergranular corrosion between  $\alpha$  and  $\beta'$  grains (**Figure 9b**), and corrosion under the nickel coating (**Figure 9c**). In the vicinity of both types of corrosion, Zn-rich products of grey colour are visible (**Figure 9d**).

**Figure 9:** Metallographic photos of an angle valve plug a); with a visible intergranular fracture from the fractured surface – intergranular crack propagation marked with red arrows b); interior corrosion under coating c); dezincification inside intergranular corrosion, marked with black arrows d)

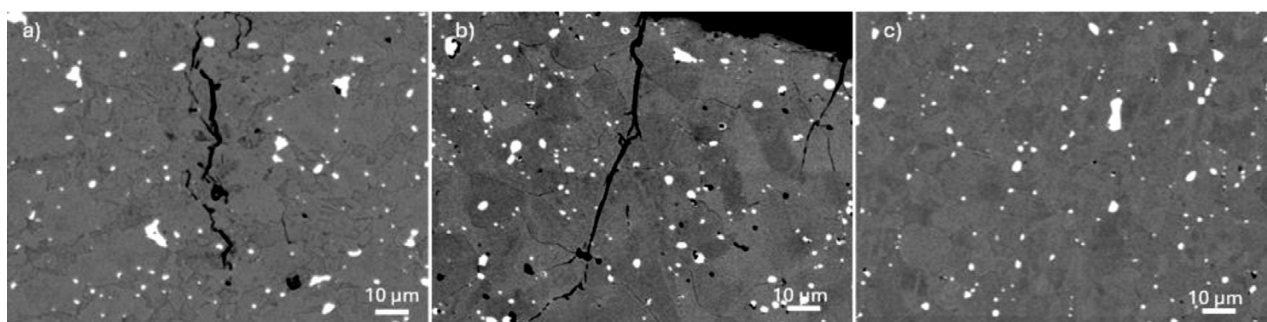
**Figure 10:** Backscattered electron images of the investigated brass components A (a), B (b), C (c). Pb particles are white in all images.

According to the literature<sup>2</sup>, coarsened lead particles in brass can increase internal stresses and promote SCC. The amounts, shapes, and distribution levels of Pb in the investigated cases were similar (**Figure 10**). Only in the case of brass component A, in addition to round particles, there were also coarser particles of irregular shapes. However, no correlation between crack initiation or propagation and such Pb particles was observed.
