# Innovative Calcium Carbonate-Based Products to Repair Cracked Cement Mortars

**Abstract:** The durability of Portland cement mortars is often affected by environmental factors, which can cause physicochemical and mechanical degradation processes. In this study, the performance of three products, calcium acetoacetate and calcium tetrahydrofurfuryloxide dissolved in two different solvents developed and tested as stone consolidants, was evaluated in terms of crack filling or sealing and consolidation. Realistic cracks were induced in quasibrittle cement mortar prisms using a custom-designed test rig. The effectiveness and the performance of the considered treatments, investigated on specimens, were evaluated by optical and scanning electron microscopy, colourimetry, water absorption rate, ultrasonic pulse velocity, and surface hardness measurements. Results revealed that, in the examined conditions, the products were more suitable as surface consolidants than as crack fillers.

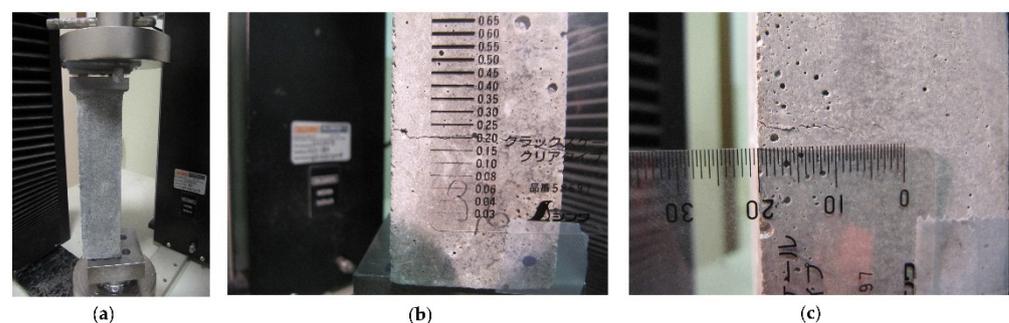
**Figure 1.** Cracking procedure: (a) test rig for eccentric axial compression; (b) width and (c) depth of induced cracks.

The cracking method and related laboratory test rig envisaged the application of an eccentric axial compression to the mortar prisms. An eccentricity of 15 mm along one of the two axes of symmetry of the  $40 \times 40$  mm<sup>2</sup> cross-section was used. This eccentricity and a proper contact with the  $40 \times 40$  mm<sup>2</sup> surfaces of the mortar prisms were produced

by using a steel ball-joint and a linear hinge as bottom and top boundary conditions, respectively (Figure 1a). The linear hinge was placed parallel to one of the 40 mm sides of the cross-section and with an inward offset of 5 mm from the edge, thus producing the abovementioned eccentricity of 15 mm. The eccentric compression imposed by the boundary conditions generated combined internal plane-stress tension and compression stress field parallel to the vertical plane perpendicular to the linear hinge. Owing to the quasifragile behaviour of the cement mortar prisms [42], during loading, the internal tensile stresses reached the tensile strength of the mortar and generated the crack (Figure 1b), while the compressive stresses were still within the elastic behaviour and maintained undamaged about one-third of the  $40 \times 40 \text{ mm}^2$  mortar cross-section. The compression load was applied in displacement control at a rate of  $5 \mu\text{m/s}$ . Loading was stopped once 3 to 4 stable cracks with a mouth of about 0.2 mm (Figure 1b), a depth of 20 mm to 30 mm (Figure 1c), and spaced apart about 40 mm, had been induced in each mortar prism.

The achievement of a crack mouth opening of about 0.2 mm was the stopping criterion for the loading procedure. After unloading, the crack mouth relaxed to about 0.1 to 0.15 mm once the eccentric axial compression had been removed from the mortar prisms, thus reproducing typical microcracks in reinforced concrete structures during their service life [43]. Hairline cracks (microcracks smaller than 0.3 mm) are usually left untreated in common practice due to the difficulty of injecting them with commercial epoxy resins [17]. Nonetheless, microcracks adversely influence the durability of reinforced concrete structures, for instance, the resistance to chloride penetration and related damage [44]. Therefore, compatible consolidants with concrete substrates and having good penetration into microcracks, and reconsolidation ability were tested in the present investigation.

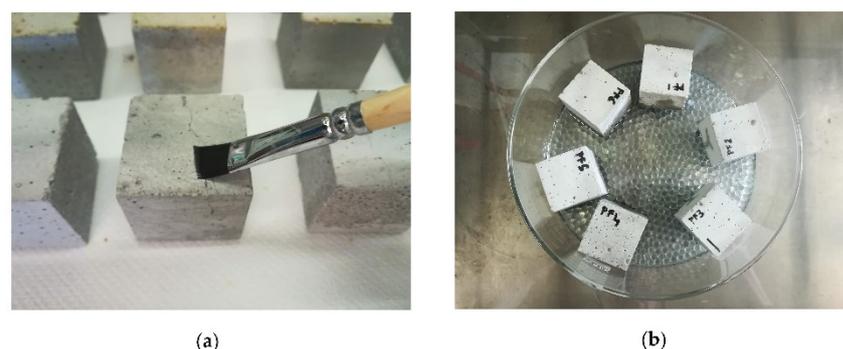
**Figure 2.** Example of application procedures of CFW: (a) brush till refuse, AP1; (b) absorption through capillarity, AP2.

Two procedures were used to apply the consolidating products: by brush till refuse (AP1), and by absorption through capillarity (AP2). In the first case, the application stopped when the surface had remained wet for more than 1 min, and it consisted of 8 applications each sample (Figure 2a). In the second case, specimens were placed over a glass sphere bed with the face to be treated left in contact with the products for 2 h (Figure 2b). For each type of test, results are expressed as the mean value of three samples.

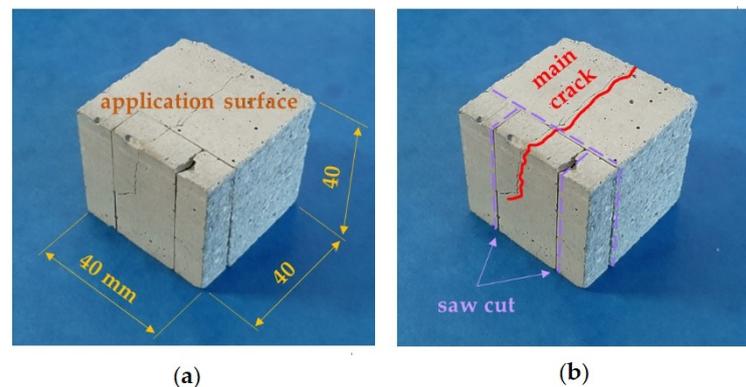
**Figure 3.** Mock-up cut to obtain smaller samples suitable for OM and SEM analysis: (a) application surface for the different protective treatments; and (b) typical location of the main crack and saw cuts.

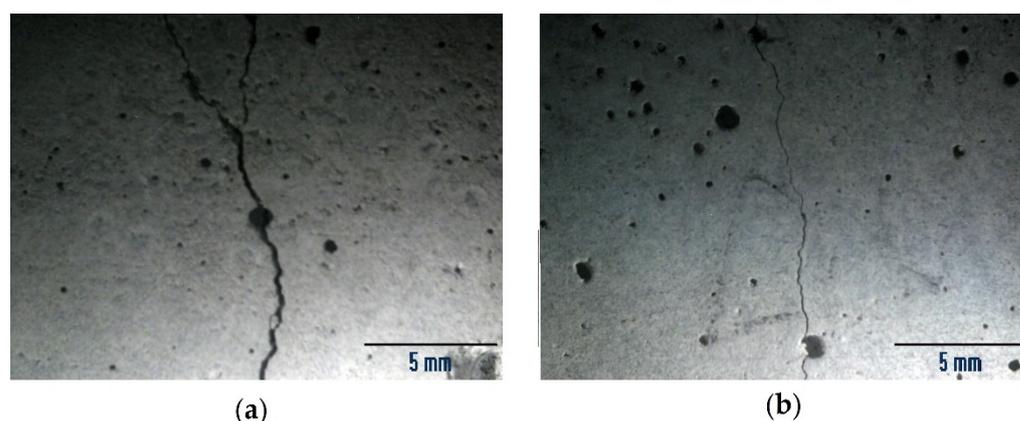
**Figure 4.** Stereomicroscopy images (7 $\times$ ) of samples (a) untreated and (b) treated with ALK2\_AP1: a reduction in crack width is visible.

Observations of the application face of samples through optical microscopy on representative samples of all the applied products (one for each product and treatment and 2 not treated as references, 8 samples in total) generally seemed to reveal a reduction in the width of the cracks after the introduction of the consolidants (Figure 4a,b, referring to ALK2\_AP1). This was a general trend, although measurements were not performed on the same samples before and after application.

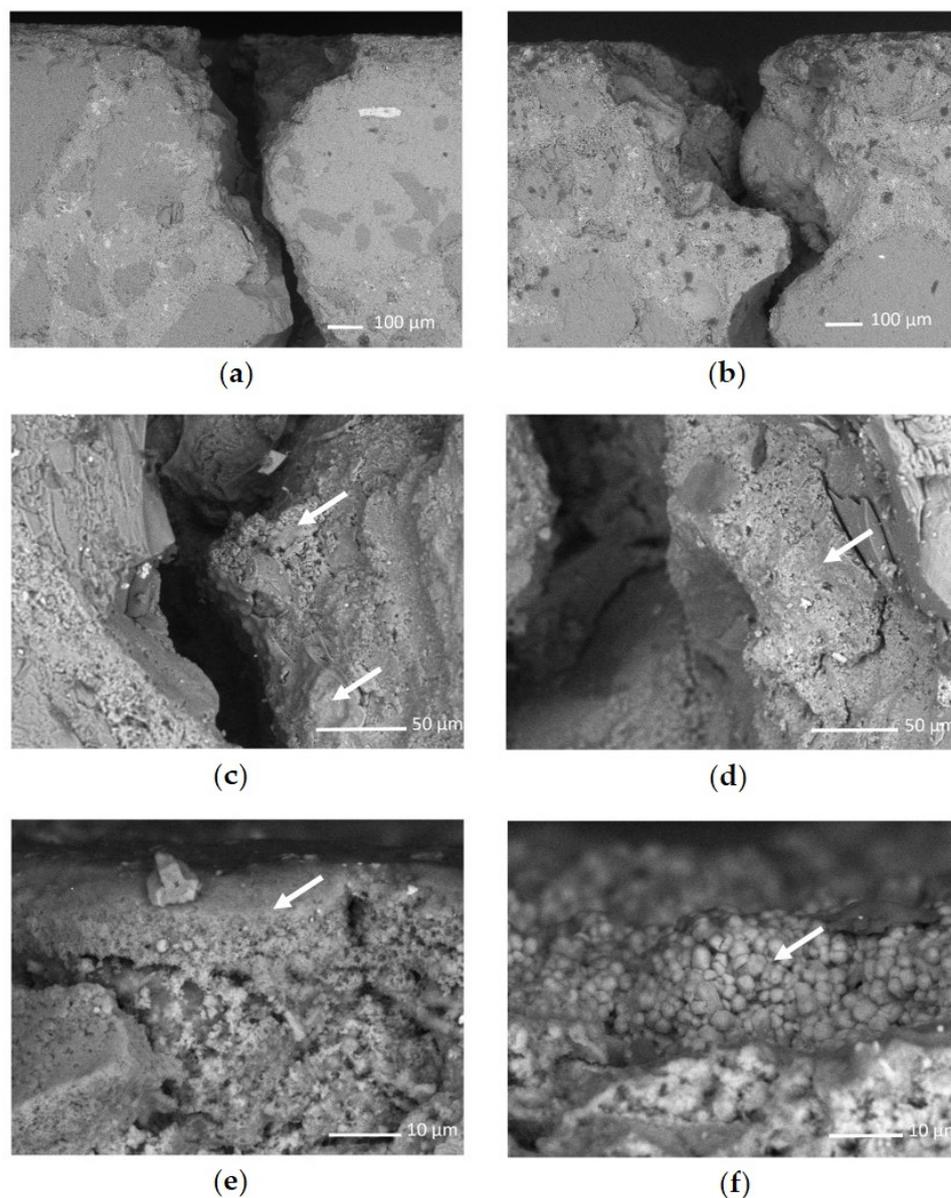
**Figure 5.** SEM images of samples treated with (a,c,e) ALK1 and (b,d,f) CFW, applied via absorption through capillarity (AP2), at different magnifications ((a,b): 100 $\times$ ; (c,d): 500 $\times$ ; (e,f): 2000 $\times$ ). (a,b) At low magnification, it is evident that the crack was not filled with consolidants; (c,d) at higher magnifications, the consolidant material was deposited on the crack walls. At even higher magnifications, the morphology of different consolidants was clearly seen to be (e) needlelike and (f) spherical particle formation.

Four selected cubic mock-ups (one untreated and one treated by absorption through capillarity for each product: ALK1\_AP2, ALK2\_AP2, CFW\_AP2), observed in advance with optical microscopy, were then observed with the scanning electron microscope (JEOL instrumentation) to evaluate a possible crack-filling effect. SEM images of samples treated with ALK1 and CFW by immersion (AP2) are shown in Figure 5. At low magnifications, consolidants apparently did not exhibit a crack-filling effect (Figure 5a,b). Higher magnifications of cracks show that consolidants were deposited on the crack walls, as indicated by the arrows in Figure 5c,d: on the surface of samples, the formation of needlelike (Figure 5e) and spherical (Figure 5f) particles can be seen. Needlelike particles are characteristic for alkoxide transformation [51], while spherical particles are characteristic for vaterite formation, typically occurring in CFW transformation [52]. Formed vaterite particles are approximately 1 to 3  $\mu\text{m}$  in size, which is in accordance with previous studies [52].

It is interesting to compare these results with those obtained from the use of the other SEM instrumentation (FEI Quanta 200), where the preparation of samples required a rather aggressive cutting in presence of water. In one case (ALK1\_AP2), the deposit of the treatment inside the cracks was evident, but with an inhomogeneous distribution. For CFW\_AP2 and ALK2\_AP2, the deposit was scarcely visible in the cracks; however, CFW seemed to have a more homogeneous distribution. The procedure used to cut the samples might have partially removed the coating, as also observed by Roig-Flores and Serna [53].

Therefore, a certain consolidation effect was observed for all treatments with both application procedures. The major differences before and after treatment were with application method AP2, except for CFW. ALK1 and ALK2 had the best performance in percentage with the application by capillarity, although their retained quantity of product was the lowest. The higher UPV values after treatment were probably due to the deposition of the consolidant on the surfaces of the cracks, as can be seen from SEM images in Figure 5c,d.

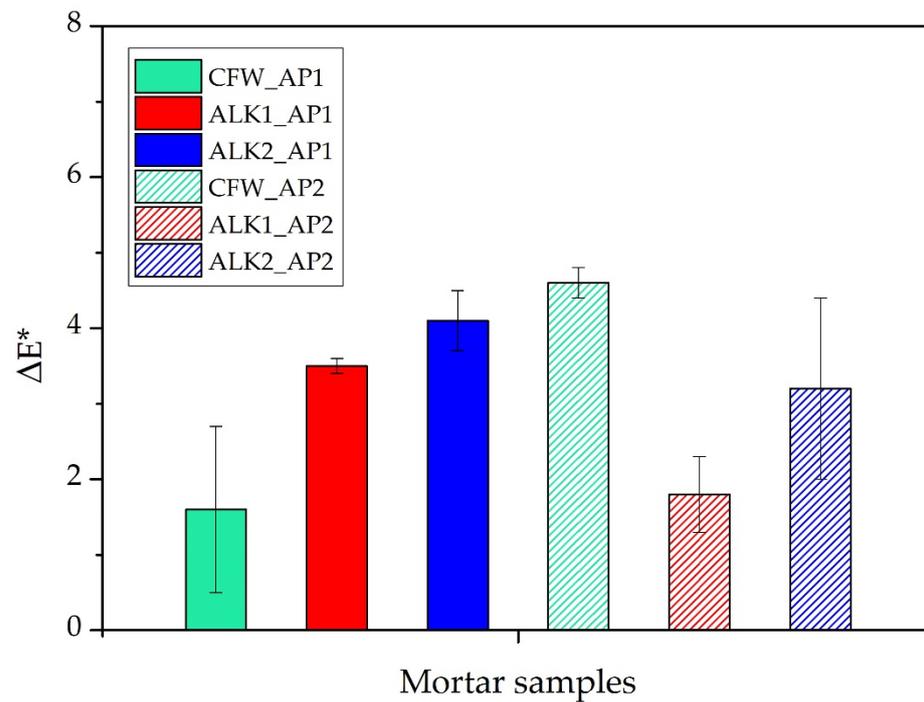
**Figure 6.** Chromatic variation after the application of all products with both procedures. CFW:  $\text{Ca}(\text{OAcAc})_2$ ; ALK1:  $\text{Ca}(\text{OTHF})_2$  in ethanol; ALK2:  $\text{Ca}(\text{OTHF})_2$  in 2-butanol; AP1: brush till refuse; AP2: absorption through capillarity.

The surface colour variation caused by treatments was, in all cases, below the acceptable limit  $\Delta E^* < 5$  (according to García and Malaga [54]), which is hardly appreciable by visual estimation, as shown in Figure 6. This datum suggests their aesthetical compatibility with the treated support. Indeed, this is an important parameter when proposing a treatment for historical buildings and cultural heritage objects, where visual integrity must be preserved [21,55].

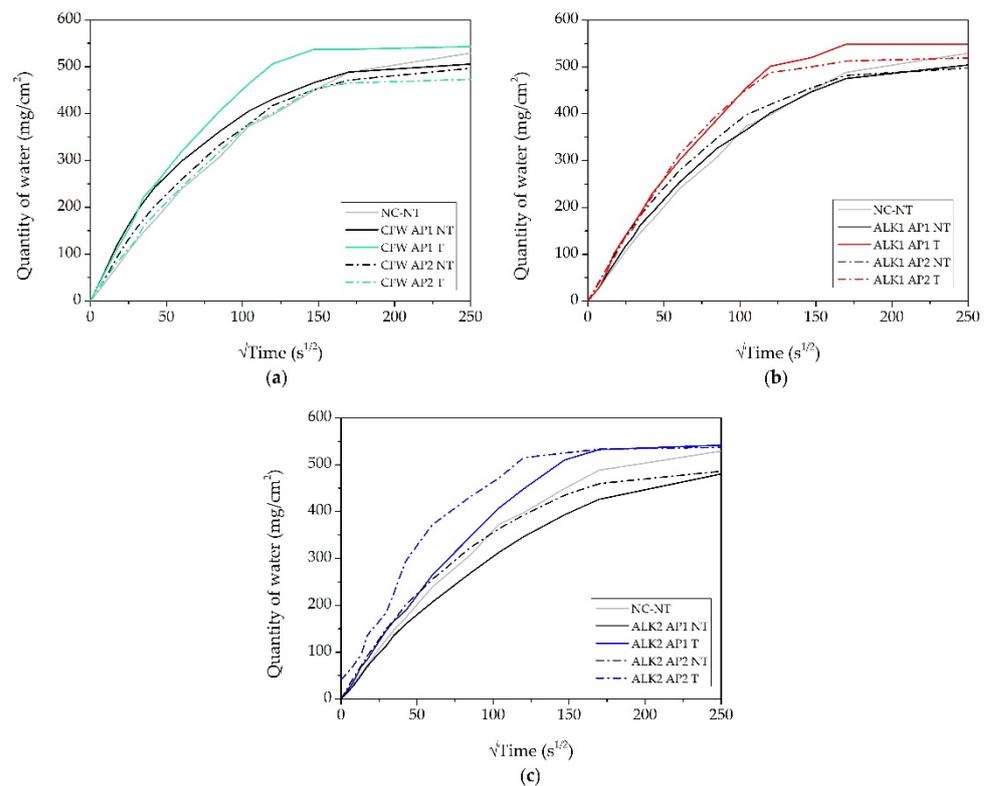
**Figure 7.** Quantity of water absorbed by capillarity—comparison among uncracked–untreated samples (NC–NT), cracked–untreated samples (CFW\_AP1 NT, CFW\_AP2 NT, ALK1\_AP1 NT, ALK1\_AP2 NT, ALK2\_AP1 NT, ALK2\_AP2 NT) and cracked–treated samples (CFW\_AP1 T, CFW\_AP2 T, ALK1\_AP1 T, ALK1\_AP2 T, ALK2\_AP1 T, ALK2\_AP2 T): (a) focus on CFW (b) focus on ALK1 and (c) focus on ALK2. CFW: Ca(OacAc)<sub>2</sub>; ALK1: Ca(OTHF)<sub>2</sub> in ethanol; ALK2: Ca(OTHF)<sub>2</sub> in 2-butanol; AP1: brush till refuse (continuous lines); AP2: absorption through capillarity (dashed lines).

Water absorption tests were carried out for all the samples, and the results are reported in Figure 7 and Table 2. After the application of the products, water absorption was generally similar to that of the untreated mortars. The water absorption of CFW\_AP2 decreased during the first 8 h when compared to the cracked-untreated samples (NT) and to the other treatments with both application procedures, which could have been related to the maximal material uptake into the fracture (Table 1).

In general, products did not affect the water absorption, although a small reduction in CWAC was considered to be related to the efficacy of a consolidation treatment. However, untreated samples start with a low CWAC; therefore, it is difficult to have consistent variation in this parameter. Furthermore, a variation in CWAC of less than 10% is generally suggested [56] to assess the compatibility of a consolidation product. Regarding ALK1\_AP1, which showed an unusual increase in CWAC, the standard deviation was significant, probably due to the different morphology of the cracks and inhomogeneity among samples. However, more in-depth investigations might suggest alternative hypotheses.

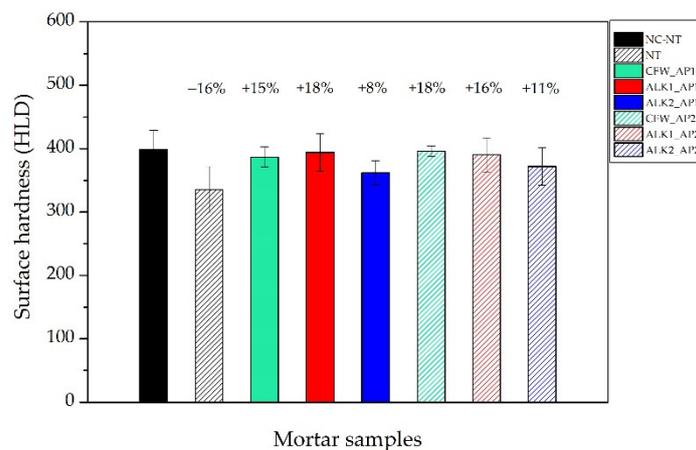
**Figure 8.** Comparison of surface hardness among: uncracked–untreated samples (NC–NT), cracked–untreated samples (NT) and cracked–treated samples. CFW: Ca(OAcAc)<sub>2</sub>; ALK1: Ca(OTHF)<sub>2</sub> in ethanol; ALK2: Ca(OTHF)<sub>2</sub> in 2-butanol; AP1: brush till refuse; AP2: absorption through capillarity.

Rebound data of reference samples and specimens treated with all the products and their percentages of variation (%) are presented in Figure 8. The percentage of variation (%) of cracked–untreated samples (NT, −16%) was calculated concerning to untreated and uncracked samples (NC–NT); the results referring to treated samples are expressed with respect to the cracked–untreated samples. In this case, tests were not performed on the same specimens before and after the treatment, but the reference was provided by a separate set of samples. Figure 8 reports in more detail the relative variation in surface hardness, referring to either uncracked–untreated results (NC–NT) for cracked–untreated samples (NT) or to the latter for treated ones.

The presence of cracks on untreated samples (NT) led to a decrease of 16% with respect to intact NC–NT, while treatments were able to increase the surface hardness to similar values to those of uncracked–untreated samples, with the exception of ALK2, which showed an improvement of between 50% and 70% compared to the average performance of the other treatments. This may provide weak protection of damaged or altered surfaces to abrasion.
