Article

# Monitoring the Corrosion of Steel in Concrete Exposed to a Marine Environment

**Abstract:** Reinforced concrete structures require continuous monitoring and maintenance to prevent corrosion of the carbon steel reinforcement. In this work, concrete columns with carbon and stainless steel reinforcements were exposed to a real marine environment. In order to monitor the corrosion processes, two types of corrosion probes were embedded in these columns at different height levels. The results from the monitoring of the probes were compared to the actual corrosion damage in the different exposure zones. Electrical resistance (ER) probes and coupled multi-electrodes (CMEs) were shown to be promising methods for long-term corrosion monitoring in concrete. Correlations between the different exposure zones and the corrosion processes of the steel in the concrete were found. Macrocell corrosion properties and the distribution of the separated anodic/cathodic places on the steel in chloride-contaminated concrete were addressed as two of the key issues for understanding the corrosion mechanisms in such environments. The specific advantages and limitations of the tested measuring tech

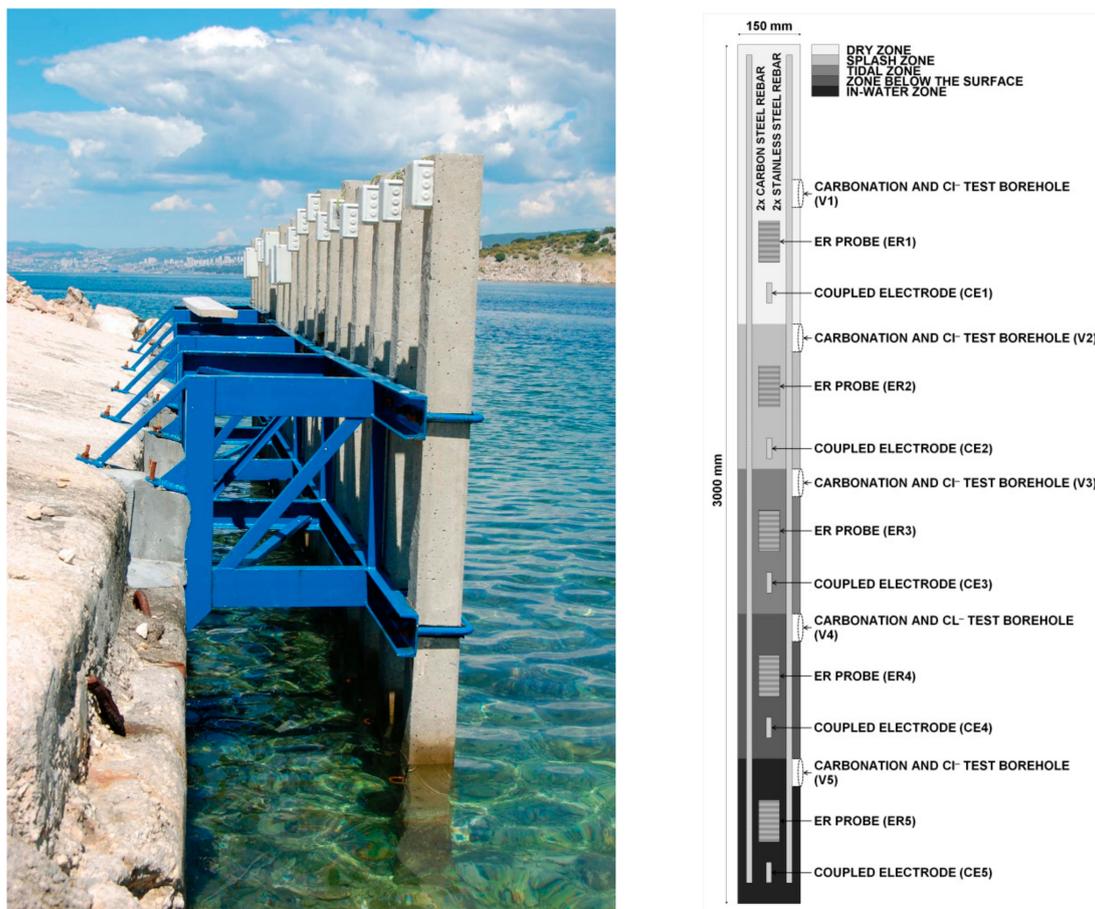
**Figure 1.** (a) Photograph and (b) schematic of a concrete column, placed vertically into the seawater, with the location of the steel reinforcement bars, electrical resistance (ER) probes, and coupled multi-electrodes (CMEs) at different heights (different exposure zones).

Large-scale concrete specimens (Figure 1) were prepared and exposed to a marine environment on the north Adriatic coast under the Krk Bridge (Croatia) for 52 months (4.3 years). The location of the test site was chosen because of its extreme environment, i.e., strong winds (bora and sirocco) and the high salinity of the water (3.5%) [42].

Altogether, 18 concrete columns, 3 m high and 15 cm × 15 cm wide, were prepared and exposed; however, only 4 columns (C10, C11, C12, C16) were equipped with ER and coupled multi-electrode (CME) sensors for long-term corrosion monitoring (Table 1, Figure 1) and are therefore presented in this paper. The bottom part of the columns was placed vertically into the sea, enabling corrosion monitoring in five different exposure zones: in-water zone (0 to 0.5 m from the bottom), zone just below the sea surface (0.5 m to 1 m from the bottom), tidal zone (1 m to 1.5 m from the bottom), splash zone (1.5 m to 2 m from the bottom), and dry zone (2 m to 3 m from the bottom). All the concrete columns were prepared using a concrete mixture with CEM I 42.5 cement (Salonit Anhovo, Slovenia) and a w/c ratio of 0.75, with no chemical additives. A high w/c ratio was used in order to accelerate the experiment and enable a qualitative comparison between the corrosion resistance of ordinary carbon

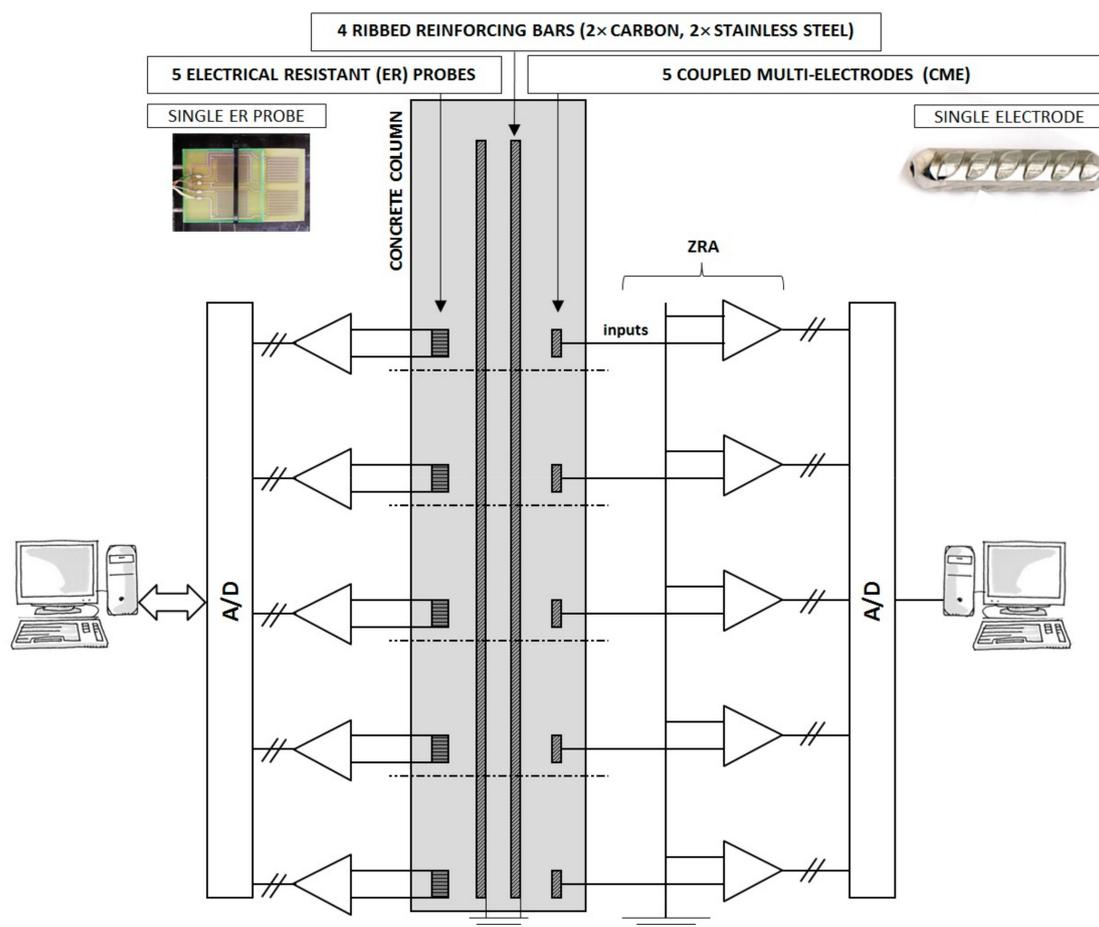
**Figure 2.** Schematic presentation of five individually measured electrical resistance (ER) probes and five coupled multi-electrodes connected through the Zero Resistance Ammeter (ZRA), with a photograph of a single ER probe and single electrode.

In addition to the reinforcing steel bars and ER probes, the same four columns were equipped with five special coupled multi-electrodes (Figure 2) made of carbon or stainless steel reinforcement (nominal diameter, 14 mm; exposed external surface,  $25 \text{ cm}^2$ ), placed with one in each zone of exposure (Figure 1, Table 1), and electrically connected through Zero Resistance Ammeters (ZRAs, ZAG, Ljubljana, Slovenia).

An ER probe is a sort of instrumented corrosion coupon: the thickness of the metal conductor is reduced due to the corrosion, while the resulting increase in its resistance is measured. Therefore, it is not an electrochemical but a physical method. Based on its performance characteristics, it is possible to determine the cumulative corrosion damage, as well as the corrosion rate in specific periods. The exact operating principle for ER probes was described in our previous papers [28,30,34,45]. The voltage drop over the entire ER probe ( $U$ ) and the voltage drop between two branches ( $\Delta U$ ) were measured with a Portable Current Source SCS-100 (ZAG) at a 50 mA applied current and a Fluke 289 high-impedance voltmeter (Fluke Corporation) with an accuracy of 0.025%. Measurements of the thickness change had a resolution of less than 0.1  $\mu\text{m}$ . The Wheatstone bridge configuration ensures the elimination (self-compensation) of temperature fluctuations. The configuration of ER probes in individual columns is presented in Figure 2.

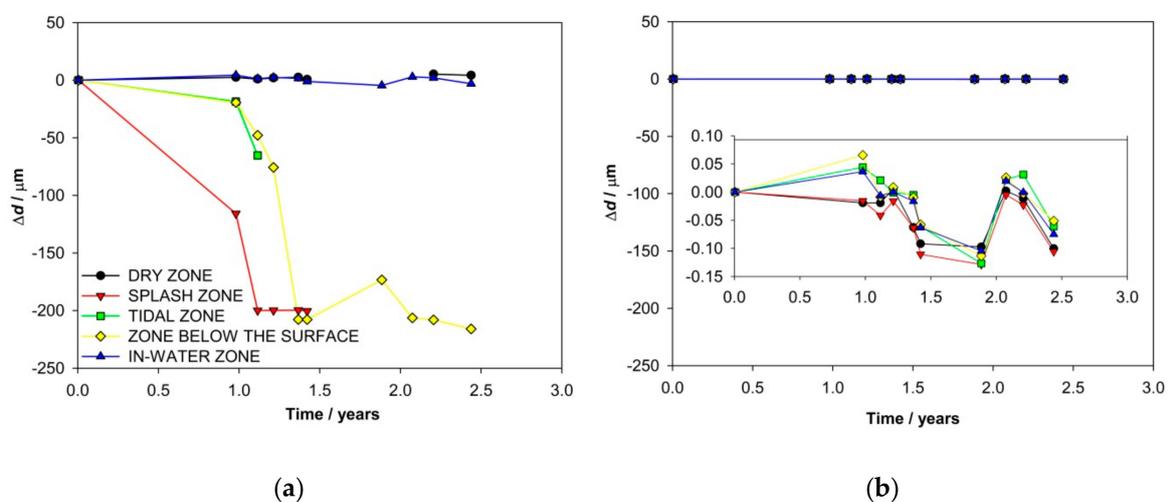
**Figure 3.** Thickness reduction of ER probes in different zones of exposure made of (a) carbon steel (column C11) and (b) stainless steel (column C10).

The ER probes' thickness reduction  $\Delta d$  was measured in the five zones of exposure for the four concrete columns. Two columns were equipped with carbon steel and two with stainless steel ER probes. The thickness reduction on the carbon steel ER probes in the individual zones of exposure is almost identical in both equipped columns (C11 and C12); therefore, only the results from one column are presented (Figure 3a). The initiation of the corrosion in the splash, the tidal, and the zone below the surface was detected very early, after one year of exposure. The initiation was observed from the increased thickness reduction ( $\Delta d$ ), which is directly related to the corrosion rate (faster thickness reduction, higher corrosion rate). The corrosion rates in the second year of the exposure increased from roughly 100  $\mu\text{m}/\text{year}$  to a few hundred  $\mu\text{m}/\text{year}$ . According to our previous research [28,30], such fast measured thickness reduction indicates localized corrosion damage. Due to this, the estimation of the general corrosion rate can be misleading. No evident thickness reduction was measured on the ER probe exposed in the in-water zone. On the other hand, even a slow increase of the thickness was observed on the ER probe exposed in the dry zone. This can be explained by the unwanted corrosion of the compensating (protected) resistor elements, which increased its resistance. Unfortunately, an exact examination of the corrosion damage to these probes could not be performed, since it was not possible to dismantle the corroded ER probes from the concrete after the end of the exposure.

ER probes made of AISI 304 stainless steel were embedded in each zone of exposure for the two concrete columns (C10 and C16). The results measured in either column showed no corrosion activities for all 1569 days of exposure (Figure 3b). The short-term fluctuations of thickness (up to 0.15  $\mu\text{m}$ ) are below the detection limit of the measuring system and can be attributed to instrumental noise.

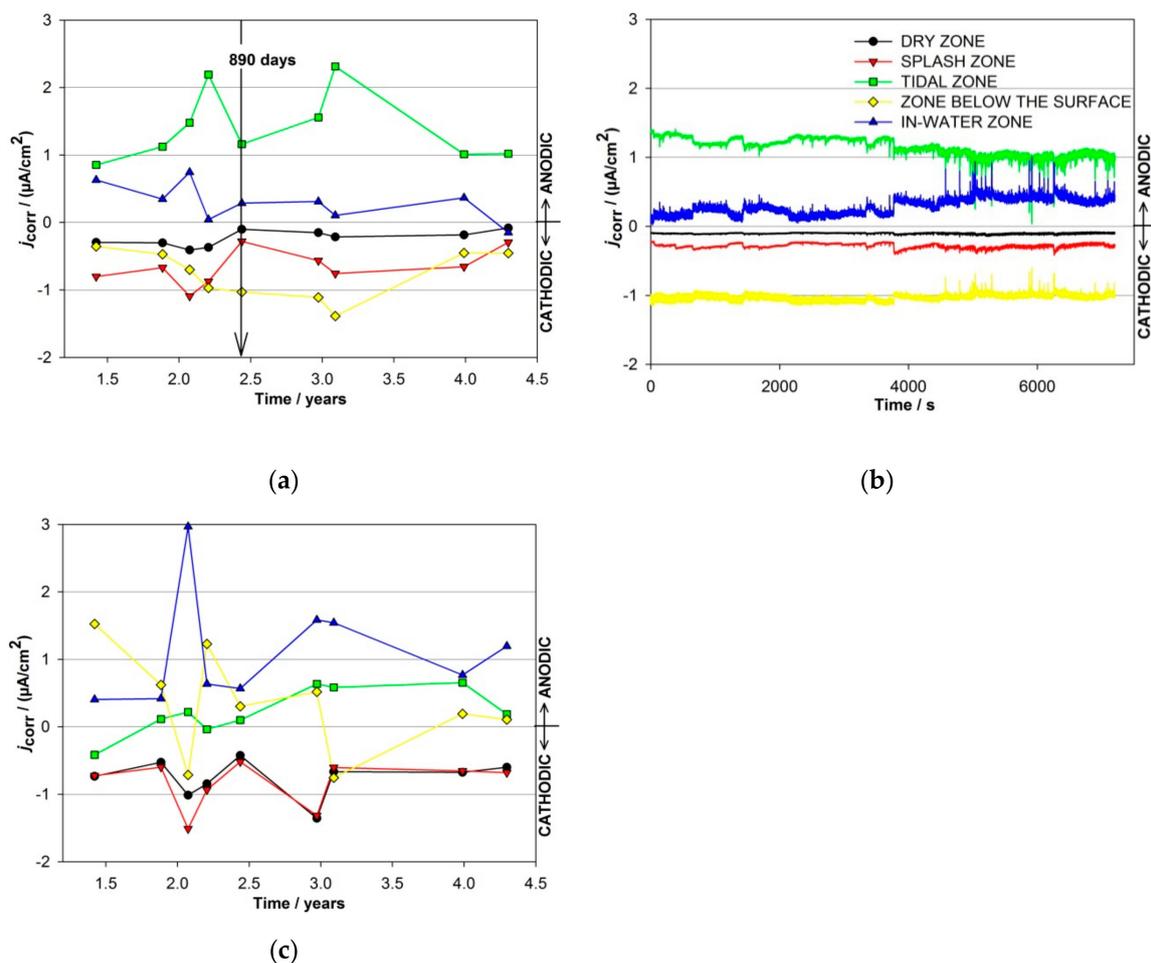
**Figure 4.** (a) Average values of the partial currents and (b) individual measurements of the partial currents after 890 days of exposure on carbon steel-coupled multi-electrodes exposed to different zones of exposure in column C11; (c) average values of the partial currents on carbon steel-coupled multi-electrodes exposed to different zones of exposure in column C12.

The arrow in Figure 4a represents the average values of a 2 h measurement on the 890th day of exposure (Figure 4b). Certain similarities were observed in the current responses measured in both columns equipped with carbon steel-coupled multi-electrodes (C11 and C12). The average partial currents measured in columns C11 and C12 are presented in Figure 4a,c, respectively. Only the cathodic currents were measured in the dry and splash zones of both columns with the carbon steel-coupled multi-electrodes. The highest anodic currents in column C11 were measured in the tidal

zone ( $2.3 \mu\text{A}/\text{cm}^2$ ), while the highest anodic currents in column C12 ( $3 \mu\text{A}/\text{cm}^2$ ) were measured in the in-water zone. These corrosion currents correspond to approximately  $25 \mu\text{m}/\text{year}$  and  $30 \mu\text{m}/\text{year}$ . The zone below the surface was the most cathodic in column C11 ( $-1.4 \mu\text{A}/\text{cm}^2$ ), while the currents shifted between cathodic and anodic in another column (up to  $1.5 \mu\text{A}/\text{cm}^2$  and down to  $-0.7 \mu\text{A}/\text{cm}^2$ ). Low cathodic responses were measured in the dry area of column C11 (down to  $-0.4 \mu\text{A}/\text{cm}^2$ ), while the amplitudes of the cathodic currents measured in the dry zone of column C12 were slightly higher, i.e.,  $-1.4 \mu\text{A}/\text{cm}^2$ .

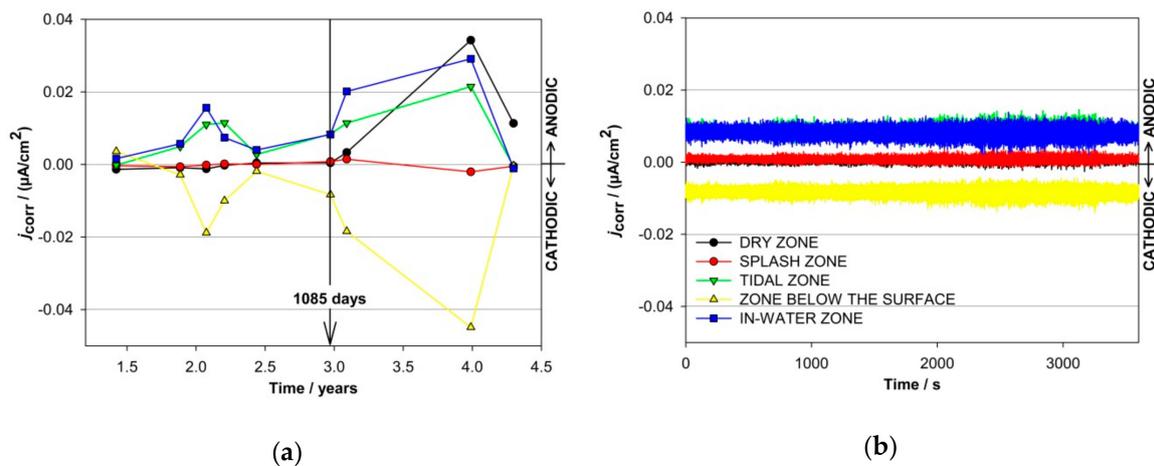
**Figure 5.** (a) Average values of the partial currents and (b) individual measurements of the partial currents after 1085 days of exposure on stainless steel-coupled multi-electrodes exposed to different zones of exposure in column C10.

Partial currents were also measured on five coupled multi-electrodes made of stainless steel, placed in five exposure zones of the concrete columns C10 and C16. The results in both columns showed very low values for the measured currents, i.e., no evident corrosion activities were observed on the electrodes made of AISI 304 embedded in column C10 (Figure 5).

In column C16 (electrodes made of AISI 304L) the highest measured anodic current was slightly higher than in column C10, but still relatively low ( $j_{\text{corr}} < 0.7 \mu\text{A}/\text{cm}^2$ , corresponding to  $v_{\text{corr}} \sim 7 \mu\text{m}/\text{year}$ , measured in the in-water zone electrode), while the average anodic currents were again negligible (corresponding to  $v_{\text{corr}} \sim 0.01\text{--}2 \mu\text{m}/\text{year}$ , higher at the beginning of the exposure).

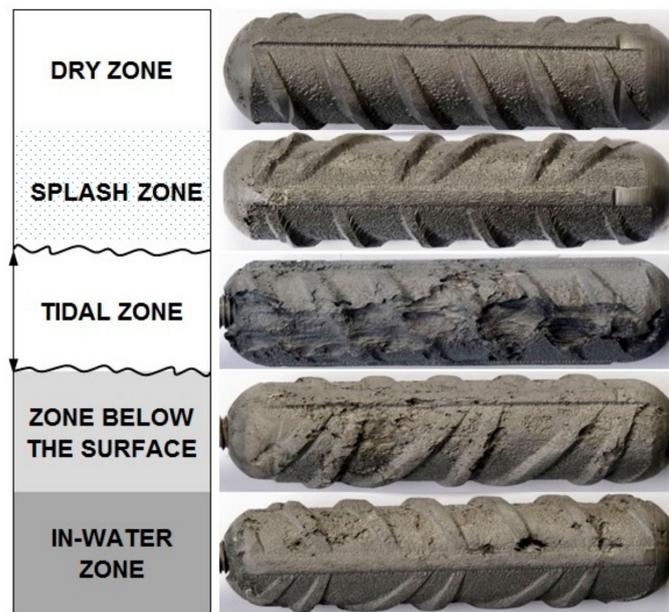
**Figure 6.** Photographs of the corrosion damage on the carbon steel-coupled multi-electrodes after extraction from the column C11.

A visual analysis indicated that the carbon steel-coupled multi-electrodes (CMEs) embedded in column C11 suffered corrosion in all the zones of exposure (Figure 6). The extent of the visual corrosion damage on these individual electrodes mostly correlates with the measured partial anodic currents (Figure 4), but not entirely. The visual examination confirmed that the highest corrosion damage was generated on the electrode exposed in the tidal zone, whereas slightly less corrosion damage was found on the electrode exposed in the in-water zone. These correspond to the anodic currents measured in both zones. The electrodes exposed to the dry and splash zones are the least damaged, which is in agreement with the predominant cathodic currents. However, the visual examination indicated relatively severe corrosion damage on the electrode exposed in the zone below the surface, which does not correspond to the measured cathodic currents. One of the reasons for this inconsistency is that the monitoring was not continuous, and there is no information about how the currents were distributed between the separate measurements. The second possible reason is the simultaneous presence of anodic and cathodic corrosion processes at the same electrode, so only the difference between the processes was measured. Apparently, the use of a CME system requires an optimal surface area of the individual electrode, which should be small enough to enforce the special division of anodic and cathodic sites and large enough to minimize the local steel-concrete non-uniformities.

The most severe and the deepest corrosion damage (i.e., 2.4 mm, which represents 17% of the reinforcement diameter) were estimated in the dry zone (Table 3). This result is not consistent with the cathodic corrosion currents measured on the coupled multi-electrodes in the same zone and is also not in agreement with the visual examination of this electrode (Figure 6).

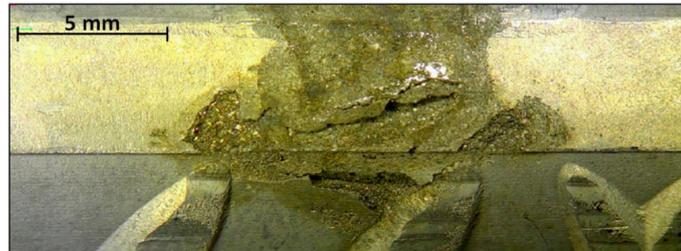
**Figure 7.** Optical image of the most severe corrosion damage found on a stainless steel reinforcement in concrete column C11 (located in the dry zone).

In contrast to the carbon steel rebars, the stainless steel reinforcing bars (AISI 304) in the same column C11 were practically undamaged. However, two corrosion spots were found, each on a separate bar, but both exposed to the dry zone. The damaged areas are not deep (below 500  $\mu\text{m}$ ), appearing on a very small area and representing the most severe damage found on the stainless steel (Figure 7). In both cases, it is assumed that the corrosion occurred at places where existing mechanical damage caused the corrosion initiation on the steel surface.

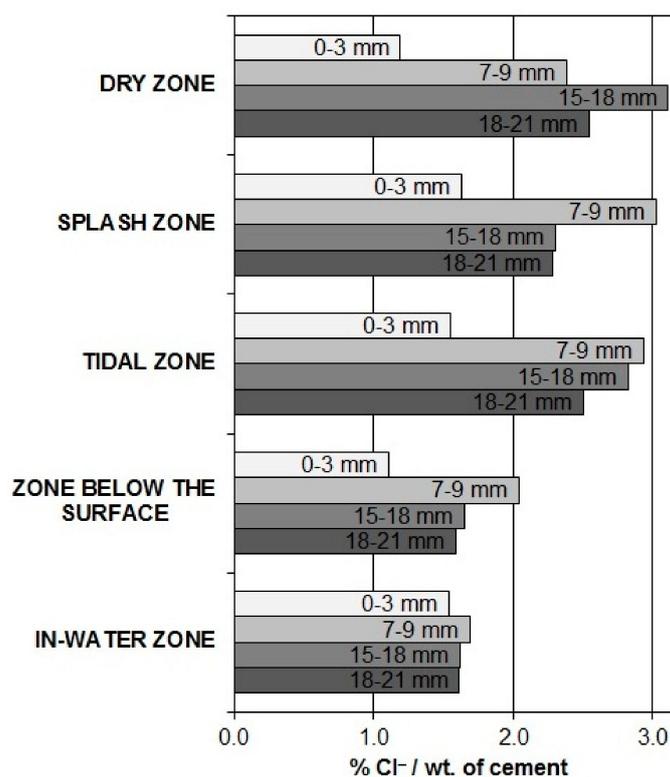
**Figure 8.** Total  $\text{Cl}^-$  content in all the exposure zones at four different concrete depths.

In all the zones of exposure, the lowest contents of  $\text{Cl}^-$  (Figure 8) were found close to the surface of the concrete (0–3 mm deep), where the chlorides can be washed out. In general, the highest contents of  $\text{Cl}^-$  were detected at a concrete depth between 7 mm and 9 mm. At this depth, the  $\text{Cl}^-$  content is the highest in all the zones of exposure, except in the dry zone, where the highest  $\text{Cl}^-$  content was found to be deeper (between 15 mm and 18 mm). On average, the highest  $\text{Cl}^-$  content was found in the tidal zone, although the highest  $\text{Cl}^-$  content at the level of the steel reinforcement and probes was detected in the tidal zone and the dry zone. The splash zone followed with just a slightly lower percentage. These zones were exposed to the harshest environmental conditions (e.g., strong winds, heavy rain, constant wetting, and drying, etc.) that can penetrate chlorides deeper into the concrete [42]. The lowest  $\text{Cl}^-$  content in general and also in the depth of the steel reinforcement was measured just below the water surface and in the in-water zone, where the distribution of  $\text{Cl}^-$  at different depths is very uniform. This indicates very stationary conditions concerning the diffusion of chlorides through the concrete.

It can be seen that the distribution of  $\text{Cl}^-$  content at the level of the embedded steel and probes does not fully correspond to the distribution of the corrosion damage in the different zones of exposure. On the other hand, it is evident that in all the zones at the level of the reinforcement and the probes the concentration of  $\text{Cl}^-$  is relatively high.
