Review of the research and evolution of landslides in the hinterland of Koroška Bela settlement (NW Slovenia)

Tina PETERNEL¹, Ela ŠEGINA¹, Jernej JEŽ¹, Mateja JEMEC AUFLIČ¹, Mitja JANŽA¹,
Janko LOGAR², Matjaz MIKOŠ³ & Miloš BAVEC¹

¹Geological Survey of Slovenia, Dimičeva ulica 14, SI-1000 Ljubljana, Slovenia; e-mails: tina.peternel@geo-zs.si, jernej.jez@geo-zs.si, mateja.jemec@geo-zs.si, mitja.janza@geo-zs.si, milos.bavec@geo-zs.si

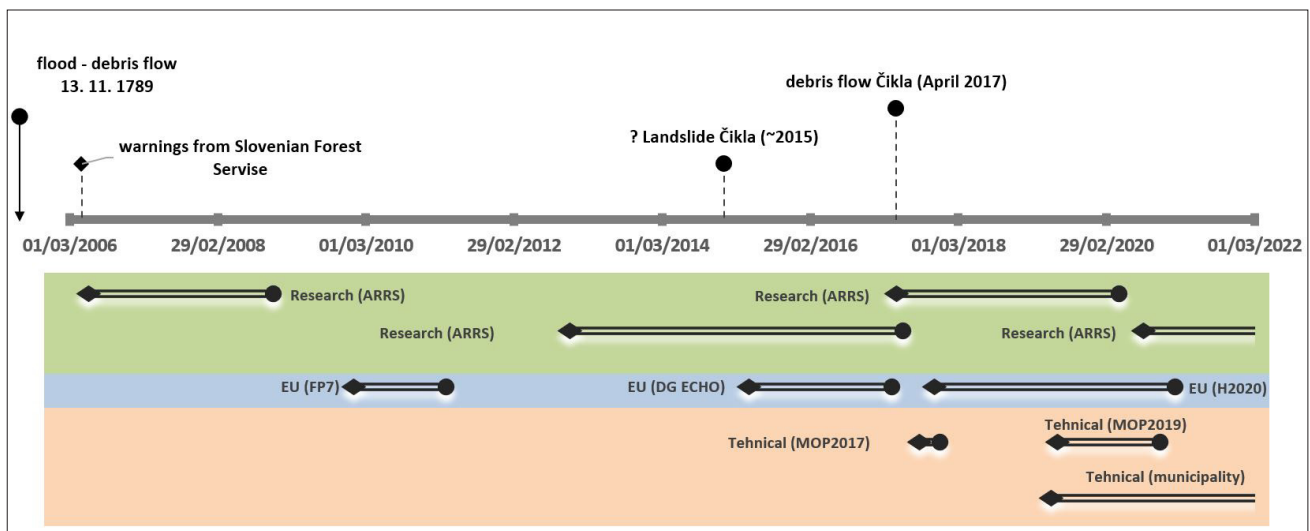
Fig. 2. Timeline of landslide activity and research since 1789. The coloured background defines the type of project (green – research projects funded by Slovenian Research Agency; blue – projects cofunded by EU Programmes; orange – technical projects funded by the Ministry of the Environment and Spatial Planning and the Municipality of Jesenice).

In this respect, the landslide-prone area in the hinterland of Koroška Bela has been under investigation since 2006. The research started within the framework of various national and international projects (Fig. 2; Table 1). All of the investigations can be roughly divided into two stages: before and after the Čikla debris flow in April 2017. The first set of studies, carried out before April 2017, was primarily scientific. Their main objective was to identify and understand the characteristics and kinematics of landslides. Studies carried out after April 2017 were primarily conducted with the goal of developing and implementing mitigation measures (Fig. 2; Table 1).

group, were reports of sliding by the Slovenian Forest Service. They reported the subsidence of a local road, the presence of curved trees and erosion flanks in the wider catchment area of the Urbas water reservoir (Fig. 2).

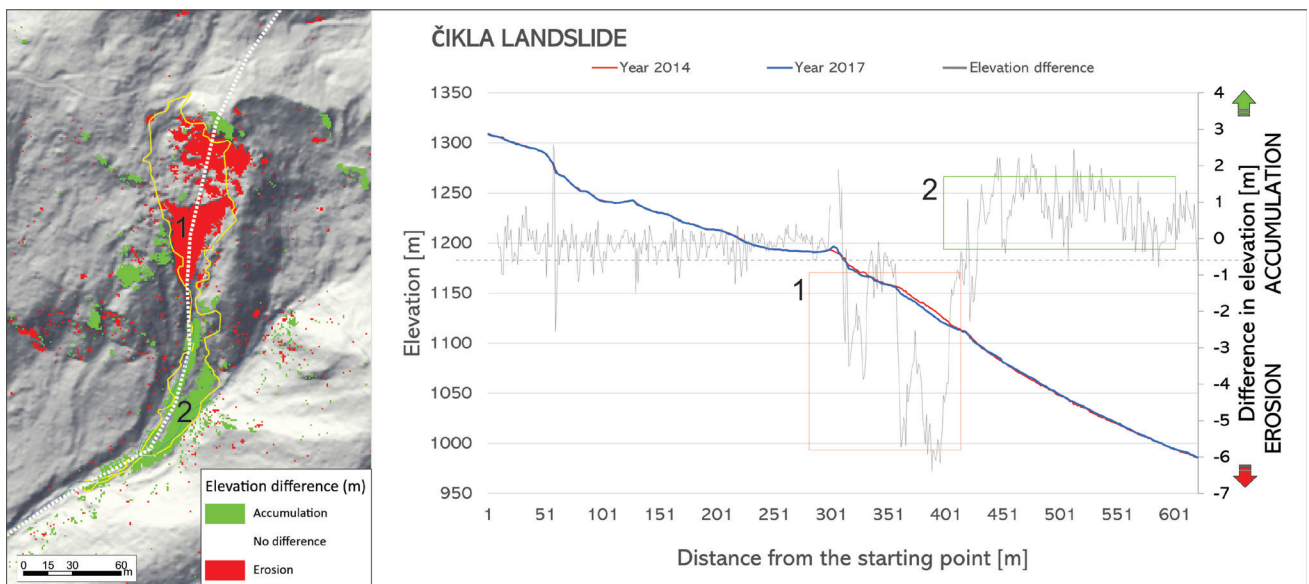
Fig. 6. Surface elevation difference (z-axis) between two LiDAR-derived DEMs from 2014 and 2017. Cross-section shows elevation differences along the Čikla landslide. The yellow line indicates Čikla debris flow (Fig. 5C).

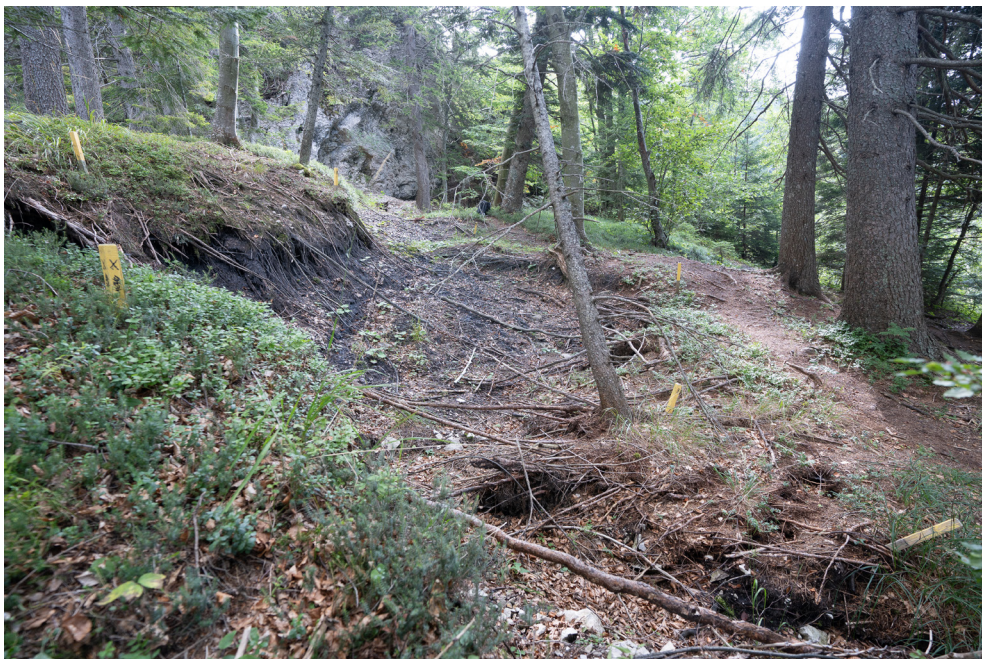
Fig. 10. Position of local road that crosses the Urbas landslide. Cross-sections represent the position of the road's left shoulder, which has been manually digitalised in orthophotos.

For this reason, the road has been reconstructed several times by adjusting the road level to the terrain, which can be observed on cross sections in Figure 10. Cross section 3 also indicates strong

subsidence of the road level, ranging from 0.7 m (for the period from 1999 to 2017) to 11.0 m (for the period from 1999 to 2017) (Fig. 10). Road reconstruction was carried out by backfilling with gravel material and log cribs. Backfilling material represents an additional weight that accelerates sliding. Due to subsidence, the road level was later relocated by cutting into the slope. No appropriate drainage system has ever been implemented.

Reviewing the available archival orthophotos, we also observed the deformation of the local road that crosses the main body of the Urbas landslide. Digitised road shoulders provided information about the continuous subsidence and collapse of the road. Nearby boreholes along the road indicated that the road crosses the landslide area with a depth of sliding surface ranging between 8 and 15 m (Peternel et al., 2018). Monitoring of the surface displacements using GNSS also indicates the constant displacements of the landslide main body. The GNSS antenna located below the road, and measuring the surface displacements in real-time, showed displacements of 37 mm over a period of one year (Šegina et al., 2020).
