Sensor Development for Corrosion Monitoring of Stainless Steels in H₂SO₄ Solutions

Abstract: Equipment made of different stainless steels is often used in the hydrometallurgical processing industry. In this study, an electrical resistance sensor was developed for monitoring corrosion in acidic solutions at high temperature. Two types of stainless steel were used as the electrode materials, namely grade 316L stainless steel (EN 1.4404) and grade 2507 duplex stainless steel (EN 1.4410). The materials and sensors were exposed to a 10% H₂SO₄ solution containing 5000 mg/L of NaCl at various temperatures. Results from the sensors were verified using electrochemical techniques and postexposure examination. Results showed that the microstructure played an important role in the interpretation of corrosion rates, highlighting the importance of using an appropriate stainless steel for the production of sensors. Electrochemical tests and postexposure examination both showed that the grade 2507 had a significantly lower corrosion rate compared to the grade 316L. Under industrial-process conditions, the results for the grade 2507 sensor were promising with respect to sensor durability and perfo

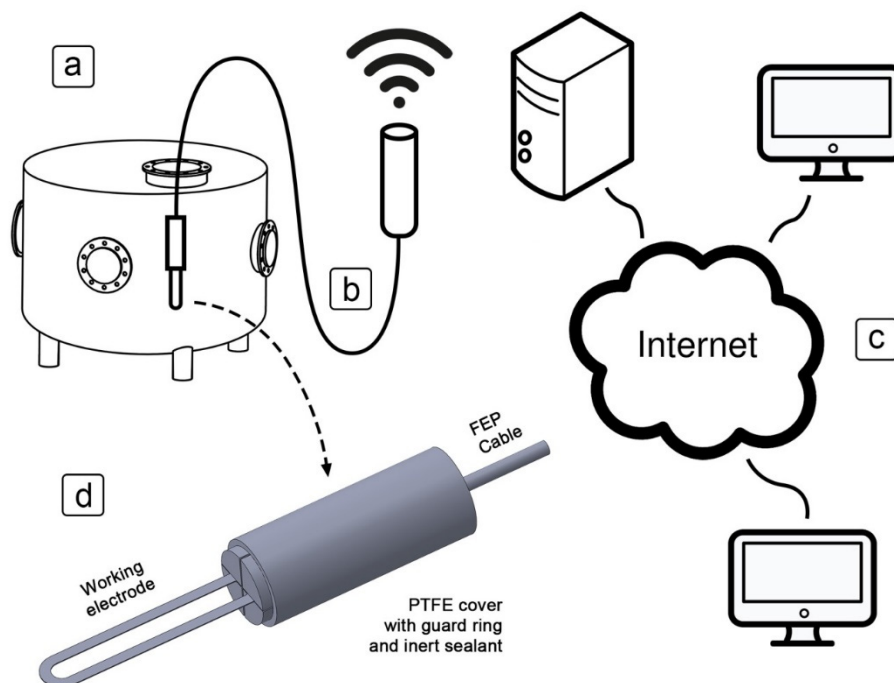
Figure 1. Schematic representation of the electrical resistance (ER) sensor: (a) the sensor inside an industrial boiler; (b) the datalogger connected to the sensor, with wireless transmission of the gathered data; (c) the server, which stores and serves data to end user devices over the internet; (d) the design of the sensor, comprising two polytetrafluoroethylene (PTFE) covers and a working electrode cut from a stainless steel sheet, with an inert sealant in between.

A schematic representation of the ER sensor in operation is shown in Figure 1. The exposed part of the sensor is placed inside an industrial tank (Figure 1a) and connected by wire to a datalogger (Figure 1b), which houses the measuring equipment to wirelessly transfer the recorded data to a nearby server. The datalogger consists of an A/D converter and multiple operational amplifiers which measure the electrical resistance, a microprocessor which analyses the signal and stores data locally, and an RF transmitter which communicates with the nearby server. A 15 mA electrical current is used when the electrical resistance is measured; the current was measured once every 5 min. Under regular

The server is connected to the internet and provides the function of storing and serving data to end users over a web browser (Figure 1c). This allows for both graphical and tabular representation of the data in real time. The prototype of the sensor was made from a top and bottom polytetrafluoroethylene (PTFE) cover parts, and a U-shaped working electrode cut from a stainless steel sheet (Figure 1d). A copper cable made of three twisted pairs and coated with fluorinated ethylene propylene (FEP) insulation was soldered to one end of the working electrode. An inert sealant was used between the bottom and top cover, and around the cable connections, to prevent liquids from entering the protected part of the sensor.

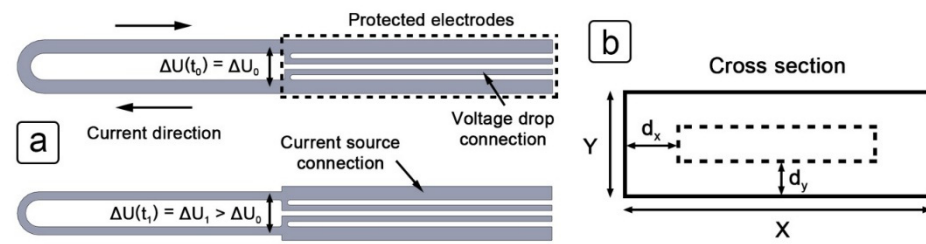
Figure 2. Schematic view of the principle of operation of the ER sensor: (a) plan view of the working electrode with labels to indicate the connections, current direction and voltage drop; (b) cross-section of the working electrode with the reduction in thickness illustrated in the X and Y direction.

Electrical resistance sensors measure the reduction in thickness of a metal cross-section based on the change in electrical resistance [28]. Figure 2a shows the plan view of the working electrode before (top) and after (bottom) exposure. Separate twisted pairs are used to carry the current and measure the voltage drop. An additional third twisted pair is connected to the outer electrodes to measure the voltage drop on the protected part of the sensor. These measurements compensate for both the fluctuations in current and the changes in temperature. During operation, a constant current is sent along the outer electrodes (source current), while the inner connectors are used to measure the voltage drop on the exposed part of the sensor. As the thickness of the exposed part of the sensor reduces, the measured voltage increases from ΔU_0 to ΔU_1 .

Before the new surface area can be translated into the thickness reduction of the cross-section, another assumption must be made. Figure 2b shows the reduction of the cross-section in the X and Y directions, respectively labelled d_x and d_y . The rate at which the thickness is reduced during corrosion in both the X and Y directions depends on a combination of the stainless steel grade, its microstructure and the environmental conditions. A new constant labelled k is introduced, which represents the quotient of the two variables, as shown in Equation (4). This constant needs to be experimentally determined.

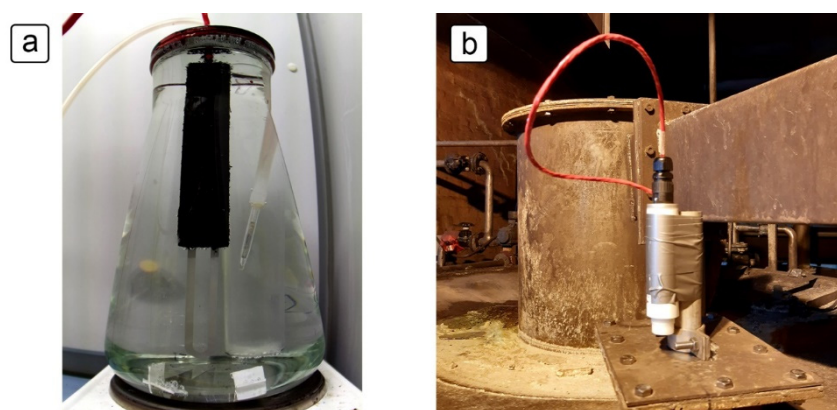
Figure 3. ER sensor exposure setup: (a) in the laboratory; (b) under industrial conditions.

Multiple ER sensors were tested in order to determine their functionality and accuracy. The tests were done in both controlled laboratory conditions and in fluctuating industrial conditions. Stainless steel grades 316L and 2507 were used in both conditions. Laboratory exposure tests were carried out in a 3000 mL Erlenmeyer flask, as shown in Figure 3a. The temperature was controlled and maintained using a temperature sensor, a proportional integral derivative (PID) controller, and a hot plate below the flask. The mouth of the flask was sealed using custom-made plastic 3D printed lids and polytetrafluoroethylene (PTFE) insulation tape. The ER sensor made of grade 316L steel was exposed to a 10% H₂SO₄ solution containing 5000 mg/L NaCl at 65 ± 0.5 °C for 8 days, followed by exposure to the same solution at room temperature for 20 days. The ER sensor made of grade 2507 steel was exposed to a solution of same chemistry, first at 50 ± 0.5 °C for 7 days, then at 65 ± 0.5 °C for 7 days and finally at 90 ± 0.5 °C for 14 days. The 90 °C exposure included a period of 3 days during which the sensor was kept at room temperature (22 ± 2 °C), due to a need to service the heating equipment.

Exposure to industrial conditions was performed in a solution with varying concentrations of sulfuric acid, chloride ions, fluoride ions, ferric ions and arsenic ions. An example of the exposure arrangement is shown in Figure 3b, where a datalogger was strapped to a metal tube with the sensor inside. The cable and tube were long enough to reach the solution inside the tank, such that the sensor was fully immersed in the process solution.

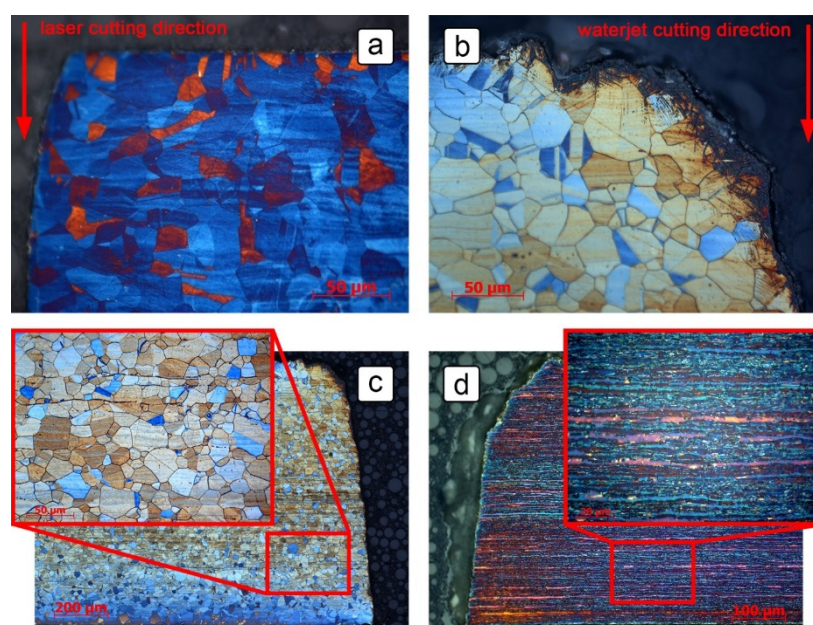
Figure 4. Metallographic images of: (a) the angular shape of the laser cut edge in the grade 316L steel sheet; (b) strain-induced deformation martensite formed on the edges of the steel sheet cut by abrasive waterjet technique; (c) the austenitic microstructure of steel grade 316L with longitudinally oriented inclusions and phases; (d) the microstructure of steel grade 2507 with elongated crystal grains in the rolling direction of the steel.

The overall microstructure and the sensor edges from the two cutting procedures were examined in order to determine their effect on the corrosion behavior of the sensor. The changes in microstructure along the edges of the steel sheet can potentially play a major role in service life prediction of the equipment, as there are machine components, such as blades of a mixer, that are exposed to the corrosive environment from all sides during operation. The effect of the laser cutting procedure on grade 316L is shown in Figure 4a, where a cross-section of the edge of the steel sheet following laser cutting is displayed. The edge generally had an angular shape, but it was slightly inclined at an obtuse angle. No indication of recrystallization of the grains was observed near the cut. The grade 2507 steel had similar geometrical and microstructural features along its edges when subjected to laser cutting (not shown in Figure 4).

Figure 4b shows the effect of the abrasive waterjet cutting process on the edge of a grade 316L steel sheet. The edge was heavily damaged at the proximity of the cut on the upper side of the sheet. The cut edge was significantly inclined and visibly rounded. The depth of the damage on the top side ranged from 10 to 30 μm , yet the original sharp edge was removed down to a depth of 150–200 μm . Strain-induced deformation martensite was also formed on the upper corner and upper side of the cut, to a depth of about 50 μm . It was expected that the corrosion resistance of the alloy would be weaker in this area than in the bulk of the material [30]. The grade 2507 showed similar geometrical changes along its edges when subjected to abrasive waterjet cutting, but the depth of the damage was slightly less (10 to 20 μm), and no strain induced martensite was formed. Based on these results, laser cutting was identified as the less intrusive cutting procedure. If not stated otherwise, all specimens used during the research were cut using the laser cutting technique.

The microstructures in the center of the sheet cross-sections are shown in Figure 4c,d, for grades 316L and 2507 respectively. The microstructure of the grade 316L steel consisted of uniform austenitic grains ranging in size between 10 and 40 μm . Strain lines were

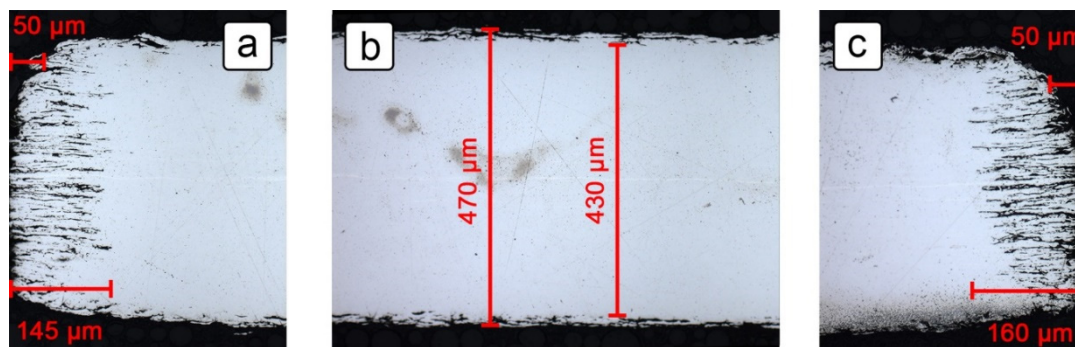
Figure 5. The cross-section reduction of the grade 316L after 28 days of exposure in the 10% H_2SO_4 solution containing 5000 mg/L NaCl at 65 °C and at room temperature: (a) left edge of a 0.5 mm thick steel sheet; (b) middle section of a 0.5 mm thick steel sheet; (c) right edge of a 0.5 mm thick steel sheet.

Figure 5 shows parts of the cross-section of the 5 mm wide and 0.5 mm thick 316L stainless steel sheet with visible corrosion damage after 28 days of exposure to the 10% H_2SO_4 solution containing 5000 mg/L NaCl at temperatures of up to 65 °C. The thickness of the material in the middle of the cross-section (Figure 5b) ranged from 430 to 470 μm . Since the thickness prior to exposure to the solution was about 500 μm , the corrosion damage on one side of the sheet reached a depth of 15–35 μm . For the purpose of calculating the constant k (Equation (4), Figure 2b), a mean value of 25 μm was taken as the d_y parameter. On the edges of the cross-section, however, determining the d_x parameter was more complex. Although the corrosion damage extended up to 160 μm in depth (Figure 5c), this did not reduce the surface area, as modeled in Figure 2b, as bulk steel remained in between the attacked areas. Since maximum corrosion damage is the most critical for the service life of steel equipment, however, the worst-case scenario was considered. A maximum corrosion depth of 160 μm was taken as the d_x parameter, making the resulting constant k equal to 6.

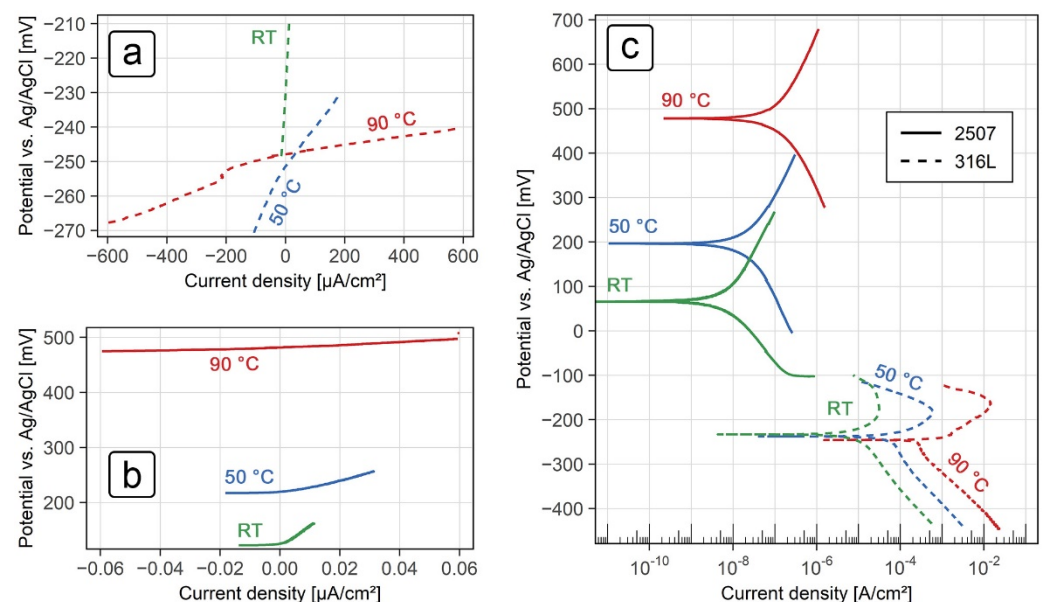
Figure 6. (a) Linear polarization curves for the grade 2507 stainless steel in a 10% H_2SO_4 solution with 5000 mg/L NaCl at various temperatures; (b) linear polarization curves for the grade 316L stainless steel in a 10% H_2SO_4 solution with 5000 mg/L NaCl at various temperatures; (c) potentiodynamic polarization curves for both grades of stainless steel in a 10% H_2SO_4 solution with 5000 mg/L NaCl at various temperatures.

24 h and the electrochemical parameters determined from the measurements for the grade 316L and 2507 steel sheets are shown in Tables 2 and 3 respectively. Linear polarization curves are shown in Figure 6a (stainless steel grade 316L) and Figure 6b (stainless steel grade 2507), while the potentiodynamic curves for both alloys are shown in Figure 6c.

The cathodic polarization curves (Figure 6c) for the grade 316L steel showed distinct Tafel regions, whereas the anodic polarization curves for the same material showed an active-to-passive current transition. Evaluation of the corrosion parameters for the grade 316L steel (Table 2) showed that the corrosion potential (E_{corr}) was around -240 mV vs. Ag/AgCl at all temperatures investigated. Corrosion current densities (j_{corr}) and the resulting corrosion rates (v_{corr}), on the other hand, increased significantly with an increase in temperature and indicated active corrosion at all temperatures. The corrosion rates measured were $134 \mu\text{m}/\text{year}$ at room temperature, $795 \mu\text{m}/\text{year}$ at 50°C and $2790 \mu\text{m}/\text{year}$ at 90°C .

Potentiodynamic polarization curves for the grade 2507 steel (Figure 6c) showed well-defined anodic and cathodic Tafel regions at all temperatures investigated. Both the corrosion potential (E_{corr}) and the corrosion current density (j_{corr}) increased with an increase in temperature (Table 3). E_{corr} values at room temperature, 50°C and 90°C were approximately 70 mV , 200 mV and 480 mV respectively, while the corrosion rates, calculated from the corrosion current densities, were approximately $0.09 \mu\text{m}/\text{year}$, $0.32 \mu\text{m}/\text{year}$ and $1.6 \mu\text{m}/\text{year}$, respectively.

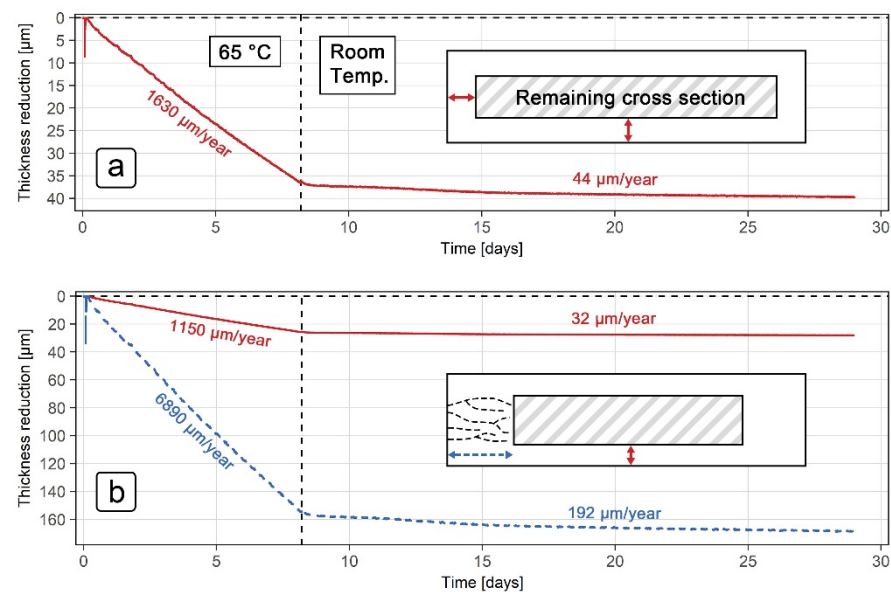
Figure 8. ER thickness reduction results for grade 316L steel in the 10% H_2SO_4 solution with 5000 mg/L NaCl: (a) model using the same cross-section reduction in vertical and horizontal direction; (b) model using the maximum reduction in cross-section in the horizontal direction.

The thickness reduction results for the grade 316L ER probe in a 10% H_2SO_4 solution with 5000 mg/L NaCl are shown in Figure 8. The results are based on the same ER sensor measurement data as demonstrated in Figure 7, but presented using two different thickness reduction models. In the first model (Figure 8a), it was assumed that the same thickness reduction occurred in the normal and transversal directions of the cross-section ($k = 1$ in Equations (5) and (6)), while the second model (Figure 8b) uses the maximum thickness

When interpreting the ER sensor measurements according to the first model, where the thickness reduction in both directions of the cross-section is the same (Figure 8a), the corrosion rate is shown to be 1630 $\mu\text{m}/\text{year}$ at 65 °C and 44 $\mu\text{m}/\text{year}$ at room temperature. The results for the 65 °C exposure were in line with those obtained using the electrochemical techniques (870 $\mu\text{m}/\text{year}$ at 50 °C and 2650 $\mu\text{m}/\text{year}$ at 90 °C, as shown in Table 4), while the corrosion rate at room temperature was about 3 times lower compared to that found by the electrochemical results (around 140 $\mu\text{m}/\text{year}$, Table 4). When comparing the modeled thickness reduction with the corrosion damage observed at the end of the exposure, however, the first model showed additional discrepancies in the results obtained. Postexposure examination revealed corrosion damage to be around 25 μm in the normal direction and up to 160 μm in the transverse direction, whereas interpretation of the ER

The second model, shown in Figure 8b, corrects this disparity by separating the reduction in thickness into normal and transverse directions. According to the improved interpretation of the ER results, the reduction in thickness at the end of the exposure was 27 μm in the normal direction and 165 μm in the transverse direction. The corrosion rates in the second model (Figure 8b) were also modified accordingly in both directions. In the normal direction, the values for the corrosion rate decreased slightly compared to the first model, specifically 1150 $\mu\text{m}/\text{year}$ at 65 °C and 32 $\mu\text{m}/\text{year}$ at room temperature (solid line, Figure 8b), whereas the corrosion rates in the transverse direction increased significantly (dashed line, Figure 8b), with new values of 6890 $\mu\text{m}/\text{year}$ and 192 $\mu\text{m}/\text{year}$ at 65 °C and room temperature, respectively. Although the corrosion rates in the normal direction remained comparable to corrosion rates obtained using the electrochemical techniques (Table 4), corrosion rates in the transverse direction increased by a factor of 6, showing the importance of taking into account the microstructure when evaluating corrosion rates from ER measurements.

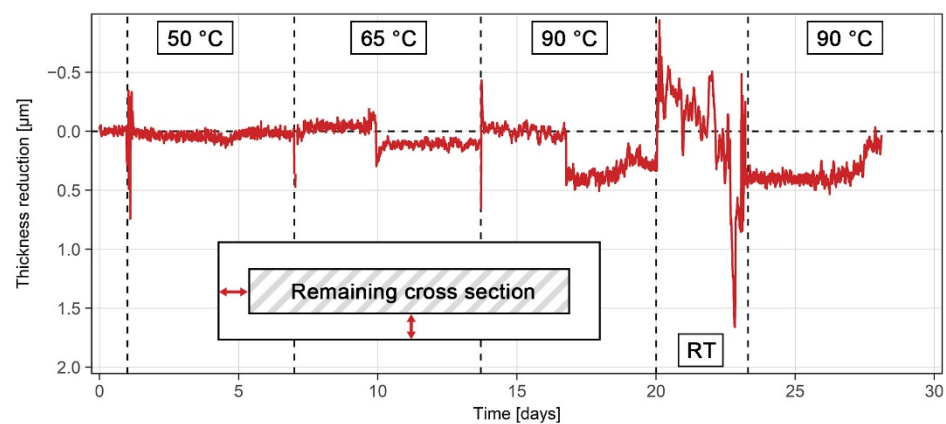
Figure 9. ER thickness reduction results for the grade 2507 steel during 28 days of exposure to a 10% H_2SO_4 solution with 5000 mg/L NaCl at various temperatures.

In addition to exposure of the grade-316L sensor, the ER sensor made of grade 2507 steel was similarly exposed to the 10% H_2SO_4 solution with 5000 mg/L NaCl for 28 days. Since the postexposure examination did not show any notable damage to the grade 2507, the k value in Equation (4) was assumed to be 1. The initial electrical resistances of the exposed and protected part of the 2507 probe at room temperature prior to the exposure were measured as 68.36 m Ω and 63.00 m Ω , respectively. The thickness reduction results for the steel grade 2507 are presented in Figure 9. The results were consistent both with observations of corrosion behavior and the electrochemical measurements. Minimal corrosion was recorded at all temperatures (Tables 3 and 4), which also suggests corrosion would not impact the service life of equipment made from such steel. Only some discrete jumps, up to 0.5 μm around the baseline, were detected at 10, 14, 17, 20 and 24 days of exposure (Figure 9). These perturbations were present due to external experimental factors, such as physically moving the sensor or the measuring device, changing the temperature around either the sensor or the measuring device, turning the heating system on and off, and refilling the solution due to evaporation. Once enough corrosion occurs (equating to a reduction in thickness of at least 2–3 μm), the impact of these external factors on determining accurate corrosion rates significantly reduces.

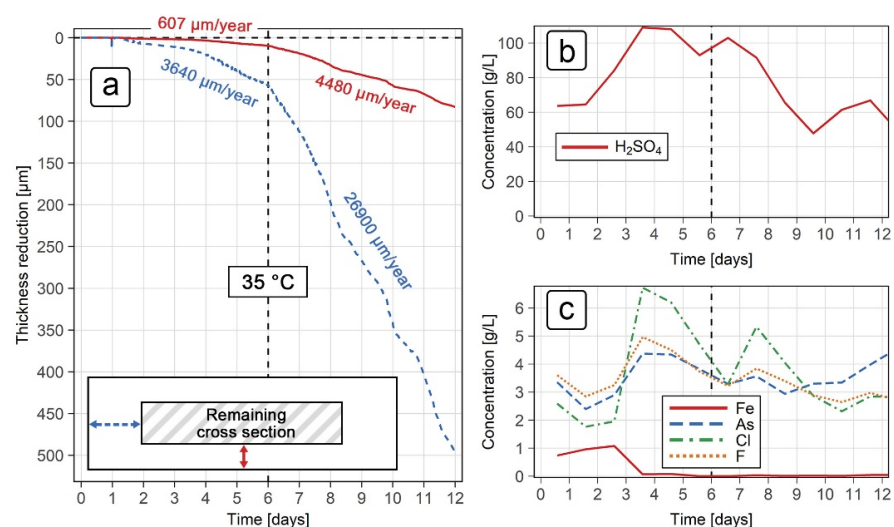
Figure 10. Exposure of grade 316L ER sensor under industrial conditions: (a) thickness reduction results; (b) concentration of sulfuric acid; (c) concentration of the various ions.

The results for the grade 316L sensor (Figure 10a) show two distinct regimes with relatively stable corrosion rates, which occurred during the first and last 6 days of exposure. In the first 6 days of exposure, the corrosion rates were measured to be around 600 $\mu\text{m}/\text{year}$ in the normal direction, and around 3640 $\mu\text{m}/\text{year}$ in the transverse direction. Both corrosion rates increased significantly after day 6, with average values of 4480 $\mu\text{m}/\text{year}$ in the normal and 26,900 $\mu\text{m}/\text{year}$ in the transverse direction. Such high corrosion rates indicated that, even in the relatively short 6-day exposure, severe corrosion damage was expected. The expected lifetime of a grade 316L ER probe in such conditions would be 1 month at most, provided no mechanical damage or localized corrosion occurs. Additionally, a 5 mm thick acid tank made from this steel grade would keep its integrity for less than 1 year. Throughout the exposure, the temperature remained relatively stable at 35 $^{\circ}\text{C}$, while the concentrations of both sulfuric acid (Figure 10b) and the various ions (Figure 10c) changed over time. The results show that, in the second half of the exposure, the concentrations of sulfuric acid, chloride ions and fluoride ions decreased compared to the first 6 days of the exposure, indicating that such conditions were beneficial for corrosion in the grade 316L steel. The sulfuric acid and the chloride ion concentrations dropped by approximately 50% (from 110 to 60 g/L, and from 6 to 3 g/L, respectively), while the fluoride ion concentration lowered from 5 to 3 g/L. The concentration of arsenic ions remained relatively stable, hovering between 3 and 4 g/L, while the iron concentration was only significant during the first 3 days of exposure (1 g/L). The presence of fluoride and arsenic ions was likely the reason for the significantly higher corrosion rate of the material under industrial conditions compared to the laboratory tests.

Corrosion monitoring stopped shortly after 12 days of exposure, as the sensor indicated that the electrical current flow over the U-shaped working electrode was interrupted. This was likely due to excessive damage in the transverse direction and mechanical wear due to liquid current flowing through the industrial process tanks. Postexposure examination revealed that the sensor was severely corroded, with parts of the working electrode missing, most likely dissolved in the acidic solution. The sensor was taken out of the tank about two weeks after the monitoring stopped; it showed excessive damage beyond what was measured towards the end of the exposure (Figure 10a). An accurate comparison of the corrosion damage with the thickness measurements was not possible.

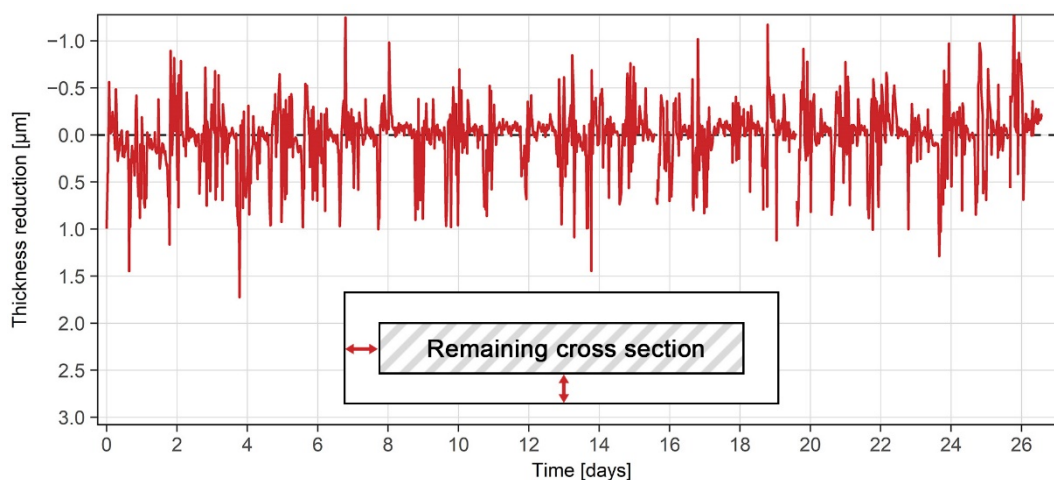
Figure 11. Reduction in thickness of the grade 2507 ER sensor under industrial conditions.

The reduction in thickness of grade 2507 steel indicated that no notable corrosion processes took place during the first 26 days of exposure, as shown in Figure 11. The noise levels of $\pm 1 \mu\text{m}$ around the baseline were likely due to the turbulent nature of the acidic solution inside the industrial process tank. After 26 days of exposure, the sensor was removed from the tank for maintenance purposes. After some solution deposits on the surface were cleaned, the sensor was examined and showed no corrosion damage. Since the grade 2507 duplex stainless steel was designed to withstand the sulfuric acid environments,
