# Development of an Electrical Resistance Sensor from High Strength Steel for Automotive Applications

**Abstract:** This work focuses on a demonstration of the monitoring of corrosion processes taking place in high strength steel in automotive applications. This is performed by means of a corrosion sensor, which operates as an electrical resistance sensor. It was developed from the same type of material that is used for the high-strength steel parts produced in the automotive industry. Using the sensor, real time corrosion processes can be measured. It is attached to a location inside the vehicle's engine and is equipped with a data logger, which enables wireless transfer of the measured data. In this study the development, operation, and evaluation of the monitoring process are presented. Corrosion estimation is verified by means of electrochemical methods. A metallographic investigation was included in order to verify the similarity between the microstructural properties of the sensor and those of the as-received high-strength steel sheet.

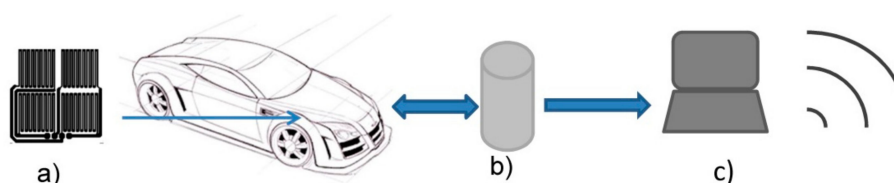
**Figure 1.** Schematic representation of the method of operation of a sensor for automotive corrosion measurements: (a) sensor unit, inserted in vehicle, (b) data logger, and (c) wireless data acquisition.

In this study, the use of an electrical resistance sensor for the monitoring of high strength steel corrosion in an automotive application was demonstrated. Firstly, the sensor was designed in order to reflect the real corrosion monitoring of a particular new type of steel for an automotive application by wireless data acquisition. The principle is shown in Figure 1. Measurements with an electrical resistance sensor made from high strength steel were performed for 6 months for one sensor, and for 2 months for a second sensor. Electrochemical measurements were also performed on various metal samples in order to compare the results obtained by the use of physical measurements and electrochemical measurements.

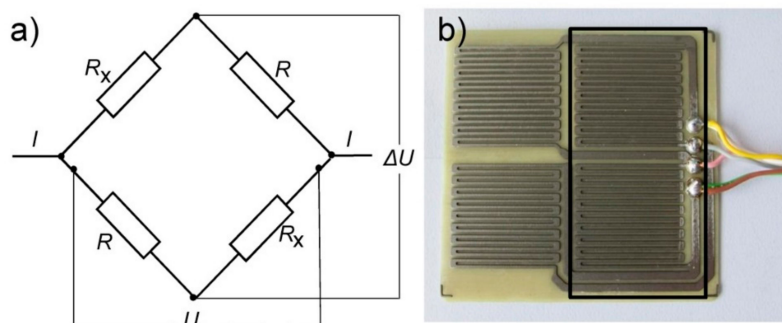
**Figure 2.** (a) Schematic presentation of the corrosion electrical resistance sensor and (b) a photo of the sensor, protected with an epoxy coating (rectangle) on the 2 sensor elements with the wiring.

The electrical resistance (ER) sensors were made of high strength steel from a 250  $\mu\text{m}$  thick foil. The 1 mm steel sheets were first chemically etched in order to obtain sensor elements of the form shown in Figure 2b. These sensor elements were then hot-glued onto a glass-fiber resin plate with a thickness of 0.7 mm. The four sensor elements were arranged in a Wheatstone bridge. Two of the sensor elements were exposed, whereas the other 2 sensor elements were protected by a transparent epoxy coating. The two dummy resistors ( $R$  in Figure 2a) were used for temperature effect compensation. The transparency is deliberate in order to control the state of protected sensors' elements. The width of the electrical leads in the sensor elements is 0.7 mm.

The ER sensor is composed of four sensor elements arranged in the Wheatstone bridge, where two of the sensor elements are protected ( $R$ ) and two are exposed ( $R_x$ ). On the assumption that sensors corrode uniformly and that the change of both exposed sensor elements is in the same range as the change of the resistance of exposed element, ( $\Delta R$ ) can be written as  $\Delta R = R_x - R$  and the relation between  $U$ ,  $\Delta U$ ,  $R$ , and  $\Delta R$  can be written as:

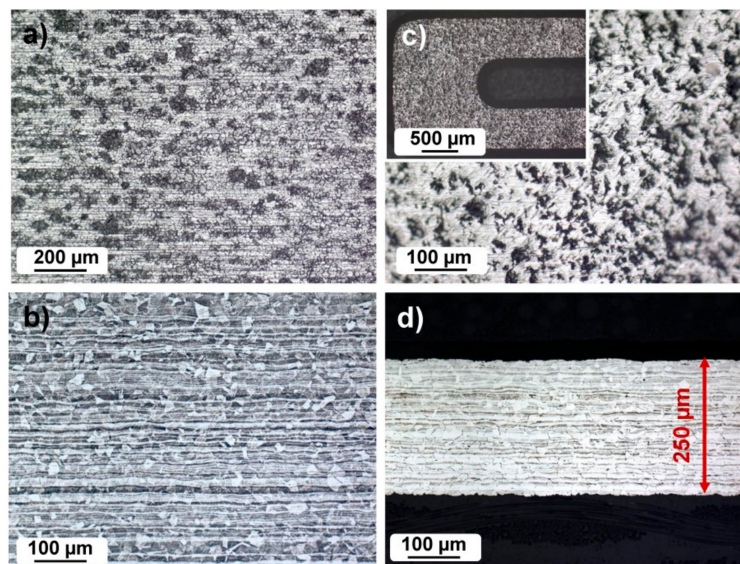
**Figure 3.** (a) The microstructural investigation of high strength steel sheet in top view, as-received; (b) the cross-section of the as-received sheet; (c) Etched surface, with an inset of the details of the sensor lead, and (d) the cross-section.

The microstructural properties of the as-received high strength steel and of the thinned steel sheet are presented in Figure 3. Both the as-received and thinned steel sheets are analyzed in a top view direction and in cross-section. The top view of the as-received high strength steel shows imperfections, rolling lines, and in general a non-homogeneous surface (Figure 3a). The orientation of the crystal grains is uniform in all directions, and the size of the crystal grains is  $20$ – $40$   $\mu\text{m}$  (Figure 3b). The microstructure of the steel sheet core is completely austenitic. In the core, the austenitic crystalline grains are smaller (Figure 3b) than in the vicinity of the surface. In some crystalline grains, twin boundaries are visible. The top view of the chemically etched surface of the high strength steel shows a relatively rough surface (Figure 3c). The cross-section of the thinned steel sheet is presented in Figure 3d. It can be seen that the microstructure remained unchanged after chemical etching for thinning purposes.

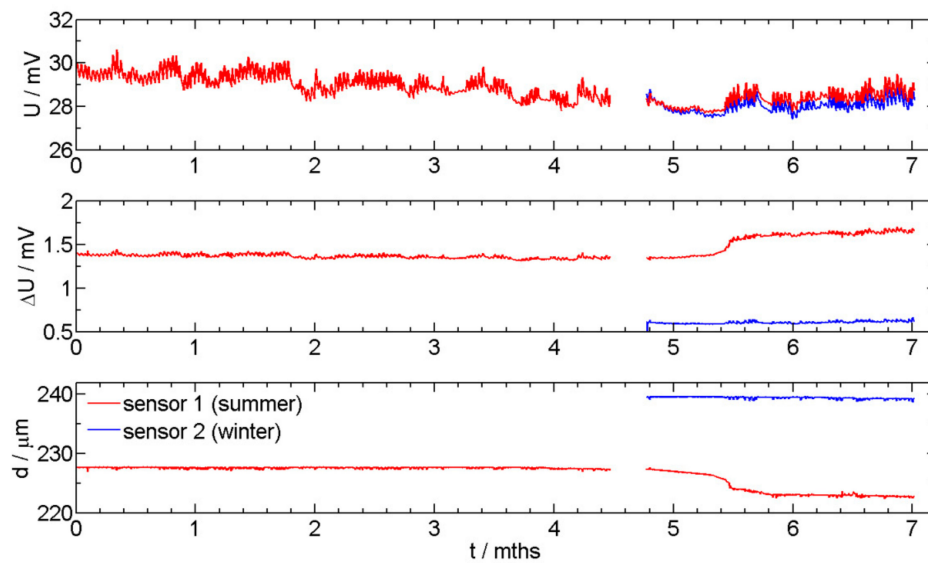
**Figure 4.** The corrosion sensor readout (the output potential ( $U$ ), the potential drop on the Wheatstone bridge ( $\Delta U$ ), the remaining thickness of the sensor ( $d$ ) exposed for 6 months (red curve), and of the sensor exposed for 2 months (blue curve).

Two newly designed sensors were installed in a vehicle. The installation position is in the inner compartment of a vehicle that is designed from high strength steel. Sensor 1 was initially exposed in summer time (red curve), and sensor 2 was exposed 5 months later in winter time (blue curve). The aim was to monitor the thickness reduction, which is directly correlated to the corrosion rate. Figure 4 presents monitoring of  $U$ ,  $\Delta U$ , and thickness reduction of the readout data for sensors 1 and 2.

The values presented in Figure 4 are direct values without adjusting the thickness of the sensor to 250  $\mu\text{m}$ . The first non-corroded sensor has an initial thickness of 228  $\mu\text{m}$ , while the second sensor was initially 239  $\mu\text{m}$  thick. Figure 5a presents the thickness reduction of the two sensors exposed to corrosive environment for two different exposure times. Figure 5b presents the position of the sensors. A filtering process was used in order to remove fluctuations of the recorded data. In the case of sensor 1, which was exposed in the summer time, different intensities of corrosion attack were observed. The steeper the inclination of the curve, the higher the corrosion rate. In the first 4 months of exposure of sensor 1, no visible thickness reduction was observed. In the 5th and 6th month, the winter days resulted in the use of deicing salts, and also a higher humidity was present, thereby thickness reduction is observed. In the last 5 weeks of exposure, out of the total 7 months of the presented exposure, extremely warm and dry days were recorded, which again resulted in a slower corrosion rate (Sensor 1, the red curve). The results of the sensor exposed in winter are also presented in Figure 5 by a blue curve. The start of exposure of sensor 2 is indicated by an arrow in Figure 5a. In the first month of exposure for sensor 2 (months 5 to 6 in Figure 5), the initiation period is present, where no thickness reduction is observed. A slight thickness reduction was observed at the end of the presented exposure.

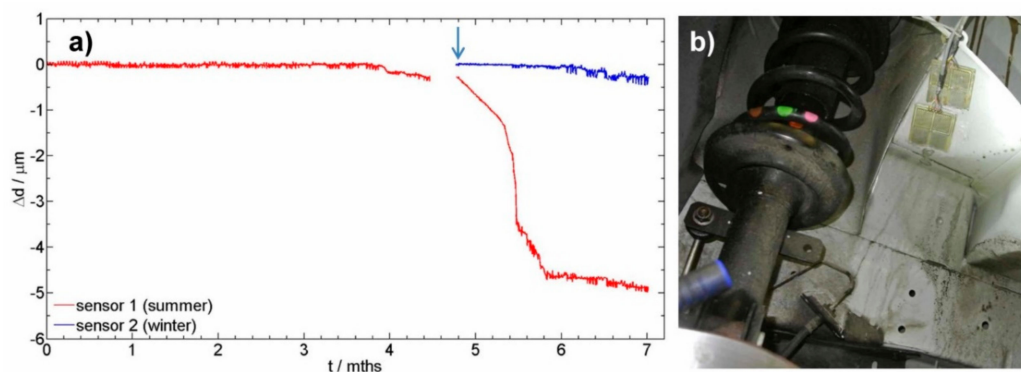
**Figure 5.** (a) The reduction of thickness of the corrosion sensor exposed for 6 months (shown in red), and of the sensor exposed for 2 months (blue curve), and (b) position of the 2 sensors exposed for real monitoring in a vehicle.

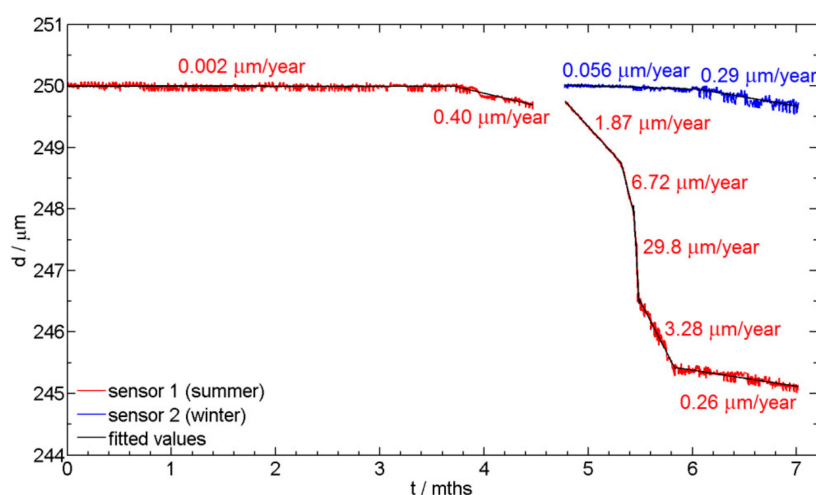
**Figure 6.** Values of the average corrosion rates in the different sections of the measured data of sensor 1 (summer) and sensor 2 (winter).

The average corrosion rates (in  $\mu\text{m}/\text{year}$ ) at different time sections of the two sensors are presented in Figure 6. The thicknesses of the sensors were adjusted to a value of  $250\ \mu\text{m}$  so that both sensors could be compared. The sections of average corrosion rate estimation were chosen according to observe periods of changes in thickness reduction. In the case of sensor 1, which was exposed in summer time, it can be observed that during the first four months of exposure the corrosion rate was just above zero. After four months the corrosion rate increased slightly and it reached its highest rate at the beginning of the sixth month of exposure. The corrosion rate was close to  $30\ \mu\text{m}/\text{year}$ . Then, it slowed down and in the following dry and warm month it was again very low at  $0.26\ \mu\text{m}/\text{year}$ . In the case of sensor 2, which was exposed in the winter time, the corrosion rate during the last exposure time was  $0.29\ \mu\text{m}/\text{year}$ , since the environment at this time of the year is dry and warm. The measured corrosion rates, i.e., for sensors 1 and 2, were very similar, as expected. The different corrosion rates for the two sensors are expected (months between 5 and 6, Figure 6), since the initiation period for the start of the thickness reduction due to the corrosion process is different, due to different corrosion environments for the two sensors in summer and winter time, respectively.

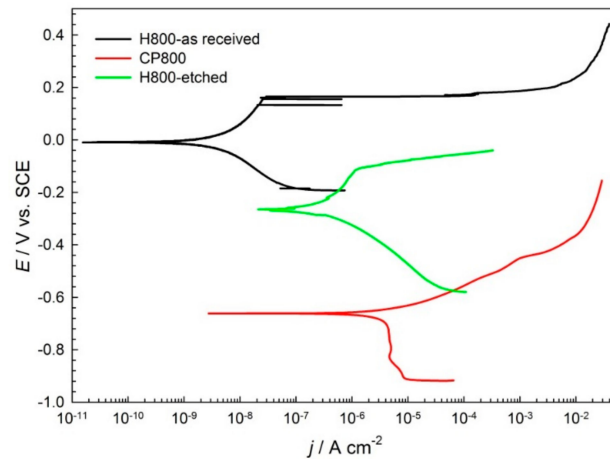
**Figure 7.** Potentiodynamic scans for the H800-as-received, H800-etched, and CP 800 steels in a 0.5 M NaCl solution, scan rate 1 mV/s.

Potentiodynamic curves were measured in order to study the electrochemical properties of the new high strength steel H800 (as-received and etched surface condition) and the commonly used steel CP-800 in automotive applications. The results are reported in Table 2 and Figure 7.

The high strength steel H800-as-received has a corrosion potential that is quite positive at  $0\ \text{V}$  vs SCE, whereas the corrosion current density  $j_{\text{corr}}$  is relatively low at  $0.018\ \mu\text{A}/\text{cm}^2$ . In the anodic region of the potentiodynamic scan, a passive region is observed with corrosion current densities at around  $10\ \mu\text{A}/\text{cm}^2$ . The passive region is limited by the breakdown potential  $E_b$  at  $0.202\ \text{V}$  vs SCE. Similarly, the passive region in the anodic scan of potentiodynamic curve is observed for H800-etched steel, while  $j_{\text{corr}}$  is higher at  $0.181\ \mu\text{A}/\text{cm}^2$ . Also, corrosion potential  $E_{\text{corr}}$  is lower at  $-262\ \text{mV}$ .

On the other hand, the corrosion potential  $E_{\text{corr}}$  for the CP 800 steel is lower at  $-0.67$  V, and the corrosion current density  $j_{\text{corr}}$  is higher at  $4.71 \mu\text{A}/\text{cm}^2$ . The CP800 material underwent active corrosion, since no passive region was observed in the anodic part of the potentiodynamic curve.
