Why Are the Early Gothic Murals in St. Jacob's Church in Ormož, Slovenia, Almost Entirely Black?

Abstract: In St. Jacob's parish church in Ormož, Slovenia, mural paintings from around 1350–1370 are partially conserved in the northeastern corner of the main nave. They are almost completely black, indicating a large-scale pigment degradation. They were studied as a part of a larger research project aiming to identify materials applied and their possible degradation. First, they were studied in situ, and next, extracted samples of plaster, pigments, and colour layers were analysed by optical microscopy, Raman spectroscopy, FTIR spectroscopy, SEM-EDS, and XRD. Haematite, green earth, malachite, azurite, and tenorite were identified, showing that azurite and perhaps also malachite degraded to black tenorite, probably due to their fine grinding and their application directly on the fresh plaster. The plaster is made with small and large amounts of aggregate with mostly quartz with some impurities, which makes it fragile. The original appearance of these murals was of bright blue and green colours.

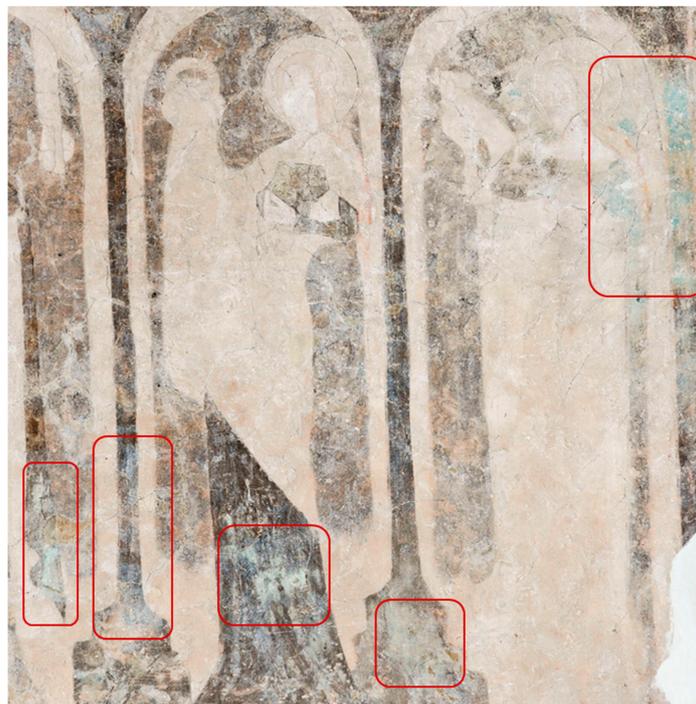
Figure 5. Areas of still conserved turquoise and bluish colour are marked with red rectangles. Female saint figures, lower pictorial band, triumphal wall of the nave, St. Jacob's church, Ormož, Slovenia.

Most of the colours have turned black, and only in some areas, turquoise, green, blue, and red colours remain (Figures 1b and 5). Turquoise colour can be found on a small area of the landscape on the Adoration of the Magi and on some areas on the vestments of the female saints, such as on the coats of the first and the third one, or on the tunic of the second one. Some turquoise rests are also still preserved on the north nave wall, on a fragmentary figure behind St. Martin. Furthermore, the architecture in the scene with the female saints (columns, bases) also reveals some turquoise parts, while the column between the first two saints still shows an intense blue colour. Red colour is still relatively well preserved on the dress of the male figure (younger king?) behind the horse on the upper band, on some areas of the Virgin's tunic, on the hair of some figures, and under the blackened bordure between the upper and lower pictorial band. Red pigment was also used for underdrawings that can be clearly seen on several areas, especially on the figures of the female saints and on the bordures around them.

A sample of green paint (ORM 11) taken from a larger area on the left side of the St. Nicholas scene on the north wall also reveals mostly small granulation of lighter and darker green particles, with some red and orange ones (Figure 7b). By the naked eye, on this part of the painting, we can easily distinguish two different greens (Figure 7a), a darker one from where this sample was extracted, and a lighter, more turquoise one used for the vestments of a figure marked with a red rectangle, which is similar to the one found on the triumphal wall (Figure 5). Two different pigments were clearly used.

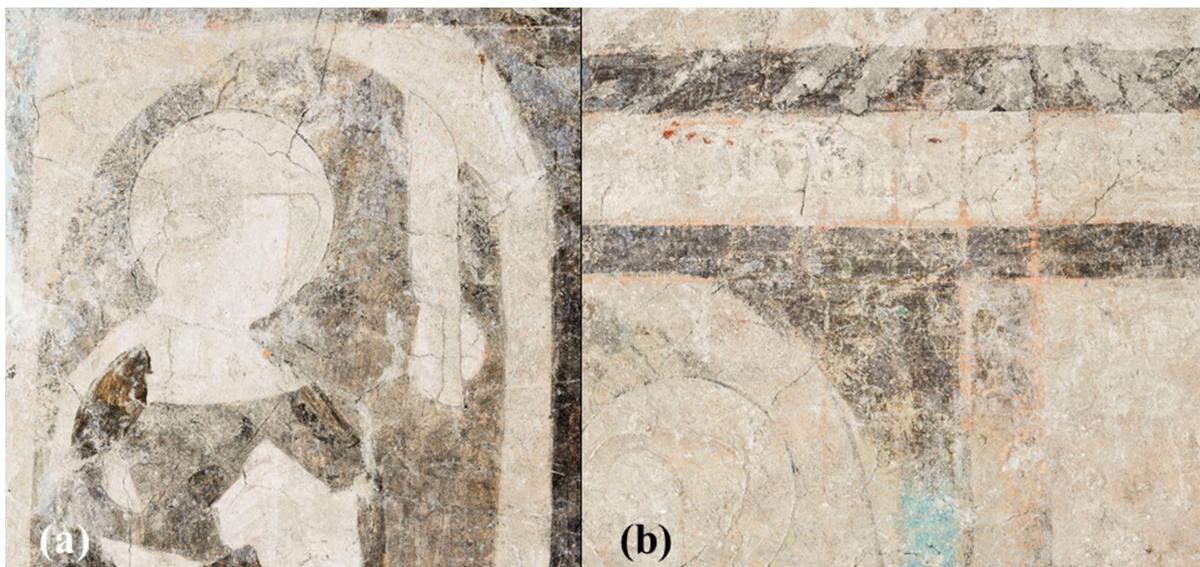
Figure 12. (a) Detail from the first female saint; incisions for her halo, head contour, and knife. The red underdrawing for her right hand is clearly seen. (b) Detail of the bordure between the last two female saints; signs of a pressed rope soaked in red colour are visible for vertical and horizontal lines. Lower pictorial band, triumphal wall, St. Jacob's church, Ormož, Slovenia.

Thin incisions were used to trace the haloes and the external head contours of the female saints, as well as their attributes (Figure 12a). It seems that their coats and the architectural niches were also incised, but the lines are very thin and shallow and hence, not very clear. The painter must have used patterns, applied on fresh plaster that was still fresh. We would also expect incisions for St. Martin's figure on the north wall, being represented as a knight, but none were found. The preparatory drawing is clearly seen on

the figures from the Adoration of the Magi and on several areas of the female saints, mostly their hands (Figure 12a); the painter used about a 0.5 cm thick brush and a red colour (red earth). The same red colour was applied for straight vertical and horizontal lines that divide the four arched niches, as observed next to the last (and lost) female saint where the colour layers are almost lost. They were performed by splashing a rope soaked in red colour on a wall, easily recognizable by a typical discontinuous line (Figure 12b). Perhaps these lines were first carried out with a rope and then incised, although this double procedure is not common in Slovene mediaeval mural painting. The colour modelling was carried out on the local basic tones, of which only some red, dark yellow, and blackened areas are conserved. All upper layers fell off; therefore, we cannot distinguish the formulation of the faces or draperies, which could tell us more about the author and would support a more precise stylistic characterization. We can just expose the long, elegant figures with oval heads, high foreheads, long chins, and somehow accentuated profile cheekbones (Figures 1 and 12a).
