Load testing of the first stress ribbon bridge in Slovenia

ABSTRACT: Paper presents selected results of the diagnostic load testing of a newly-built foot-bridge in Novo Mesto, Slovenia. The bridge is significant as the first bridge in Slovenia being built with the stress ribbon technology. The diagnostic load testing took place in March 2023 and comprised of three-stage static load testing, dynamic testing with a light truck driving over artificial obstacles, and measurement of ambient vibrations. The consistency between the actual response of the bridge and the response of the finite element (FE) model, used in the design, was evaluated by comparing vertical displacements from the static load testing, natural frequencies and mode shapes. The comparison of the results indicates a satisfactory agreement between the measurements and the response of the FE model, confirming the appropriateness of the employed FE model.

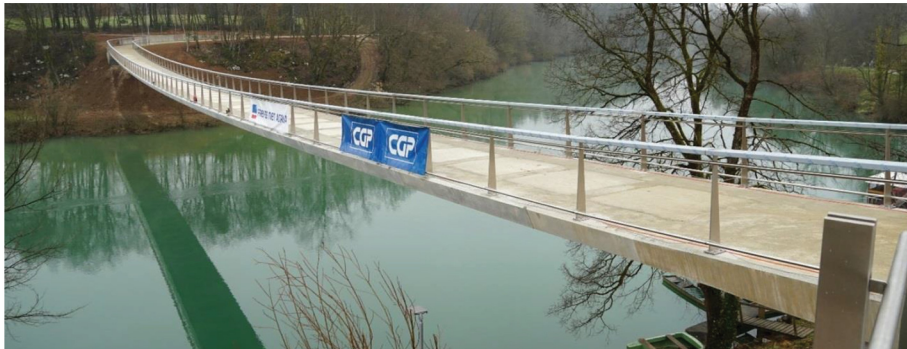
Figure 1. Bridge on the day of the diagnostic load test.

A new pedestrian bridge crosses the Krka river with a span of 131 m, as shown in Figure 1. The maximum longitudinal slope of the bridge is 6%, as the structure has an inbuilt radius, where its lowest point is around 8 m above the river surface.

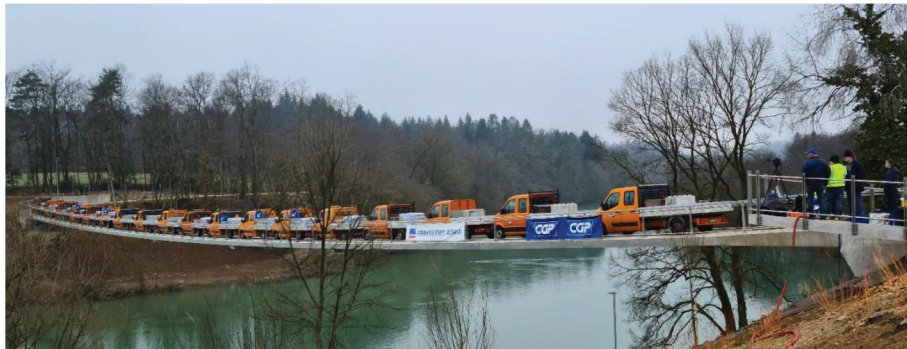
Figure 4. In the static load test (Phase 2), all 18 trucks with an overall 70.4 tonnes were present on the bridge.

- Phase 0: Resting phase before loading (zero state).
- Phase 1: 9 trucks at the 2/2 of the bridge (half-load).
- Phase 2: 18 trucks across the entire bridge (full load of 70.4 tonnes overall, Figure 4).
- Phase 3: 9 trucks at the 1/2 of the bridge (half-load).
- Phase 4: Resting phase after loading (release state).
- Phase 5: Dynamic test – trucks passes artificial bump on the bridge.

Phase 1 was conducted by placing the first 9 trucks on the 2nd half of the bridge, between the mid-span and end (left, according to Figure 4) abutment. Phase 2 was conducted without load relief by adding 9 additional trucks to the 1st half of the bridge, between the first abutments and the mid-span. Phase 3 of the static load test was performed by removing the 9 trucks from bridge such that trucks were only present in the 1st half of the bridge, between the right (according to the the Figure 4) abutment and the mid-span. In phase 4, the bridge was fully relieved. For Phase 1 – Phase 4 the vertical displacements of the deck and horizontal displacements of the abutments were measured with both total stations. Additionally, the inclinations of the deck were measured with MEMS accelerometers and the inclinations of the abutments with inclinometers. 3D laser scans were performed only for Phase 2 and Phase 4. Ambient vibrations using MEMS accelerometers were measured only in phase 4.

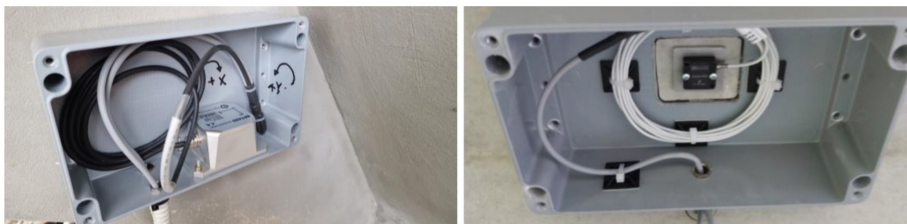
The considered bridge has a built-in permanent monitoring system which is capable of continuous measurement of bridge accelerations and rotations of the abutments, as shown in Figure 5.

Figure 5. Sensors used for the permanent monitoring: biaxial inclinometer (left) and uniaxial accelerometer (right).

The permanent monitoring system is designed such that it allows for remote access to the measured data. Each abutment is equipped with one biaxial inclinometer (type Vigor Technology SST420), which allows for the measurement of support rotation (INCL_01 and INCL_02 in Figure 6). Uniaxial accelerometers used in permanent monitoring (type Silicon Designs 2220-002) are placed on the bottom side of the precast concrete elements of the bridge deck. They were placed before the precast elements in the construction phase due to the difficulty of access afterward. Three pairs of two accelerometers were placed at the narrower part of the bridge deck (ACC_01 – ACC_06 in Figure 6). Using those accelerometers, three cross-sections were instrumented (First quarter, middle quarter, and third quarter of the span). Due to vandalism which occurred after the construction and before the load test of the bridge, connection to accelerometer ACC_06 and inclinometer INCL_01 was lost, and it was impossible to re-establish after the end of the construction.
