## Experiences from in-situ monitoring of pavement under weather conditions change

**Abstract.** Very strong winters with temperatures under 0°C and hot summers with temperatures more than 30°C are observed in the South East part of Slovenia. Those big differences in temperature during the year and especially temperatures below freezing point have strong influence on asphalt layer and sub base of road pavement. The freeze/thaw cycles lead to formation of ice lenses in base course causing cracks in asphalt layers and degrade the pavement usually in a few years. For this reason one section of the national road in the South East part of Slovenia was rebuilt with cold in-situ pavement retreatment. A test field with inbuilt sensors for measuring water content, temperature and deformation in various depths and locations was constructed during the remediation works to study the mechanism of freeze-thaw degradation of pavements. The main goal of the test field is to determine water content in sub base, freezing depth, temperature distribution and deformations, which lead to cracks in asphalt layer after the remediation work in the road construction.

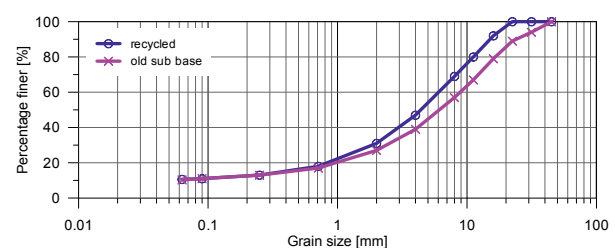
During the excavation works, soil samples of recycled material and old sub base layer were obtained for laboratory investigation. Results of dry density on test field, specific gravity, water permeability and sieving results are presented in Table 1 and Figure 2.

**Figure 2.** Grain size distribution

The remediation was done with cold in-situ retreatment by 3 % of foamed asphalt and 1 % of cement, which were mixed with old base layer (64 %) and old asphalt layer (32 %). Old base layer was fouled gravel 0/45 mm.

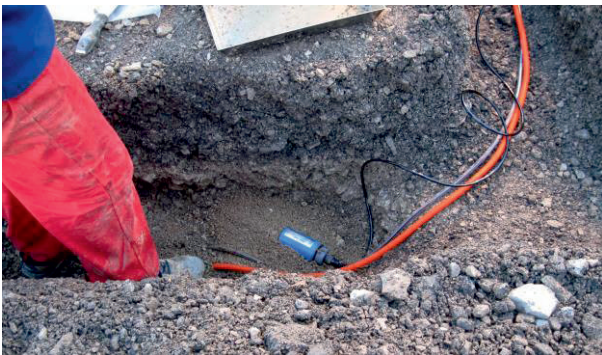
Dry densities of materials were measured by sand method on compacted layers. Figure 3 shows installation of TDR probe.

**Figure 3.** Installation of TDR probe.

All sensors were checked and calibrated in laboratory before installation work. Calibration of TDR probes included the effects of temperature, soil type and soil unit mass upon the measured values ([16, 18, 19, 20, 21, 22, 23]). The influence of temperature upon the measurement with strain gauges was also checked in laboratory and included into calibration. To minimize temperature effect dummy sensors were installed next to the test section.

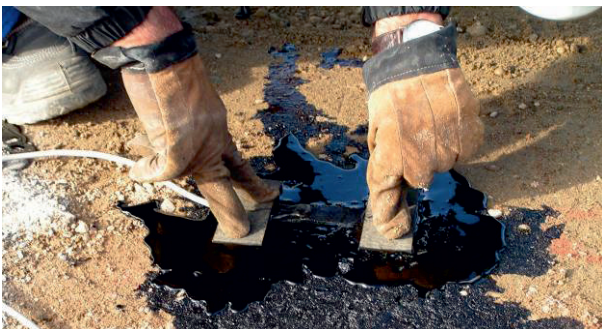
On Figure 4 installation of strain gauges is also presented. Long strain gauge is glued on bituminous tape, which is stabilised with two cardboard rectangles on each field, like letter H. The cardboard rectangles enable strain gauges good contact with bedding material. Manufactured and calibrated strain gauge was then laid on the bedding layer surface on thin bitumen spot at the field. The bitumen spot is placed just in small area around strain gauge. If strain gauge is installed in the soil, then sensor is covered with excavated soil and

compacted. In other hand, when strain gauge sensor is installed under the asphalt layer, it is protected with asphalt on upper field and then asphaltation with machine can be done. ([7])

**Figure 4.** Installation of strain gauge.

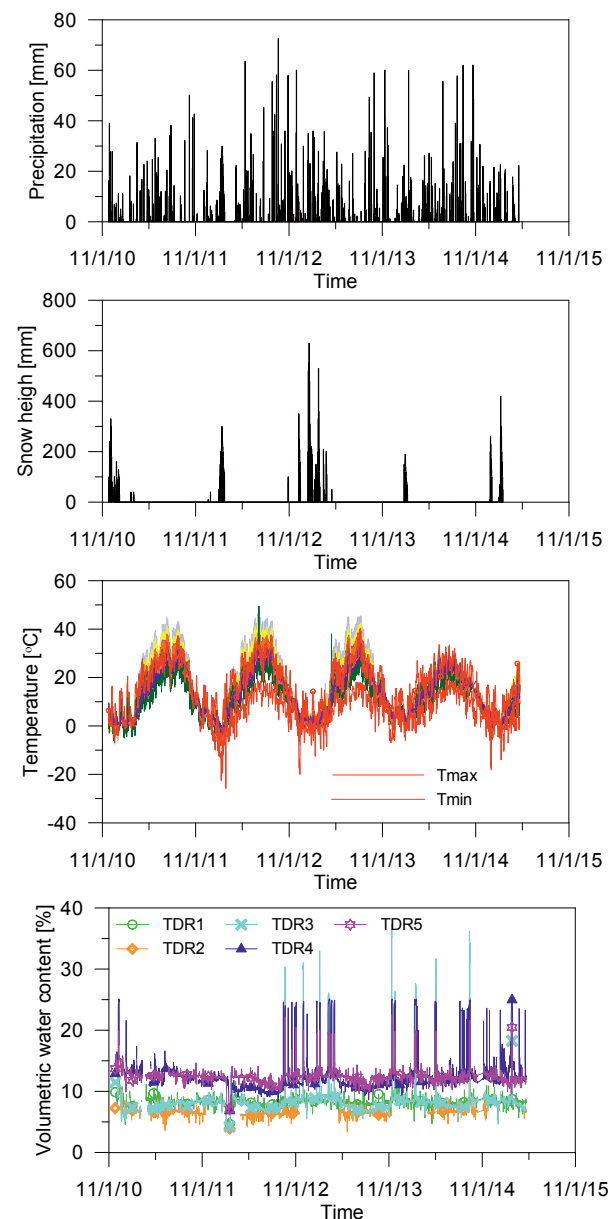
In the Figure 5 and Figure 6 all monitored data are presented. While many sensors of temperature were installed, all are presented but only minimum and maximum temperature recorded on weather station are showed in legend. Temperatures in the pavement are between daily minimum and maximum air temperature, only two sensors during summer times recorded higher temperature. Those two sensors T8 and T9 are installed in data logger covered with iron plate.

The frost can be detected like suddenly fall in volumetric water content on the diagram of water content. This happened in December 2011 for all probes and in January 2015 only in recycled layer. During the whole monitoring period volumetric water content in all layers grow to the predicted value of saturation state after longer rainfall period.

**Figure 5.** Precipitation, snow height, temperature and volumetric water content against time.

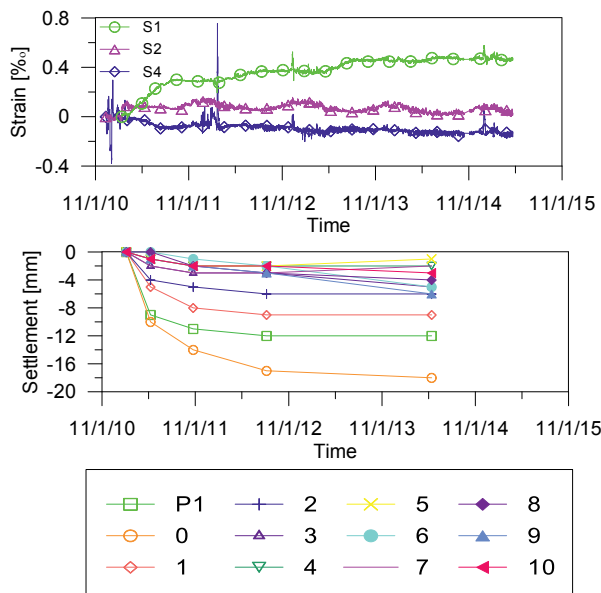
Horizontal strains that were measured in recycled layer by strain gauges are low. However some findings

can be observed. Main changes are recorded under the wheel tracks during winter times. After five years of strains monitoring at the bottom of asphalt layer (S4) the edge zone showed compression behaviour, while in recycled layer in the edge zone (S1) strains have increased slowly to extension of 0.5 ‰.

Horizontal strains in recycled layer in the middle zone (S2) have shown almost no change, while S3, which has been installed at the bottom of asphalt layer has failed.

Geodetic measurements of vertical displacement at the surface show that whole pavement settled down. While embankment and edge zone (width of 1 m) of road surface settles for 10 to 18 mm, the centre zone settles no more than 6 mm.

**Figure 6.** Strains and settlement against time.

recorded in December 2012 under asphalt layer and in the recycled layer, while in the middle zone only yearly changes are recorded. During winter times strains increased, while during summers returns almost to the start value (Figure 6). Very small changes can be influenced by temperature response of strain gauges. Other sensors show increasing of strain when temperatures decrease less than zero and when temperatures start increasing strains decrease to the values 0.02 ‰ lower than before freezing. During freezing time extension in recycled layer is present and during thawing compression is recorded.

Measurements of vertical displacements show that edge zone of pavement settle more than the middle zone. Traffic load on new or rebuilt pavement can causes higher settlements of road surface ([5, 14]) as well as frequent and high volumetric water content changes ([2, 8, 10]). While settlements have been measured only few times out of the freezing period and not continuously during the whole monitoring period, results do not capture possible heaving due to freezing. Furthermore, it is difficult to decide about the reason for settlements. On the authors opinion, measured settlements are caused mostly by the traffic loading.

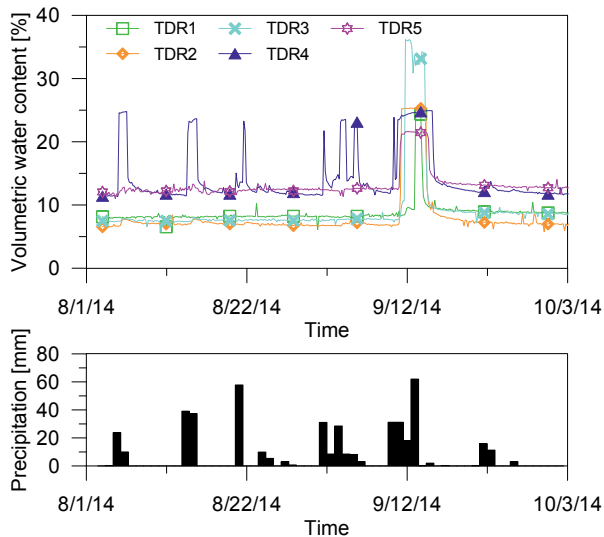
frost zone. After spring thawing, water content in the layer increases in some cases to saturated value ([2, 8]). Sensor TDR3 expresses described mechanism. TDR2 sensor shows some problems during this winter. August and September 2014 had many rainy days with high values of precipitation. When daily precipitation exceeds 20 mm, the old sub base layer on the edge part of pavement reached predicted full saturation value of volumetric water content (Figure 8). While the TDR probes were installed in finer material than the layer materials are and the real values of dry density around the probes are not know, it is not possible to speak about saturation ([15]). Values of volumetric water content for old sub base layer never exceed 26 %, which lead to prediction that this value correspond to full saturation state. Same prediction could be done for recycled layer, but value of saturation volumetric water content is 36 %. After few days of daily precipitation higher than 20 mm in all measuring points increase of volumetric water content is observed. In old sub base layer predicted full saturation is reached.

The same is observed for recycled layer on the edge part of the pavement; while in the middle part of the pavement the increase of volumetric water content for about 20 % is observed. Recycled layer is protected with asphalt layer and water from precipitation flow from middle part to the edge part, where drainage is not regulated. Thus, volumetric water content is higher in the edge part of the pavement compared to the rest of the pavement. Similarly, also other authors observe that water content in unbound layers is highly dependent on permeability properties of asphalt layer ([10]) as well as permeability properties of cold in-situ retreatment with foamed bitumen layer ([4]).

**Figure 8.** Relation between volumetric water content and precipitation (August and September 2014).

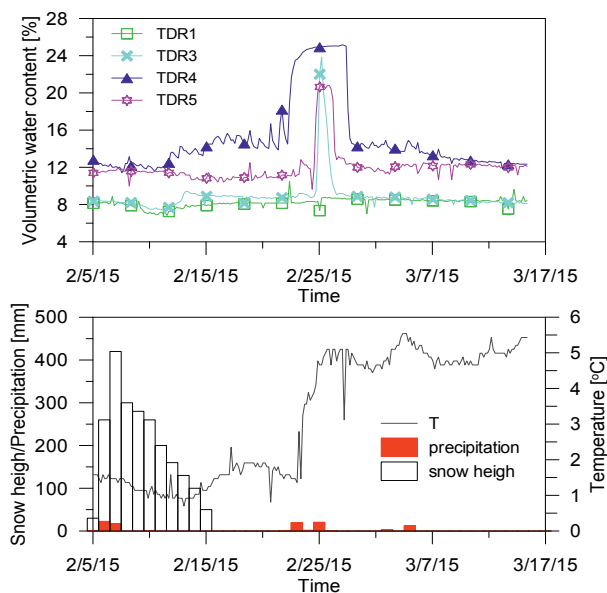
The same water flow is observed during melting of snow (Figure 9). Water from melting of snow is firstly recorded in edge zone of old sub base layer. After few days water start to penetrate in the middle zone of old sub base layer and also in the edge zone in recycled layer. The TDR probe in the middle zone of recycled layer does not record any water change due to melting of snow, and thus gives an assumption that protection with asphalt layer is enough impermeable.

**Figure 9.** Relation between volumetric water content and melting of snow (February 2015).

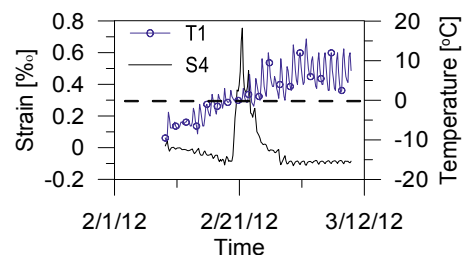
Figure 10 and Figure 11 represent relation between deformation and temperature measured by strain gauges. In February 2012 horizontal strain increase after temperature exceeds 0 °C. At this time freezing was also observed. Thawing corresponds to extension at the bottom of asphalt layer in the edge zone. During thawing time water content in soil increase and this leads to extension in recycled layer. Different behaviour is

**Figure 10.** Relation between deformation and temperature (February 2012).

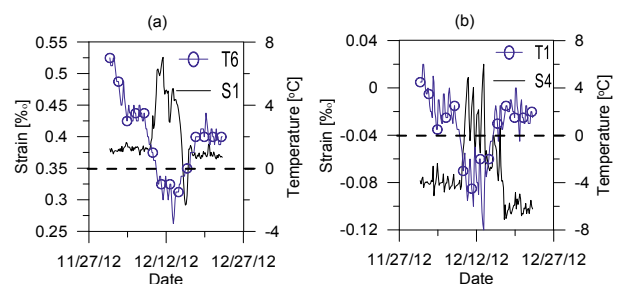
This behaviour corresponds to ice lenses formation. While temperature in top falls under zero, water from under layer starts penetrating to surface. Bituminous protection type of strain gauge prevents water to penetrate higher and in the case of temperature lower than 0 °C, ice lenses start creating under strain gauge which leads to extension. During all five years of monitoring a small compression is observed under asphalt layer, which is in contrast with [5] observations. In the case of explaining deformation under the wheel tracks, extension at the bottom of asphalt layer is presented. In this way, freeze-thaw cycles dominate on strain response.

**Figure 11.** Relation between deformation and temperature (December 2012): (a) recycled layer and (b) under asphalt.
