## CHARACTERIZATION OF THE SUBSTRATES FROM TWO CULTURAL-HERITAGE SITES AND A PREPARATION OF MODEL SUBSTRATES

**Sabina Kramar<sup>1</sup>, Vilma Ducman<sup>1</sup>, Snezana Vucetic<sup>2</sup>, Edo Velkavrh<sup>3</sup>,  
Miroslava Radeka<sup>4</sup>, Jonjaua Ranogajec<sup>2</sup>**

<sup>1</sup>Slovenian National Building and Civil Engineering Institute, Dimičeva 12, 1000 Ljubljana, Slovenia

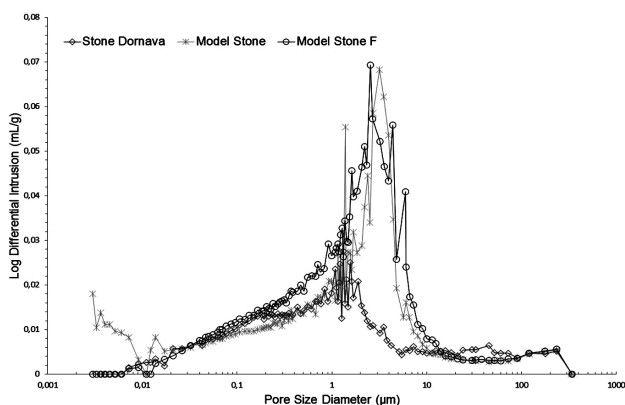
**Figure 1:** Pore-size distributions for the samples of natural stone  
**Slika 1:** Porazdelitev velikosti por v vzorcih naravnega kamna

After an exposure to the freeze/thaw cycling, only a slight increase in the porosity of the model-stone sample was observed. On the other hand, the sample's average pore diameter increased significantly, shifting from 0.04 µm to 0.26 µm (**Figure 1**). The pore-size distribution was unimodal, with an intrusion peak at 2 µm. The BET surface-area values also increased. The pressure caused by freezing range from 14 MPa to 138 MPa, with a

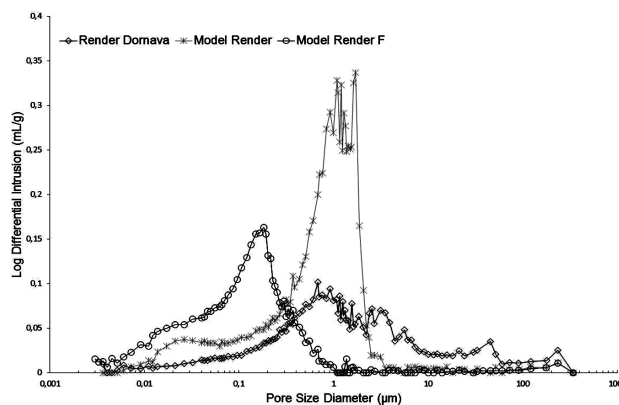
**Figure 2:** Pore-size distributions for the samples of render  
**Slika 2:** Porazdelitev velikosti por v vzorcih ometa

The porosity of the model-render sample reduced significantly after the freeze/thaw cycling, whereas the change in the average pore size was not significant (0.04 µm and 0.06 µm). The main intrusion peak after the freeze/thaw cycling shifted from 1 µm to 0.15 µm (**Figure 2**). A significant increase in the BET surface area of the render was observed after the freeze/thaw cycling. Both of these phenomena can be ascribed to the dissolution/precipitation processes that occur due to the water exposure in the freezing/thawing test.

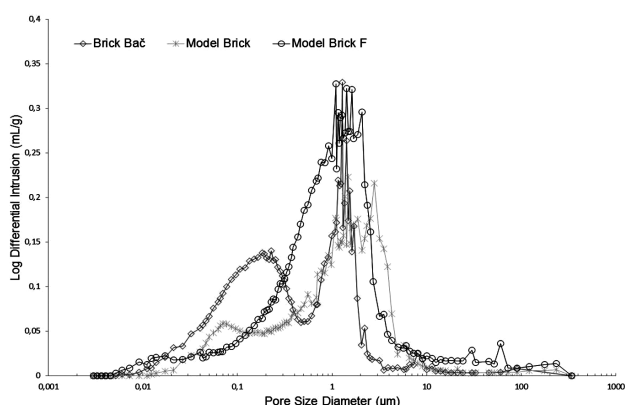
**Figure 3:** Pore-size distributions for the samples of brick  
**Slika 3:** Porazdelitev velikosti por v vzorcih opeke

freezing. The values of the BET surface area increased significantly after the ageing. The pore-size distribution of Brick Bač and model-brick samples was bimodal, but after the freeze/thaw cycling it became unimodal (**Figure 3**).

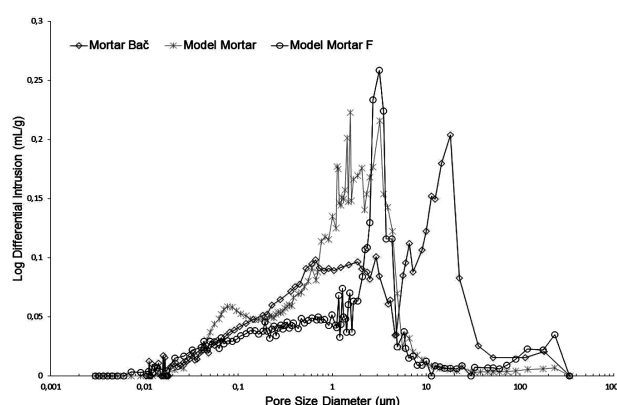
**Figure 4:** Pore-size distributions for the samples of mortar  
**Slika 4:** Porazdelitev velikosti por v vzorcih malt

The values of the porosity and the average pore diameter for the model-mortar sample decreased after the freeze/thaw cycling, most probably due to the dissolution/reprecipitation processes inside the pores. The pore-size distribution of the control sample was bimodal – this distribution was observed for a significant number of historical mortars<sup>9</sup>, becoming unimodal after the ageing<sup>10</sup> (**Figure 4**). The values of the BET surface area increased significantly after the freeze/thaw cycling, indicating a deleterious effect of freezing on the mortar.
