Non-invasive techniques in consolidation study of dolomitic lime plasters: application to wall paintings

Key words: wall paintings, dolomitic lime, consolidation, spectrophotometry, microhardness testing, DRMS, UPV

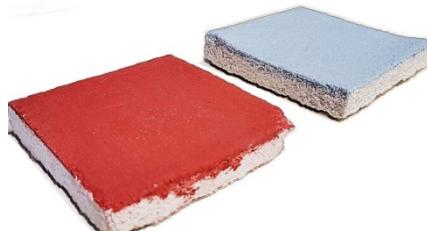
To simulate historical *secco* wall painting techniques, model substrates measuring 10 x 10 cm and 1 cm in thickness were prepared with dolomitic lime, fine aggregates composed of 1 mm calcitic sand (aggregate-to-binder ratio 1.5:1), and red ochre and azurite pigments (Fig. 1). Consolidants were applied by brush (Fig. 2), and treated samples were evaluated at multiple intervals to assess mechanical and aesthetic changes. A multimodal approach was used for performance assessment, combining non-destructive and micro-invasive methods.

Figure 1: Ochre and azurite model substrates

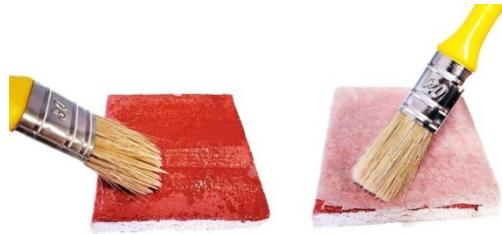
Figure 2: Application of the CFW consolidant on the model substrate
