# DFOS-Based Monitoring of Prestressed Concrete Bridge Girders

**ABSTRACT:** Due to bridges' critical role in transportation networks, the assessment and maintenance of existing bridges have become a priority. Prestressed concrete bridges constitute a significant portion of Europe's transportation network, yet many no longer meet today's technical requirements. This is primarily due to two factors: (i) the unforeseen increase in heavy goods traffic, and (ii) insufficient experience with early reinforced and prestressed concrete construction methods, coupled with inadequate regulations, which resulted in design weaknesses and structural deficiencies. One critical failure mechanism, identified when recalculating existing bridges based on updated guidelines, is insufficient shear load-bearing capacity, which has prompted the premature demolition of numerous bridges. A thorough understanding and rigorous monitoring of shear behavior is essential since neglecting this problem could lead to notable consequences, especially for aging infrastructure. In this paper, a distributed fiber optic sensor (DFOS) based monitoring system, inspired by shear detection concepts, is tested. A decommiss

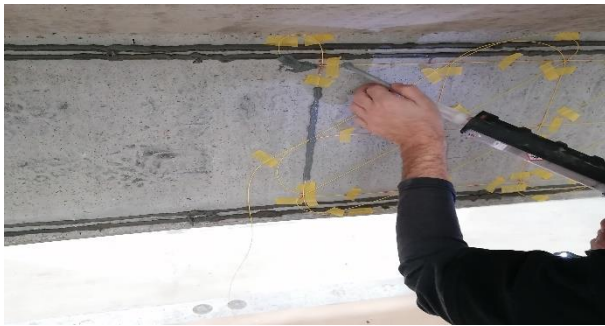
Ensuring optimal bonding to the concrete surface is important for accurate strain measurements. Since the girder was prefabricated, it possessed a smooth finish that required only dust and debris removal. The installation process involved initially fixing the sensor pointwise at predetermined intervals with a fast-curing cyanoacrylate adhesive (CYN), followed by the application of a two-component injection mortar along its entire length. This high-viscosity mortar rapidly hardens and is

Figure 4. Sensor bonding procedure on concrete

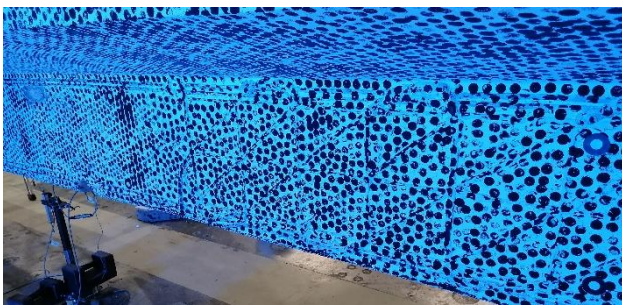
After applying the grid, the surface was painted to facilitate DIC measurements. However, the DIC evaluation is beyond the scope of this paper.

Figure 5. DFOS grid covered with DIC speckle pattern
