# OPPORTUNITIES TO REUSE FENCE POSTS USING METAL FOOTINGS

Daniel WONG<sup>1</sup>, Rod STIRLING<sup>2\*</sup>

(1) FPInnovations, Canada, daniel.wong@fpinnovations.ca

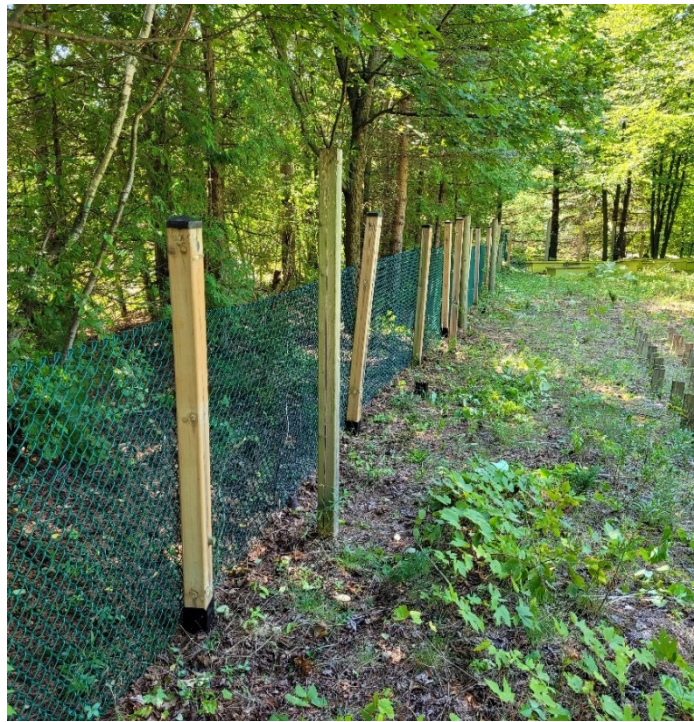
**Fig. 1:** Test fence installation in Kincardine, Ontario, Canada

All materials were installed at FPInnovations' field test site in Kincardine, Ontario, Canada (Fig. 1). The site is a residential lot within the Lorne Beach termite management area north of the town of Kincardine. It has a humid continental climate (Köppen Dfb) and hosts a population of the subterranean termite *Reticulitermes flavipes* (Kollar). It has sandy, well-drained soil and is home to several species of decaying basidiomycetes. The area receives an average of 998 mm of precipitation annually. Average annual temperature is 6.2°C, with mean daily maximum and minimum temperatures of -2°C and -10°C in January, and 24°C and 13°C in July (Stirling and Mankowski, 2022).

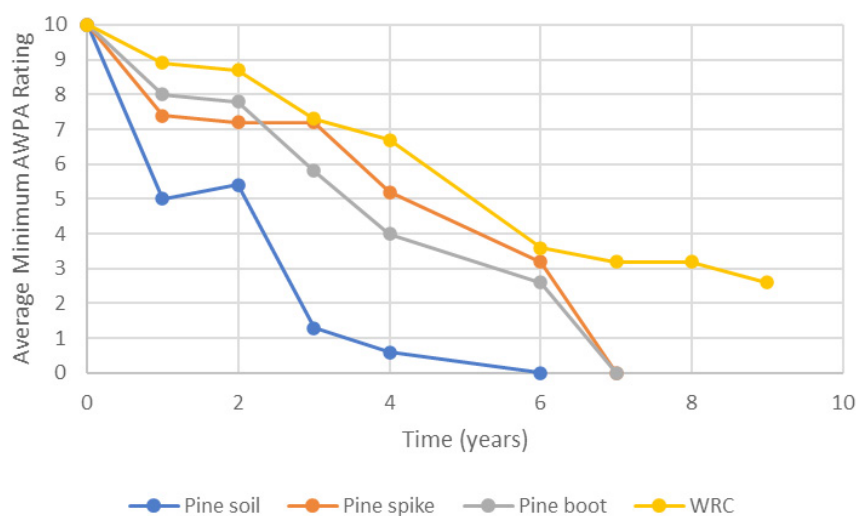
**Fig. 2:** Biodegradation of untreated fence posts exposed in Kincardine, Ontario, Canada for 9 years

The rate of biodegradation of the untreated materials is shown in Fig. 2. Red pine posts in direct soil contact failed most rapidly, with all posts failing by 6 years. Red pine posts installed on spikes or boots failed at a slightly slower rate, but all failed by 7 years. The

WRC reference was more durable, with some posts still in service after 9 years. This was expected as the WRC posts were entirely heartwood, which is known for its natural durability (Scheffer, 1957; Freitag and Morrell, 2001). Previous WRC post tests have shown service lives greater than 9 years (Morris et al., 2015).

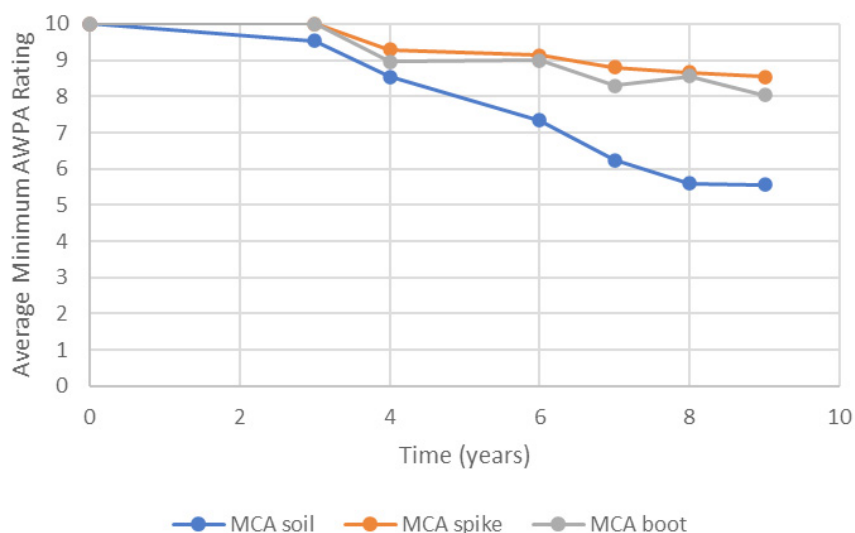
**Fig. 3:** Biodegradation of micronized copper azole (MCA)-treated fence posts exposed in Kincardine, Ontario, Canada for 9 years

The rate of biodegradation of the MCA-treated materials is shown in Fig. 3. MCA-treated posts in direct soil contact were most degraded after 9 years, with an average rating of 5.6. The boot and spike footings were less degraded after 9 years, with average ratings of 8.0

and 8.5, respectively. The rate of biodegradation in this study was greater than in a previous study where MCA-treated red pine posts were largely sound after 11 years of exposure at a test site in Petawawa, Ontario (Wilson et al., 2023). The test material had an average preservative penetration of 2.4 mm. This is substantially below standard requirements (CSA, 2021) and may explain the more rapid degradation of this material.

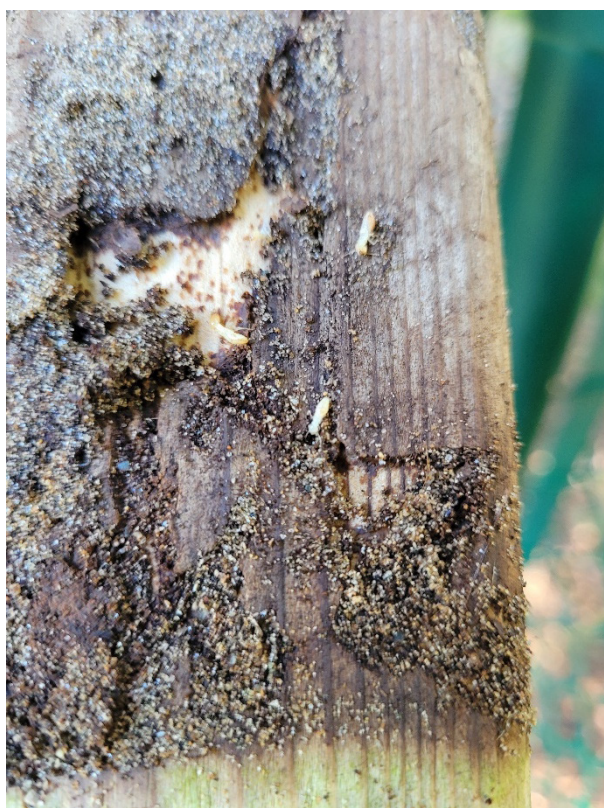
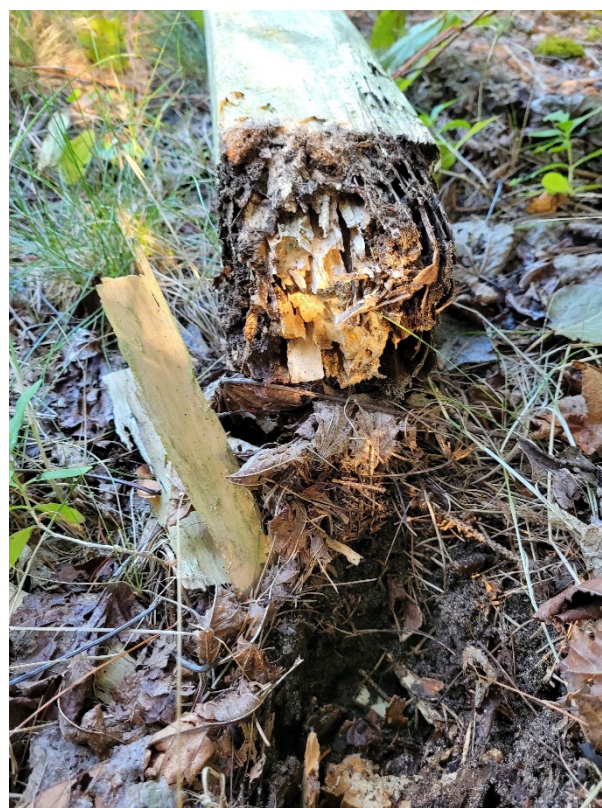
**Fig. 4:** Termite attack on an untreated red pine post installed in a boot (left) and failure of an untreated red pine post exposed in direct soil contact after 6 years (right)

contact between the soil and the post. Termite attack and post failure are visible in the images shown in Fig. 4.
