Surveillance of the banks of reservoirs on the Drava River in Slovenia after extensive floods

Pavel Žvanut*¹

¹Slovenian National Building and Civil Engineering Institute, Ljubljana, Slovenia

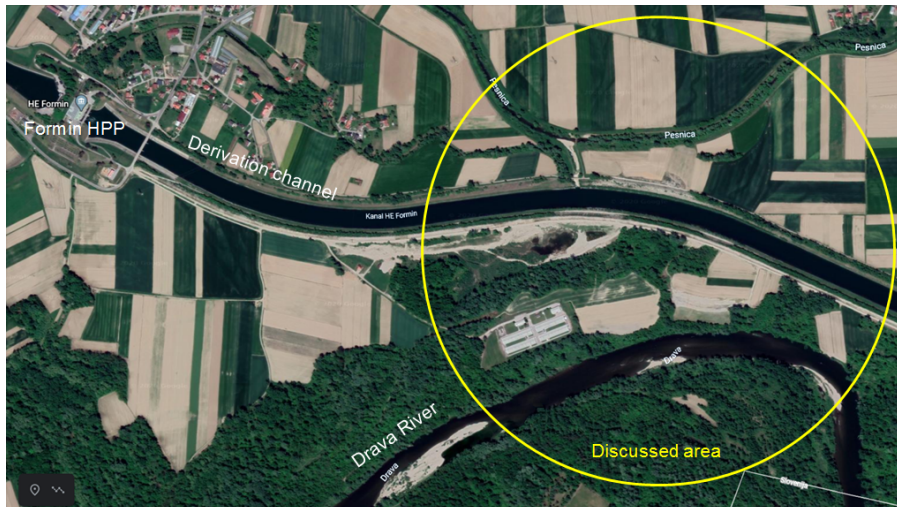
The most extensive damage was registered in the area of the derivation channel of the Drava River, about 1.5 km downstream of the Formin HPP (see Figs. 10 and 11), where the flood waters of the Drava River caused an additional river flow, which first broke through the right levee of the derivation channel and then also broke through the left levee of the derivation channel (see Figs. 12 and 13), where caused the erosion of the left bank of the derivation channel (see Fig. 14). Of course, the concrete diaphragm walls, installed in levees on both sides of the derivation channel, which prevented the drainage of groundwater into the derivation channel, were also demolished in this area (see Fig. 15). In addition, the flood waters of the Drava River transported large amounts of gravel into the derivation channel (see Fig. 14), which dammed water in the channel, with that caused rising of the water level in the channel and consequently flooding of the machine hall area of the upstream located Formin HPP [12-14]. Due to the high risk of additional damage and deterioration of the stability of the damaged banks of derivation channel, the main rehabilitation works began immediately after the detailed inventory of all noticeable damage was made, and they were completed quickly and successfully.

Fig. 11. Detailed location of the discussed area (Source: Google Earth).
