Characterization of Micro-Threaded Stem Taper Surfaces of Cementless Hip Endoprostheses

Abstract: We investigated micro-threaded stem taper surface and its impact on premature failures, aseptic loosening, and infection in cementless hip endoprostheses. Our study focused on the fretting, and crevice corrosion of micro-threaded tapers, as well as the characterization of the microstructure and surface properties of two new and three retrieved Zweymüller stem tapers. The retrieved samples were selected and examined based on the head–stem taper interface being the sole source of modularity with a metallic component, specifically between the Ti alloy taper stem and the ceramic head. To determine the surface chemistry and microstructures of both new and retrieved hip endoprostheses stem taper titanium alloy, scanning -electron microscopy (SEM) was employed for morphological and microstructural analyses. Energy dispersive spectroscopy (EDS) was utilized for characterizing chemical element distribution, and electron backscattered diffraction (EBSD) was used for phase analysis. The roughness of the micro-threaded stem tapers from different manufacturers was investigated using an optical pro

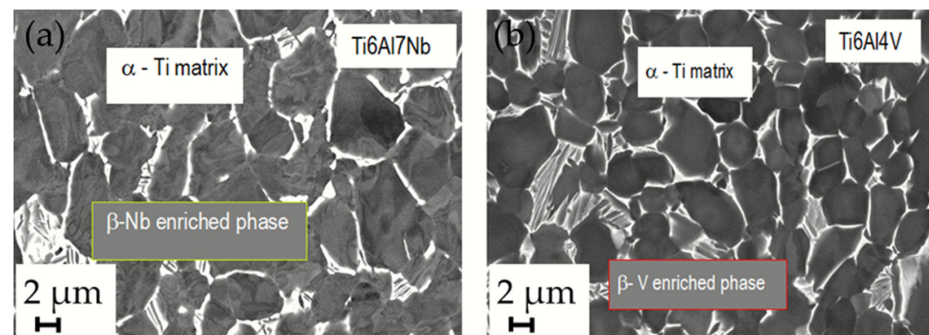
The microstructure of the stem taper of the implants manufactured from Ti alloys (Ti6Al7Nb and Ti6Al4V) is shown in Figure 3. A dual-phase microstructure is observed in the matrix, Ti phase is α -Ti (dark grey), and the Nb-rich or V-rich phase (light grey) is β -Ti (Figure 4). The dual-phase structure is confirmed using the EBSD method (Figure 5).

Figure 3. (a) SEM/BE image of Ti6Al7Nb alloy microstructure (A283). It consists of two phases ($\alpha + \beta$). α -phase (dark) represents the matrix, which has a close-packed hexagonal crystal structure (hcp), and the β -Nb-enriched β phase (white) in the body-centered cubic structure. (b) SEM/BE image of Ti6Al4V alloy microstructure of new Lima stem. α phase (dark) represents the matrix and the β -V-enriched phase (white) at M2500.

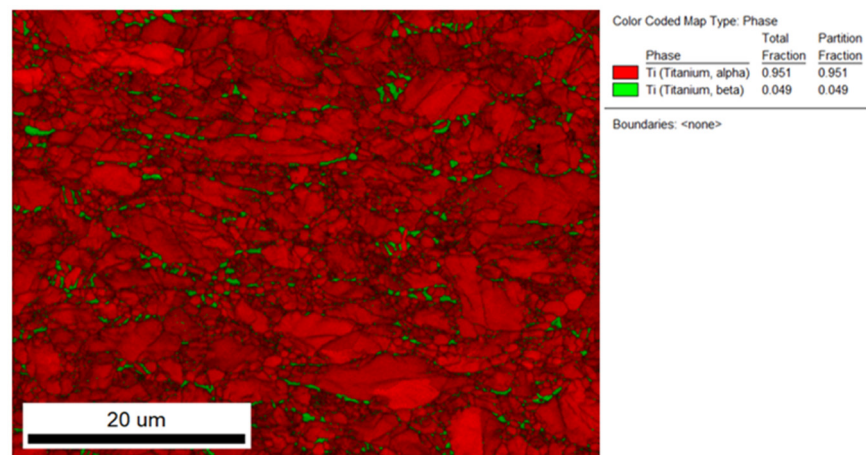
Figure 5. EBSD image of Ti6Al7Nb new sample. α phase is Ti matrix in hcp structure, red, and with Nb-enriched β phase, bcc structure is green.

The quantitative determination of phase distributions in the new sample Ti6Al7Nb alloy is possible by using the electron backscattered diffraction integrated technique on the field emission scanning electron microscope, EBSD, where the stem taper microstructure is ($\alpha + \beta$), as in Figure 5. The EBSD method is compatible with the XRD method but on a smaller scale and for that reason is mounted on the FE-SEM. The EBSD method is very precise; the limitation of EBSD, besides being a very accurate, precise method, is that it is very time-consuming, and for that reason is suitable for basic research and the development of new biomaterial alloys.

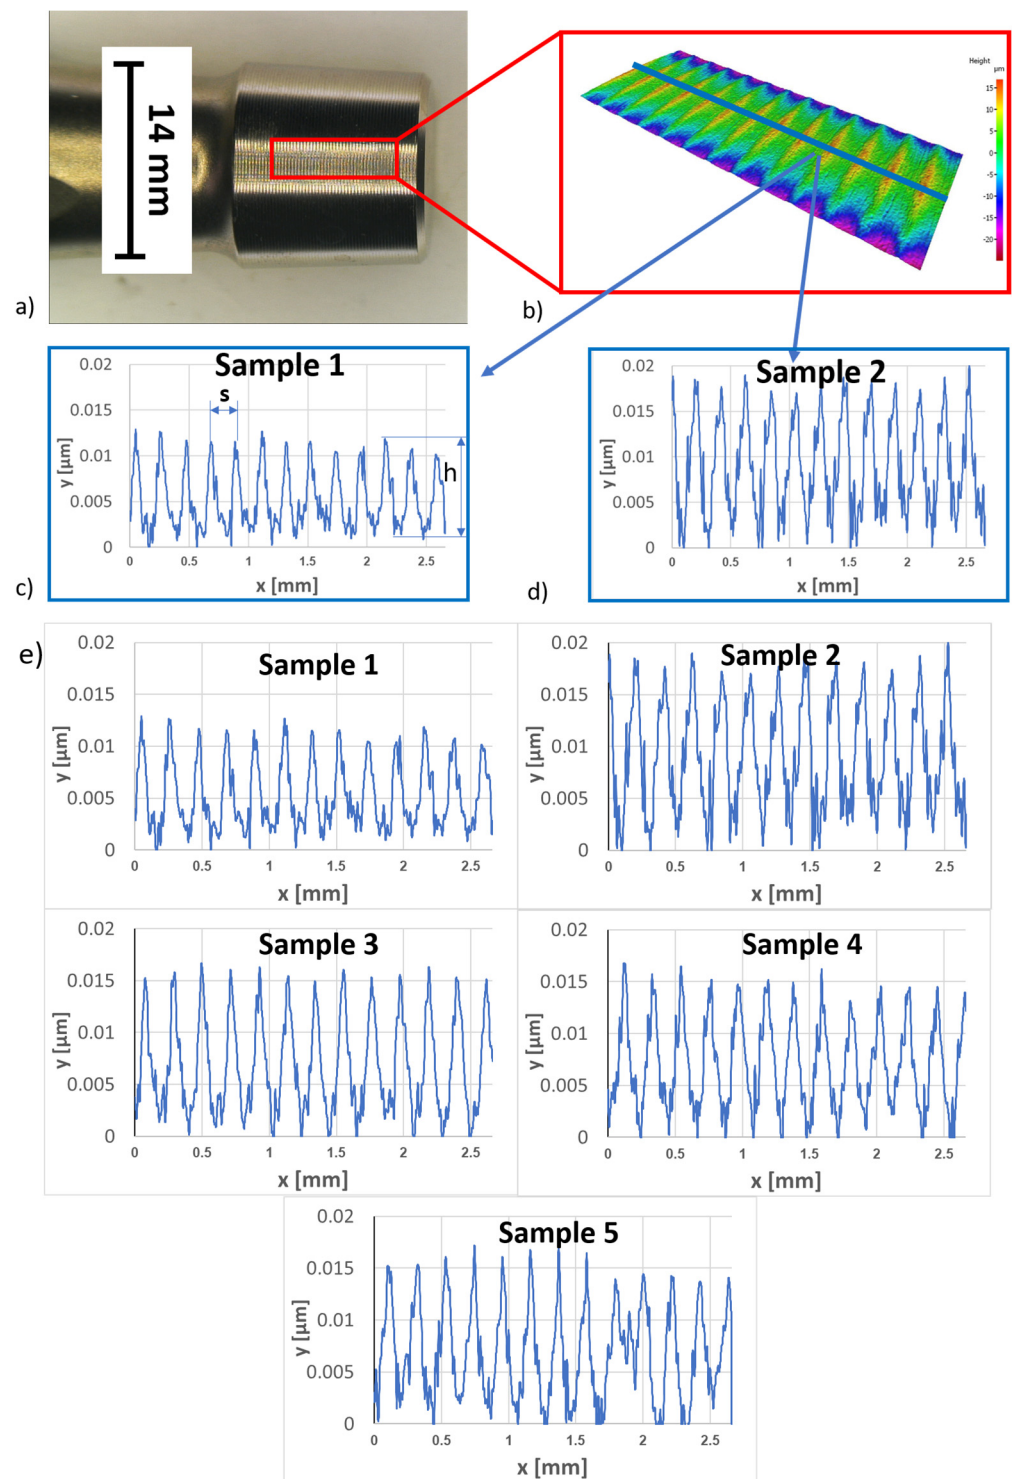
Five samples were investigated as seen in Table 3: samples 1 to 5, two new (Alloclassic Varial-AV, and Lima Corporate) and three retrieved (A-283, I-212, and I-031) with different survivorships from 3 to 239 months. Roughness profiles of stem tapers were obtained from the surface of the taper, as seen in Figure 13. Peak spacing— s and profile depth— h (Figure 13c) were also measured for comparison. As can be seen from Table 3, there is no significant difference in roughness associated with a longer time of use. New samples AV and Lima have the lowest and highest values of R_a and R_z values. Samples AV and Lima also have different profile depths for the peaks (Figure 13c,d). Sample AV has an average depth of 9.3 and sample Lima 14.4 μm . (Table 3). This can be attributed to different manufacturers and thus different manufacturing methods. Retrieved samples, on the other hand result, have slightly lower values of surface roughness and profile depth, which can contribute to the deformation of the peaks. Results of surface roughness indicate that the three retrieved samples (A-238, I-212, and I-031) were manufactured using the same or similar method as sample Lima.

Figure 13. (a) Image of male stem taper, (b) 3D pseudo-profile picture, (c) 2D roughness profile of stem A, (d) 2D roughness profile of stem B, and (e) roughness of all five investigated stem tapers collected in Table 3.

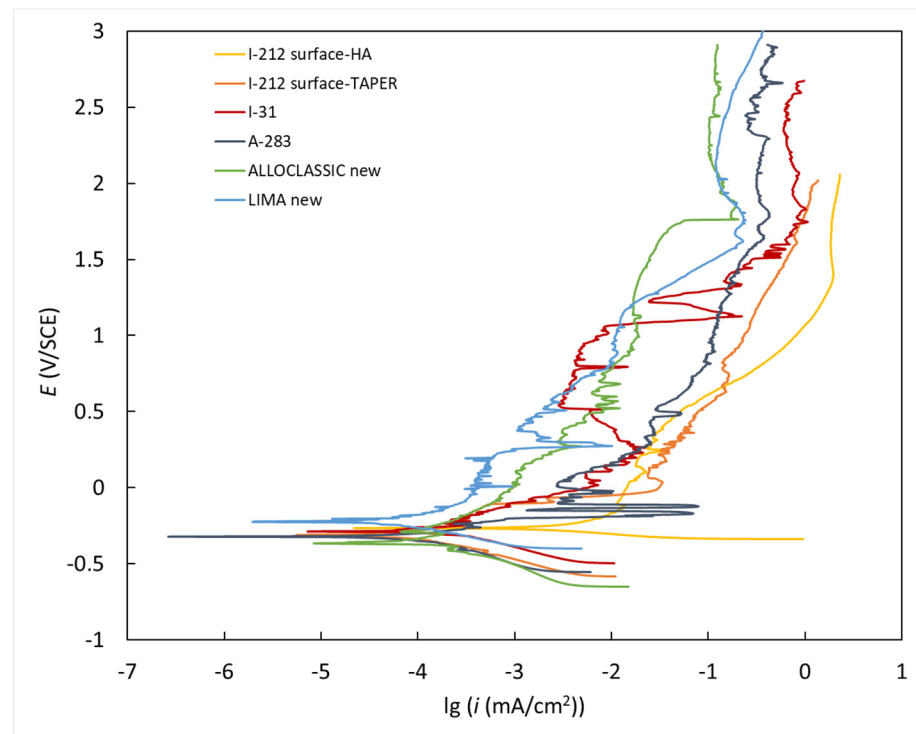
The potentiodynamic behavior of the materials investigated in Hank's solution is presented in Figure 14. All the materials demonstrated a broad passivation range following the Tafel region attributed to the formation of a compact outer passive film that impedes the diffusion of aggressive species, thereby enhancing the material's corrosion resistance [31–34]. The corrosion potentials (E_{corr}), corrosion current densities (i_{corr}), and corrosion rates (v_{corr})

are detailed in Table 4. The results show that the corrosion rates for both the new samples and the one with the longest exposure to real body conditions were lower compared to the other three with shorter exposure times. The implants with shorter exposure times to real body conditions were all subjected to infection, which is probably related to the formation of conditions that are detrimental to corrosion. In contrast, new implants with an intact surface as well as the implant with the longest survival in real body conditions showed an increased corrosion resistance.

Figure 14. Potentiodynamic curves for the investigated new and retrieved samples were measured in simulated physiological Hank's solution at pH = 7.8 and 37 °C.
