## Laboratory Testing of Old Bridge Girders: Preliminary Results

**ABSTRACT:** This paper presents key results on the laboratory testing of old girders removed from a flood-damaged bridge located near Ljubljana, Slovenia. The structure was widened in 1989 to accommodate pedestrians and cyclists by integrating prefabricated prestressed reinforced concrete T-girders. To assess the structural behaviour of the bridge, six girders were subjected to a rigorous testing program involving bending and shear tests in a laboratory setting. The tests were performed on girders with static lengths of 12.20 meters and 9.90 meters. The program aimed to evaluate the structural performance of the girders. Preliminary results indicate satisfactory structural behaviour of the prestressed T-girders under the applied loads, with insights into their performance under both bending and shear stresses. This study contributes valuable data for assessing the long-term behaviour of bridges. The outcomes are particularly relevant for optimising resource allocation in bridge rehabilitation projects and ensuring safety and functionality in transportation networks.

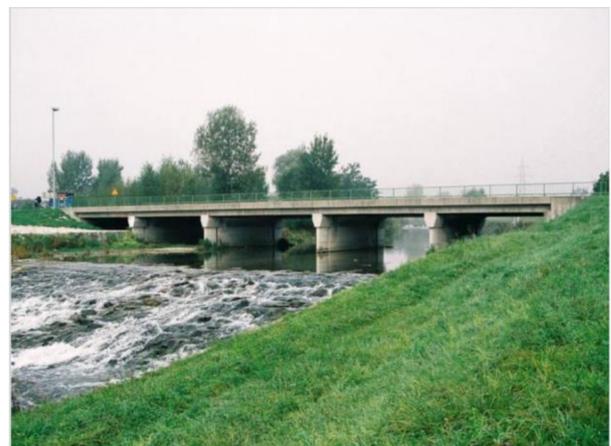
Figure 1. Existing bridge before the collapse (downstream).

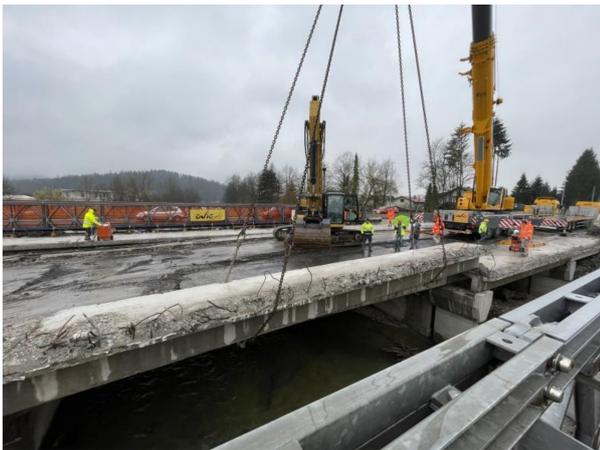
Following the catastrophic 2023 floods in Slovenia, the bridge partially collapsed, as shown in Figure 2 from the downstream side. While the intermediate supports were damaged, an inspection confirmed that the longitudinal girders remained in good condition. In agreement with the infrastructure manager and demolition contractor, selected girders were salvaged for laboratory testing (Figure 3).

Figure 3. Lifting the girders with cranes.
