# Evaluation of Oxinium (Oxidized Zr<sub>2.5</sub>Nb) Femoral Heads in Hip Endoprostheses—Case Report

Total hip arthroplasty (THA) is a widely performed and successful surgical treatment for degenerative joint disease. With increasing use in younger and more active patients, the demand for durable, biocompatible, and low-wear implant materials has grown. Oxidized zirconium (Oxinium, Zr<sub>2.5</sub>Nb) was introduced as a promising femoral head material, combining the strength of metal with the low-friction properties of ceramic. Despite encouraging early results, clinical reports have documented complications including head wear, especially after dislocation, and metallosis. We present the case of a 64-year-old male who underwent primary THA in 2009 and required revision in 2021 due to severe metallosis. Notably, no dislocation was observed that could explain the damage to the Oxinium head. Surface and subsurface analyses using X-ray photoelectron spectroscopy (XPS) and micro-indentation hardness testing revealed wear and deformation inconsistent with Oxinium's anticipated durability. These findings highlight the importance of the femoral head–polyethylene liner interface in impl

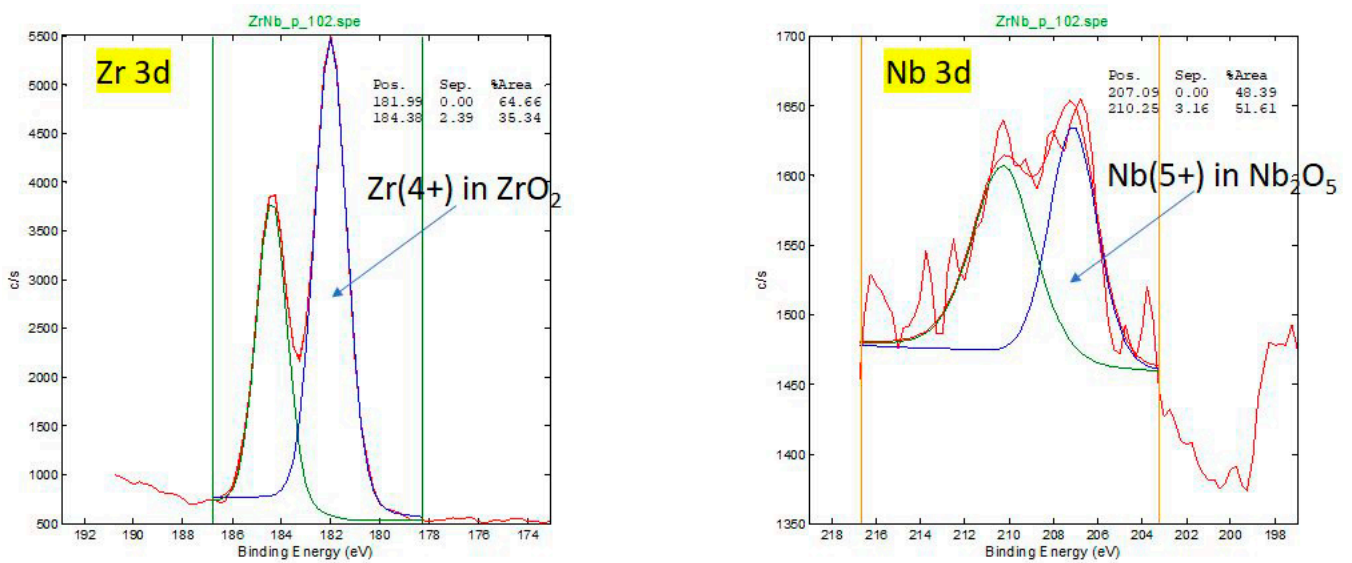
**Figure A1.** HR (high-resolution) XPS spectra for oxidation states of Zr and Nb of retrieved Oxinium femoral head. On the surface, Zr is in 4+ oxidation state in  $ZrO_2$  and Nb is in 5+ oxidation state in  $Nb_2O_5$ .

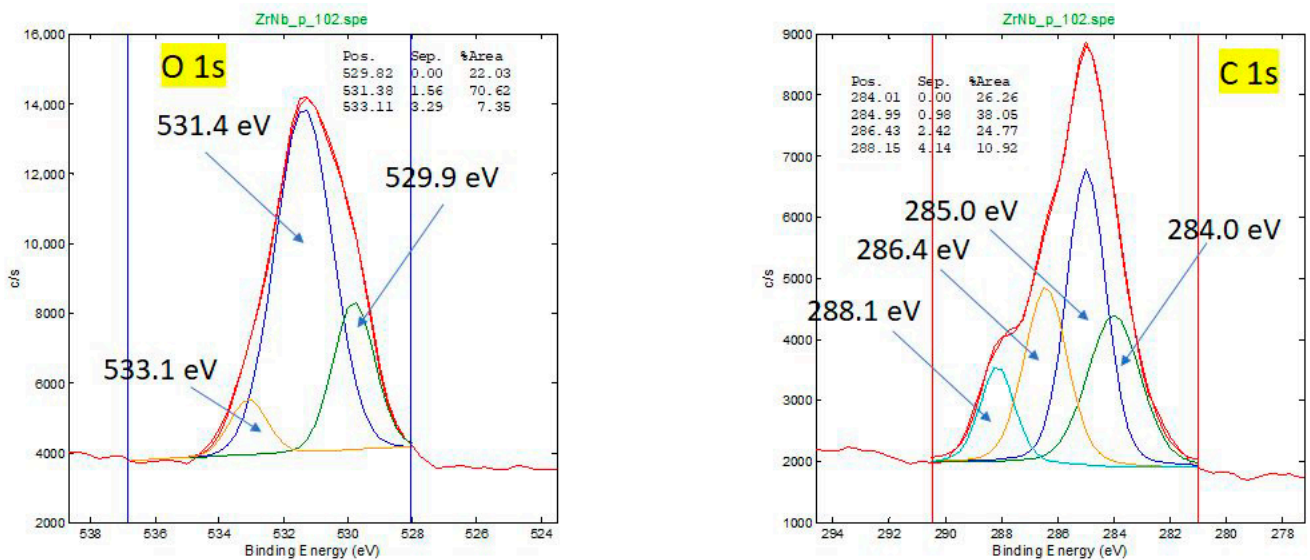
**Figure A2.** HR XPS spectra for oxidation states of O and C for retrieved Oxinium femoral head. Different oxidation states of O and C atoms on surface (oxides, polymer, contamination  $CO_2$  adsorption).

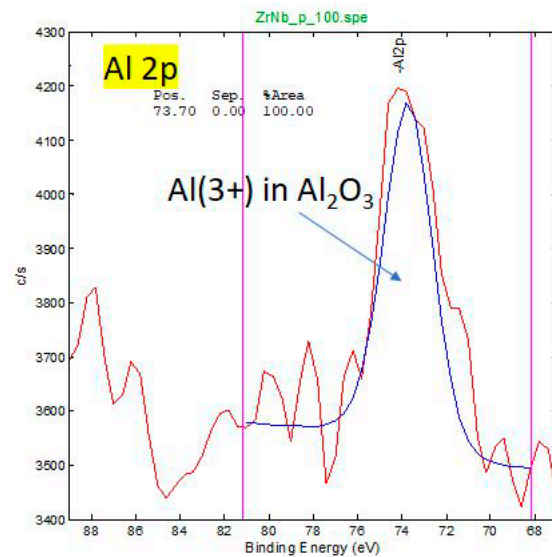
**Figure A3.** HR XPS spectra for oxidation states of Al for retrieved Oxinium femoral head. On the surface, Al is in 3+ oxidation state in  $\text{Al}_2\text{O}_3$ .
