International Conference on Analytical Models and New Concepts in Concrete and Masonry Structures AMCM'2017

Seismic behavior of strengthened URM masonry – an overview of research at ZAG

Petra Triller^a, Miha Tomaževič^a, Marjana Lutman^a, Matija Gams^{a,*}

^aZAG - Slovenian National Building and Civil engineering Institute, Dimičeva 12, 1000 Ljubljana, Slovenia

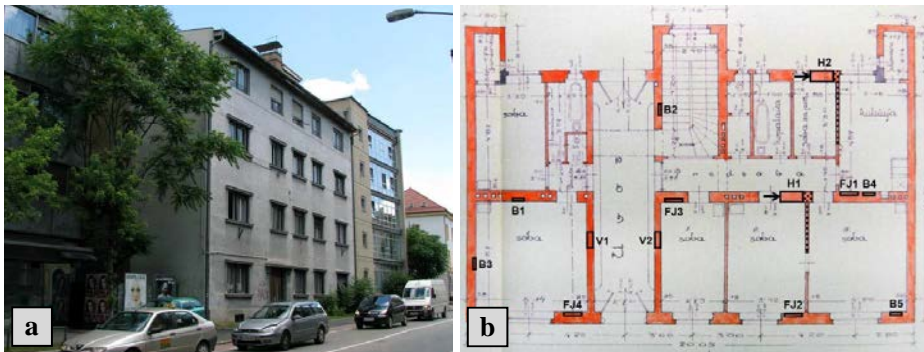
Fig. 1. View of the building (a); floor plan with test sites [2] (b).

A building in Ljubljana from 1935 (Fig. 1a) was about to be demolished and prior to the demolition the owners allowed us to perform destructive tests on the building. The walls of the building were built from so-called normal size (25 x 12 x 6.5 cm) solid bricks and lime mortar with small amount of cement. The building had reinforced-concrete slabs above the cellar, while all the stories above had timber floors. The thickness of the longitudinal walls was 51 cm in ground floor and 38 cm in floors above, whereas the transversal walls were 38 cm thick in the ground floor and 25 cm thick in floors above. The 12 cm thick partition walls were built of solid bricks. The construction is typical in Slovenia for the era between both world wars.

Two walls (denoted as H1 and H2 in Fig. 1b) were selected for shear tests. First, the walls were tested in their original state using the test setup shown in Fig. 2a). The load was applied in the form of prescribed lateral displacements at mid-height of the walls. The walls were loaded and unloaded and the loading was gradually increased. The vertical load in the walls was estimated to 0.61 MPa and 0.44 MPa for walls H1 and H2, respectively. During the first phase of testing, the walls developed clear shear damage (Fig. 2b).

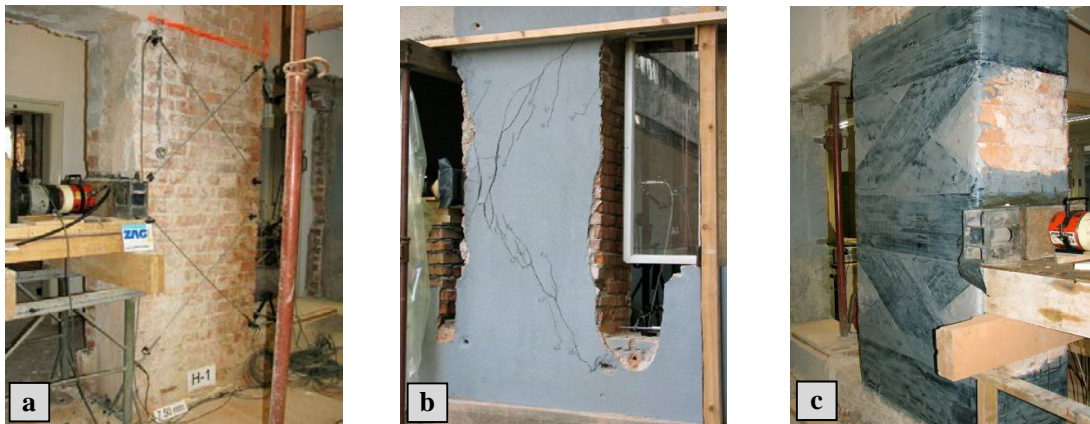
Fig. 2. Test setup on wall H1 (a), shear damage of wall H2 (b) and strengthened wall H1 (c).

Then the walls were strengthened using carbon fabric and epoxy resin. Both walls were wrapped by three horizontal strips. In addition, wall H1 had diagonal strips on both sides, whereas wall H2 only had diagonal strips on one side of the wall. The layout of the fabric is shown in Fig. 2c. The strengthened walls were labelled H1w and H2w.

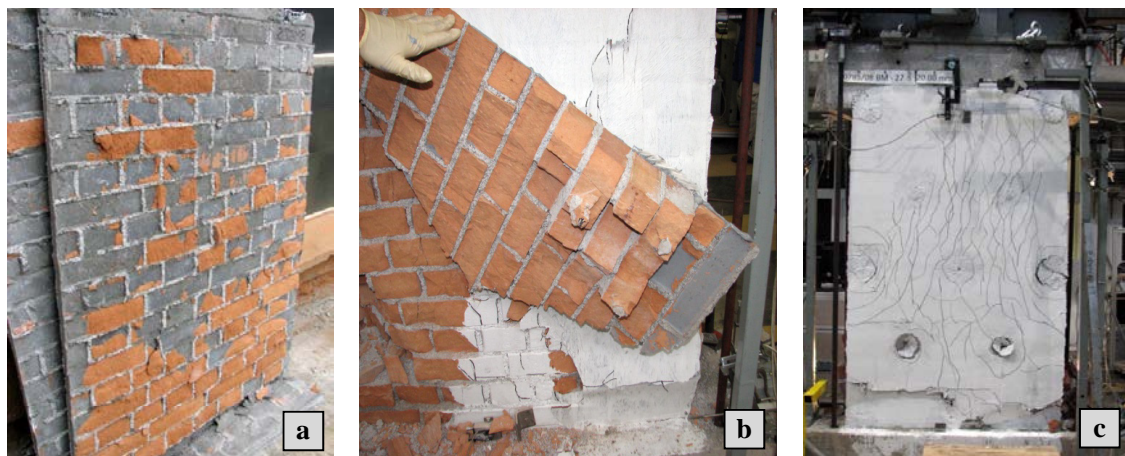
Fig. 6. Coating separated from the wall (a), delamination of epoxy based coating (b) and failure of anchors at highest density (c).

In case the coating was based on cementitious mortar and if there were no anchors, the coating could detach completely (Fig. 6a). The connection was partly lost at the bond between the coating and the masonry, and partly due to tensile failure of masonry, which essentially peeled off. In case epoxy resin was used (Fig. 6b), the

connection was lost exclusively due to tensile failure of masonry, which again peeled off. In case of such debonding, the effect of strengthening on seismic resistance of the wall was negligible. In case of mortar based coatings, the problems with delamination can be alleviated by using anchors (carbon anchors were used in our study). Different densities of anchors were used, and the response of the highest density (13 anchors per 1.5 m^2) is shown in Fig. 6c. Despite relatively high density, there were still problems with delamination, but the seismic resistance was improved compared to reference walls (Fig. 7a).
