Supplementary material:

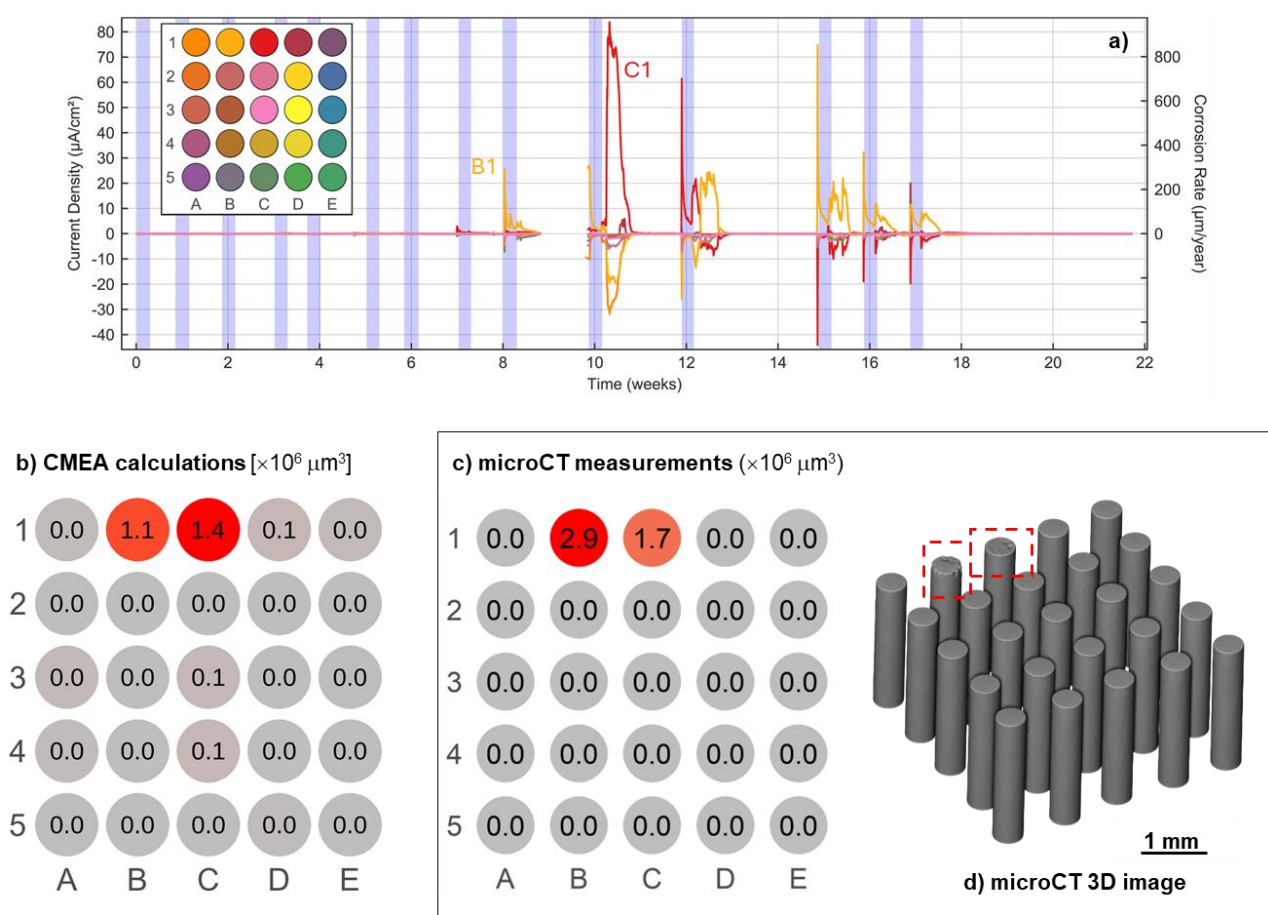
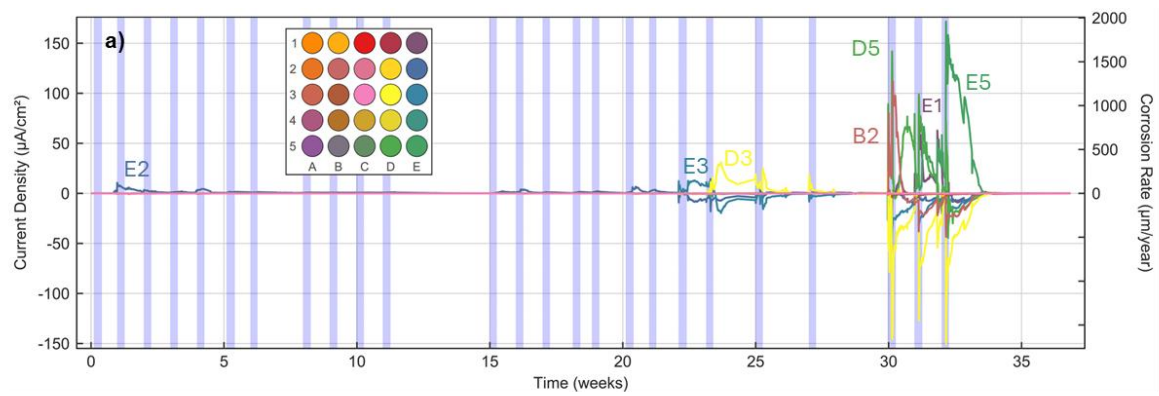
Supplementary Fig. 1. A CMEA sensor embedded in the FA8 (fly ash) alkali-activated mortar: a) continuous measurements of the ANODIC (positive, j_{corr}) and CATHODIC (negative, j_{cath}) current densities (grey sections = wetting, white sections = drying), b) corrosion damage calculated from the measured CMEA anodic currents (D_V), c) corrosion damage measured from the microCT scans, and d) a microCT 3D image of the CMEA following the period of exposure.

b) CMEA calculations [$\times 10^6 \mu\text{m}^3$]

c) microCT measurements ($\times 10^6 \mu\text{m}^3$)

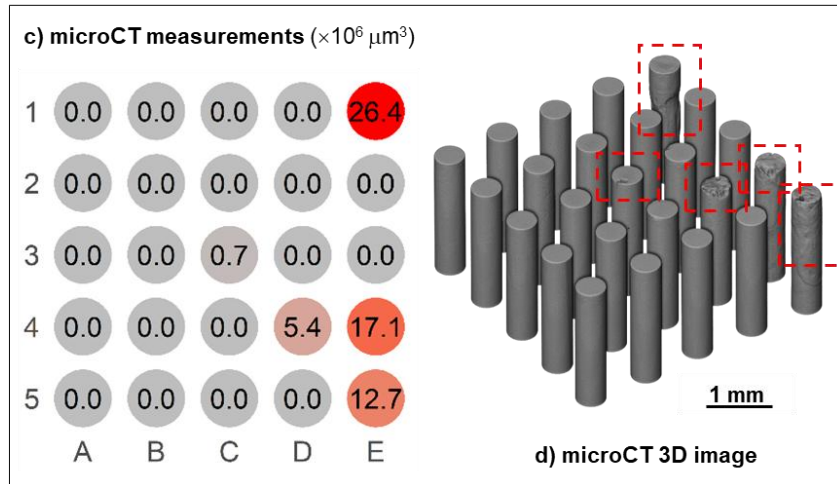
Supplementary Fig. 3. A CMEA sensor embedded in the S3a-661 (slag) alkali-activated mortar: a) continuous measurements of the ANODIC (positive, j_{corr}) and CATHODIC (negative, j_{cath}) current densities (grey sections = wetting, white sections = drying), b) corrosion damage calculated from the measured CMEA anodic currents (D_V), c) corrosion damage measured from the microCT scans, and d) a microCT 3D image of the CMEA following the period of exposure.
