## Urban open spaces as recreational areas and emergency shelters: Lessons from the Malatya earthquake

**Keywords:** public open spaces (POSs), earthquake resilience, post-disaster recovery, Malatya, Turkey

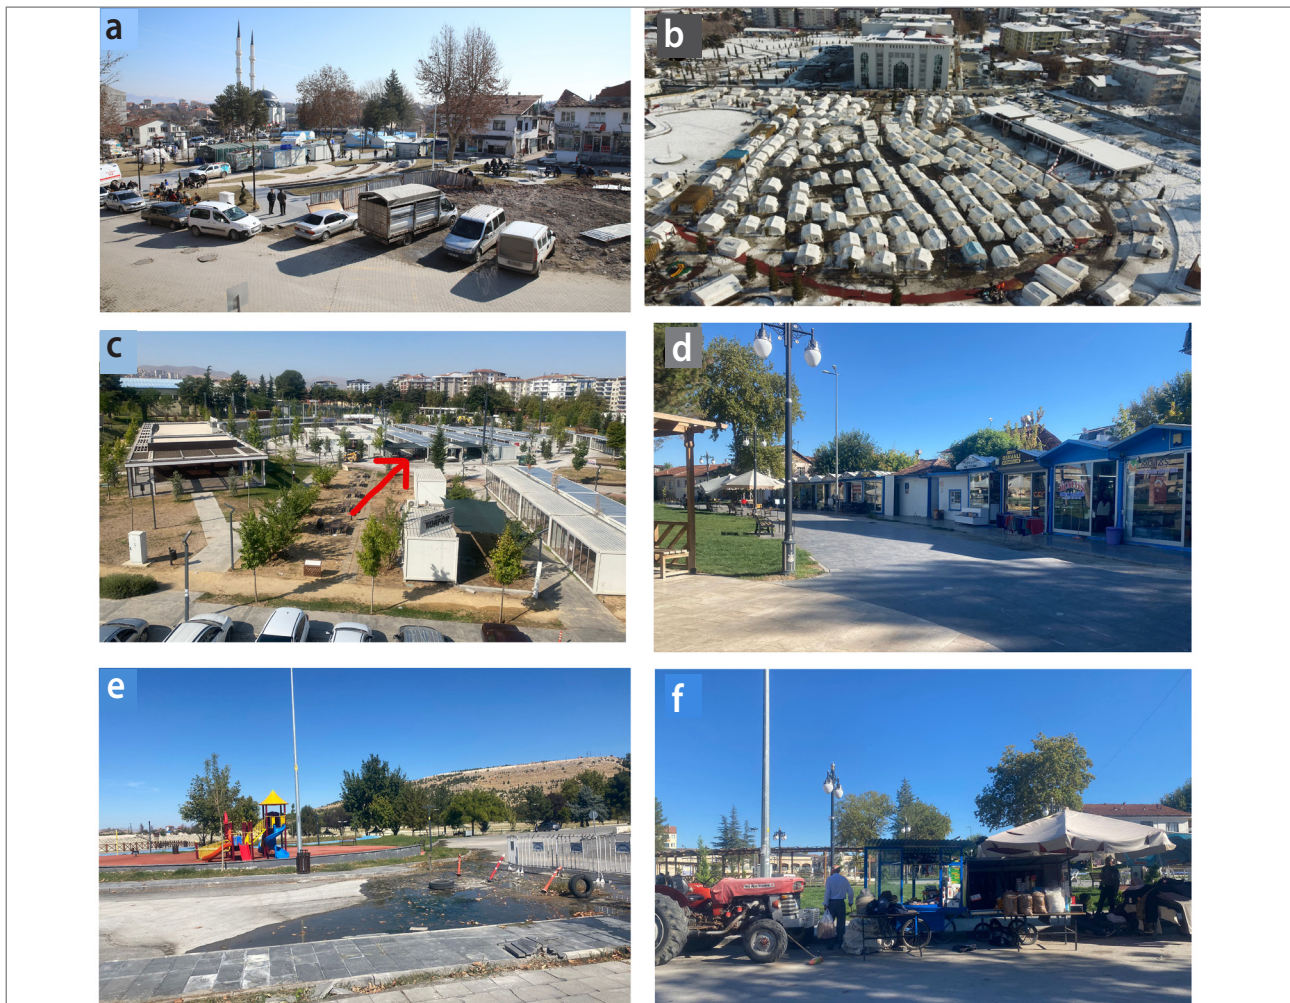
**Figure 3:** Views of selected POSs in Malatya after the 2023 earthquake: a) container settlement in Eski Malatya Meydan Park; b) large-scale tent settlement in Battalgazi Municipal Garden; c) container complexes in Millet Garden; d) kiosks and informal commercial activity in Abdullah Gül Park; e) damaged playground in Mişmiş Park; and f) informal market activities in Eski Malatya Meydan Park (photo: authors).

hub due to its proximity to the Municipality of Battalgazi and the city centre. Field visits after the earthquake revealed that the park has been converted into a commercial area dominated by container units. Green spaces and playgrounds have disappeared, replaced by small trading stalls. The infrastructure and restrooms have been damaged, lighting is inadequate, and hygiene issues are widespread. The site no longer functions as a social park but rather as a temporary commercial hub.

Before the earthquake, Eski Malatya Meydan Park was a meeting and transition point with significant pedestrian traffic due to its proximity to the bus terminal and Malatya's ancient core. After the earthquake, it was transformed into a container market and temporary housing area. Pavements are broken, and the space has become overcrowded and disorganized. It has lost its original identity and is now mostly used as a thoroughfare for pedestrians and temporary residents.

Abdullah Gül Park was once a prominent social and sports venue, especially at night. It has been turned into a dense area filled with container shops and temporary market stalls. Playgrounds and green spaces have been damaged, and infrastructure has weakened. The park's recreational purpose has declined, now mainly serving short-term visitors.
